## Profile/Photo Observation Report

Street:	<b>N High St.</b>	Flow Control:	<b>Not Controlled</b>
City:	<b>Hobart, IN</b>	Year Renewed:	
Location:	<b>Other</b>	Tape/Media #:	
Purpose:	<b>Not Known</b>	Dia/Height:	<b>10"</b>
Use:	<b>Sanitary</b>	Material:	<b>VCP</b>
Drain Area:	<b>NA</b>	Lining:	
Category:	<b>NA</b>		
Comment:

Location Details:		Direction of Survey:	<b>Upstream</b>
US MH:	<b>M-804-041</b>	DS MH:	<b>M-804-042</b>
		Total Length Surveyed (ft):	<b>81.9</b>

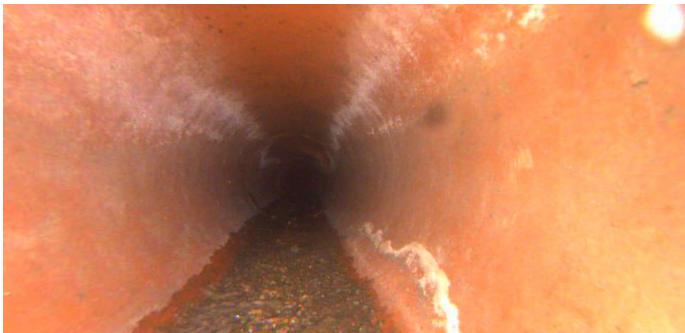
Code:	<b>DSF</b>
Description:	<b>Deposits Settled Fine</b>

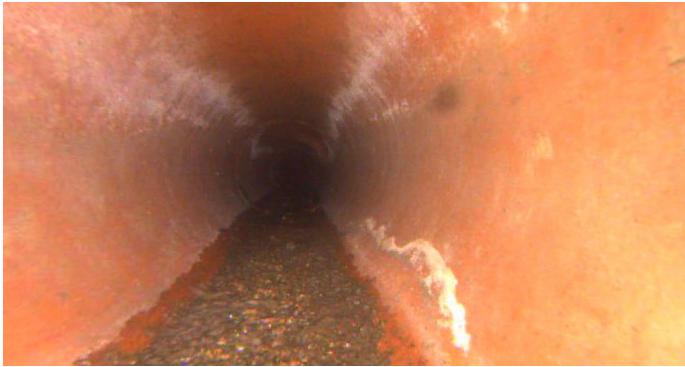
Code: **AMH**  
Description: **Manhole**

Distance (ft): **.0**  
Structural Grade: **0**  
O&M Grade: **0**  
Clock Start/From:  
Clock To:  
1st Value:  
2nd Value:  
Value Percent:  
Continuous Index:  
Within 8" of Joint: **NO**  
Remarks: **M-804-042**

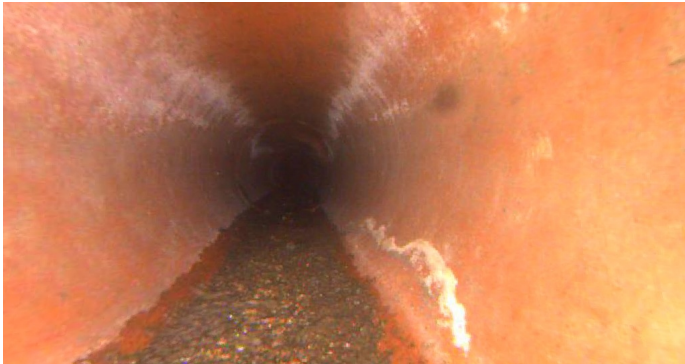
Code: **MWL**  
Description: **Water Level**

Distance (ft): **.0**  
Structural Grade: **0**  
O&M Grade: **0**  
Clock Start/From:  
Clock To:  
1st Value:  
2nd Value:  
Value Percent: **10.000**  
Continuous Index:  
Within 8" of Joint: **NO**  
Remarks:

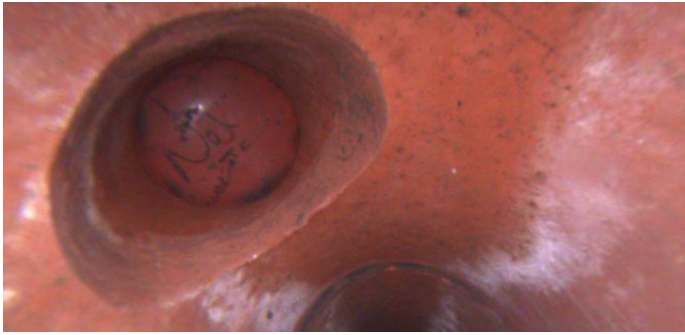
Code: **TFC**  
Description: **Tap Factory Capped**

Distance (ft): **4.9**  
Structural Grade: **0**  
O&M Grade: **0**  
Clock Start/From: **1**  
Clock To:  
1st Value: **4.000**  
2nd Value:  
Value Percent:  
Continuous Index:  
Within 8" of Joint:  
Remarks:

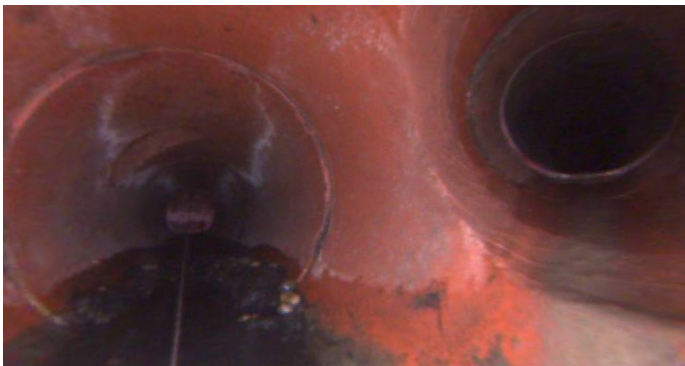
Code: **TF**  
Description: **Tap Factory**

Distance (ft): **6.7**  
Structural Grade: **0**  
O&M Grade: **0**  
Clock Start/From: **9**  
Clock To:  
1st Value: **4.000**  
2nd Value:  
Value Percent:  
Continuous Index:  
Within 8" of Joint:  
Remarks:

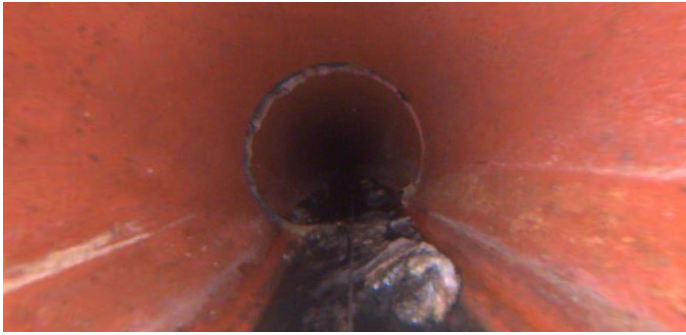
Code: **DSZ**  
Description: **Deposits Settled Other**

Distance (ft): **44.1**  
Structural Grade: **0**  
O&M Grade: **2**  
Clock Start/From: **5**  
Clock To: **7**  
1st Value:  
2nd Value:  
Value Percent: **5.000**  
Continuous Index:  
Within 8" of Joint: **YES**  
Remarks: **MISC**

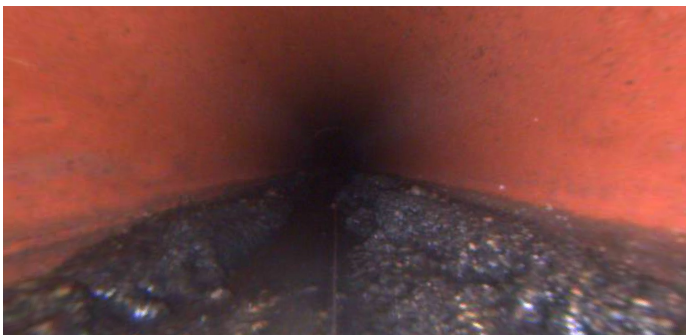
Code: **DSF**  
Description: **Deposits Settled Fine**

Distance (ft): **67.3**  
Structural Grade: **0**  
O&M Grade: **3**  
Clock Start/From: **4**  
Clock To: **8**  
1st Value:  
2nd Value:  
Value Percent: **20.000**  
Continuous Index:  
Within 8" of Joint: **NO**  
Remarks:

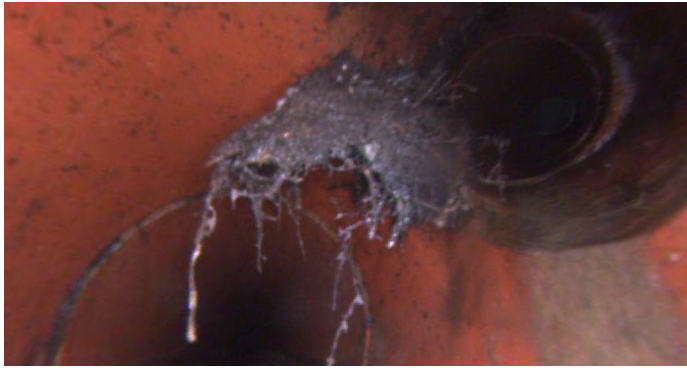
Code: **TFD**  
Description: **Tap Factory Defective**

Distance (ft): **68.9**  
Structural Grade: **0**  
O&M Grade: **2**  
Clock Start/From: **10**  
Clock To:  
1st Value: **4.000**  
2nd Value:  
Value Percent:  
Continuous Index:  
Within 8" of Joint:  
Remarks: **RFL**

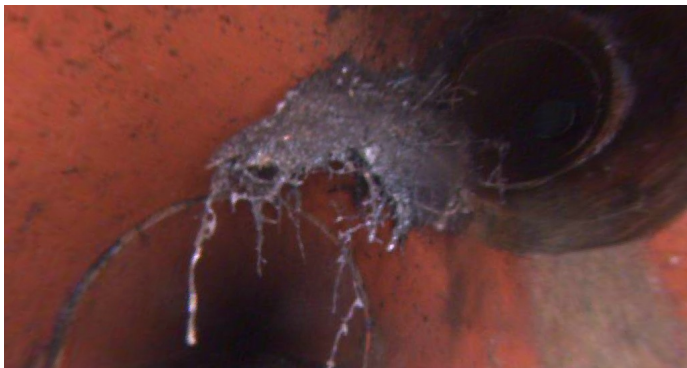
Code: **RFL**  
Description: **Roots Fine Lateral**

Distance (ft): **68.9**  
Structural Grade: **0**  
O&M Grade: **1**  
Clock Start/From: **10**  
Clock To:  
1st Value:  
2nd Value:  
Value Percent:  
Continuous Index:  
Within 8" of Joint: **NO**  
Remarks:

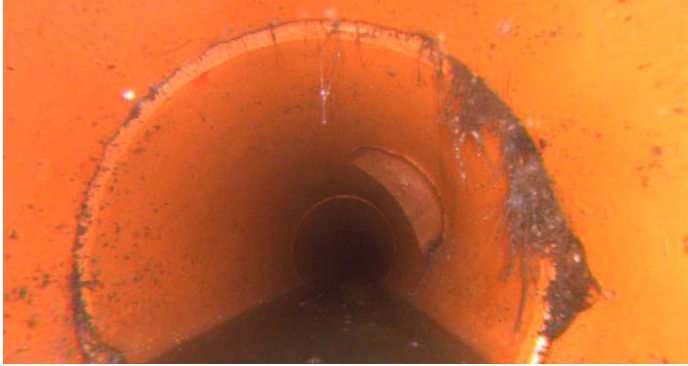
Code: **RFJ**  
Description: **Roots Fine Joint**

Distance (ft): **69.4**  
Structural Grade: **0**  
O&M Grade: **1**  
Clock Start/From: **7**  
Clock To: **5**  
1st Value:  
2nd Value:  
Value Percent:  
Continuous Index:  
Within 8" of Joint: **YES**  
Remarks:

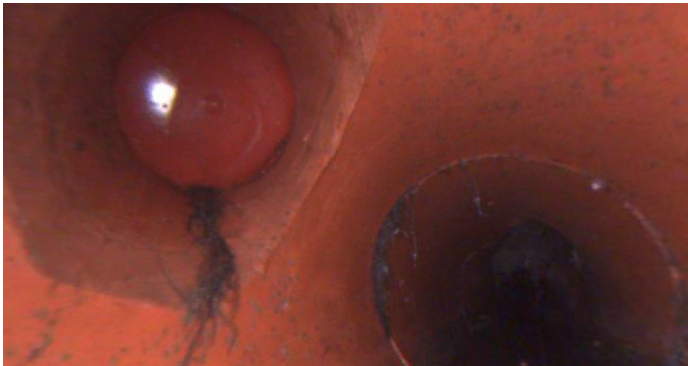
Code: **TFC**  
Description: **Tap Factory Capped**

Distance (ft): **71.1**  
Structural Grade: **0**  
O&M Grade: **0**  
Clock Start/From: **2**  
Clock To:  
1st Value: **4.000**  
2nd Value:  
Value Percent:  
Continuous Index:  
Within 8" of Joint:  
Remarks:

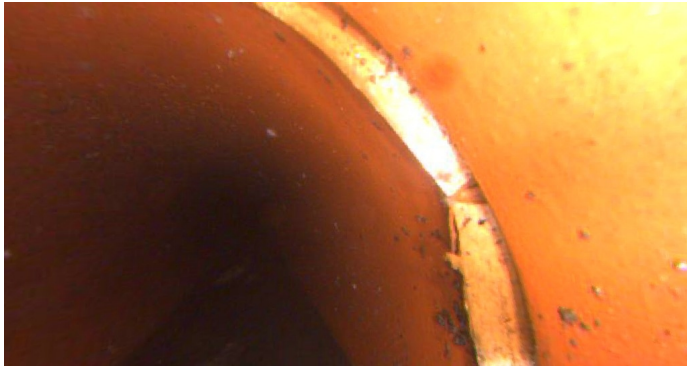
Code:	<b>MSA</b>
Description:	<b>Abandoned Survey</b>
Distance (ft):	<b>81.9</b>
Structural Grade:	<b>0</b>
O&M Grade:	<b>0</b>
Clock Start/From:	
Clock To:	
1st Value:	
2nd Value:	
Value Percent:	
Continuous Index:	
Within 8" of Joint:	<b>NO</b>
Remarks:	<b>Roll max</b>
