Profile/Photo Observation Report

Date:	10/05/2018	Weather:		Coding:	PACP 6.0
Pipe Length (ft):	382.4	Owner:	NA	Pre Clean:	Not Known
P.O.#:		Surveyor:	Justin Gonzales	PSR:	P-804-042-041
Customer:		Clean Date:	01/01/1900	Shape:	C

Street:	High St.	Flow Control:	Not Controlled
City:	Hobart, IN	Year Renewed:	
Location:	Light Highway	Tape/Media #:	
Purpose:	Routine Assessment	Dia/Height:	10"
Use:	Sanitary	Material:	VCP
Drain Area:	NA	Lining:	
Category:	NA		
Comment:

Location Details:		Direction of Survey:	Upstream
US MH:	M-804-041	DS MH:	M-804-042
		Total Length Surveyed (ft):	232.5

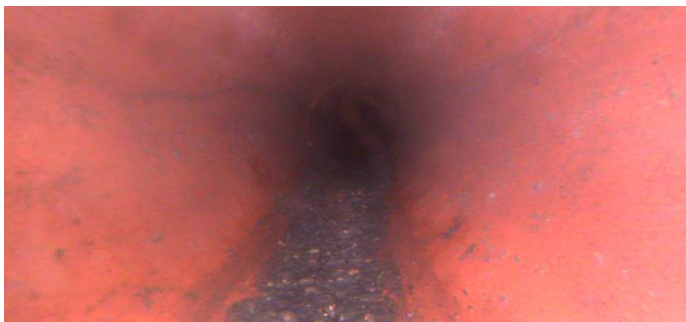
Code: **AMH**
Description: **Manhole**

Distance (ft): **.0**
Structural Grade: **0**
O&M Grade: **0**
Clock Start/From:
Clock To:
1st Value:
2nd Value:
Value Percent:
Continuous Index:
Within 8" of Joint: **NO**
Remarks: **M-804-042**

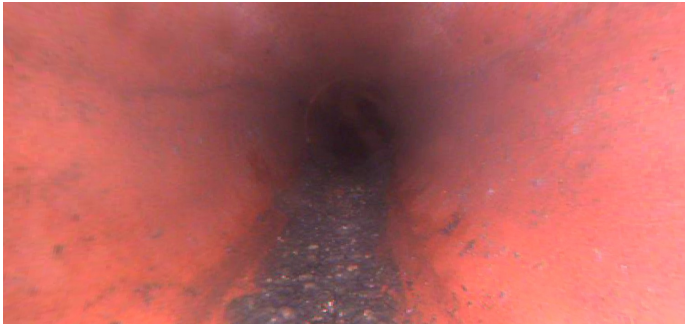
Code:	MWL
Description:	Water Level

Distance (ft):	.0
Structural Grade:	0
O&M Grade:	0
Clock Start/From:	
Clock To:	
1st Value:	
2nd Value:	
Value Percent:	5.000
Continuous Index:	
Within 8" of Joint:	NO
Remarks:

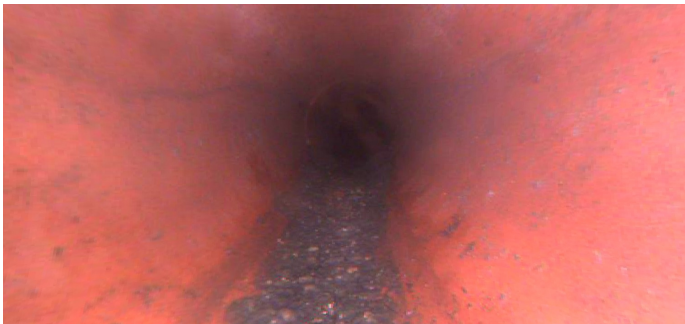
Code:	DSF
Description:	Deposits Settled Fine

Distance (ft):	.0
Structural Grade:	0
O&M Grade:	2
Clock Start/From:	6
Clock To:	
1st Value:	
2nd Value:	
Value Percent:	5.000
Continuous Index:	S01
Within 8" of Joint:	YES
Remarks:

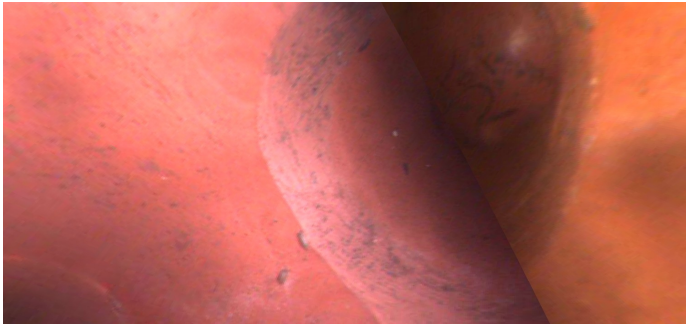
Code: **TFC**
Description: **Tap Factory Capped**

Distance (ft): **4.5**
Structural Grade: **0**
O&M Grade: **0**
Clock Start/From: **2**
Clock To:
1st Value: **4.000**
2nd Value:
Value Percent:
Continuous Index:
Within 8" of Joint:
Remarks:

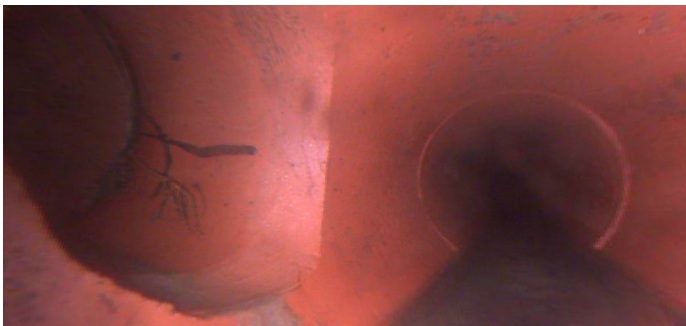
Code: **TF**
Description: **Tap Factory**

Distance (ft): **6.2**
Structural Grade: **0**
O&M Grade: **0**
Clock Start/From: **9**
Clock To:
1st Value: **4.000**
2nd Value:
Value Percent:
Continuous Index:
Within 8" of Joint:
Remarks:

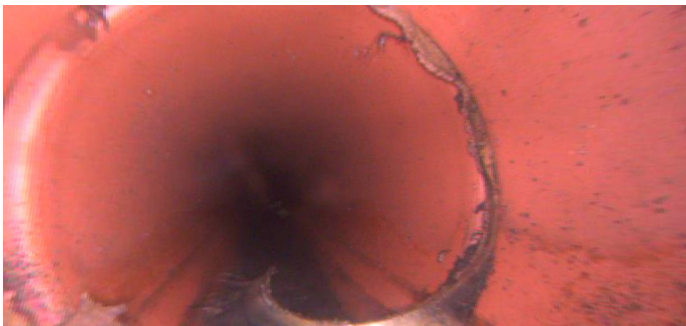
Code: **ISSRL**
Description: **Intruding Sealing Ring Loose/Poorly Fitting**

Distance (ft): **41.8**
Structural Grade: **0**
O&M Grade: **2**
Clock Start/From: **7**
Clock To: **5**
1st Value:
2nd Value:
Value Percent: **5.000**
Continuous Index:
Within 8" of Joint: **NO**
Remarks:

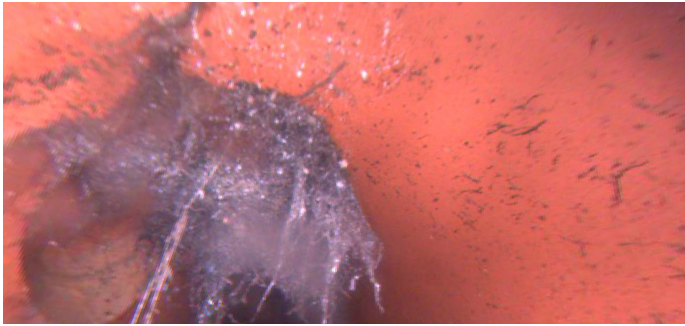
Code: **TFD**
Description: **Tap Factory Defective**

Distance (ft): **67.9**
Structural Grade: **0**
O&M Grade: **2**
Clock Start/From: **10**
Clock To:
1st Value: **4.000**
2nd Value:
Value Percent:
Continuous Index:
Within 8" of Joint:
Remarks: **RM COMING FROM TAP**

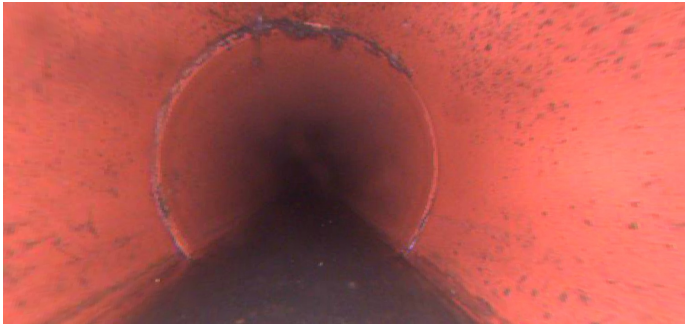
Code: **RFJ**
Description: **Roots Fine Joint**

Distance (ft): **76.0**
Structural Grade: **0**
O&M Grade: **1**
Clock Start/From: **7**
Clock To: **5**
1st Value:
2nd Value:
Value Percent:
Continuous Index: **S03**
Within 8" of Joint: **YES**
Remarks: **WANDER**
