Profile/Photo Observation Report

Street:	ALLEY BETWEEN HIGH ST & SOUTH S	Flow Control:	Not Controlled
City:	Hobart, IN	Year Renewed:	
Location:	Other	Tape/Media #:	
Purpose:	Not Known	Dia/Height:	12"
Use:	Sanitary	Material:	VCP
Drain Area:	NA	Lining:	
Category:	NA		
Comment:

Location Details:		Direction of Survey:	Downstream
US MH:	M-804-044	DS MH:	M-804-043
		Total Length Surveyed (ft):	17.0

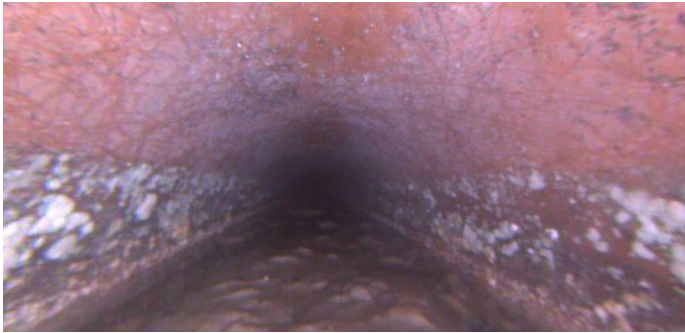
Code:	MWL
Description:	Water Level

Distance (ft):	.0
Structural Grade:	0
O&M Grade:	0
Clock Start/From:	
Clock To:	
1st Value:	
2nd Value:	
Value Percent:	20.000
Continuous Index:	
Within 8" of Joint:	NO
Remarks:

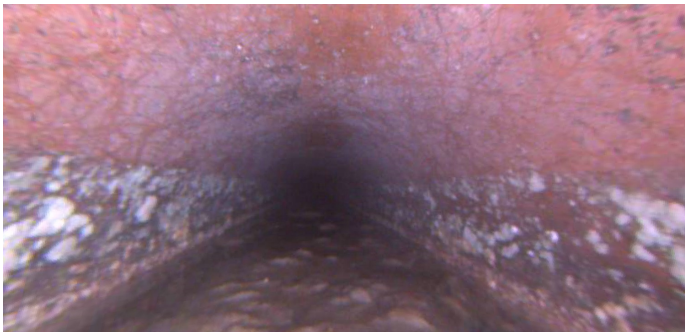
Code:	DAGS
Description:	Deposits Attached Grease

Distance (ft):	.0
Structural Grade:	0
O&M Grade:	2
Clock Start/From:	8
Clock To:	4
1st Value:	
2nd Value:	
Value Percent:	5.000
Continuous Index:	S01
Within 8" of Joint:	NO
Remarks:

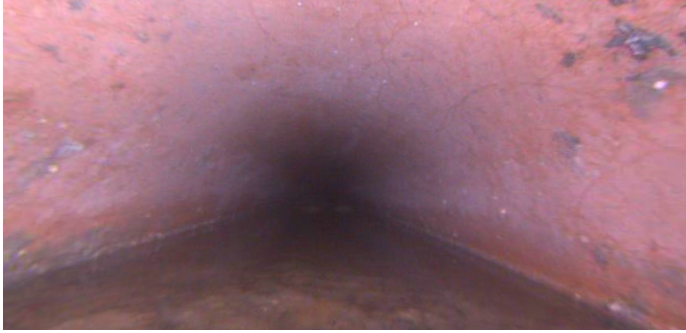
Code: **DAGS**
Description: **Deposits Attached Grease**

Distance (ft): **10.4**
Structural Grade: **0**
O&M Grade: **2**
Clock Start/From: **8**
Clock To: **4**
1st Value:
2nd Value:
Value Percent: **5.000**
Continuous Index: **F01**
Within 8" of Joint: **NO**
Remarks:

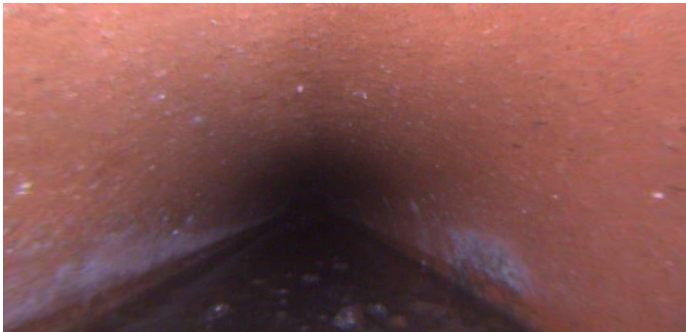
Code: **MSA**
Description: **Abandoned Survey**

Distance (ft): **17.0**
Structural Grade: **0**
O&M Grade: **0**
Clock Start/From:
Clock To:
1st Value:
2nd Value:
Value Percent:
Continuous Index:
Within 8" of Joint: **NO**
Remarks: **debris under wataer**
