## Profile/Photo Observation Report

Street:	<b>N High St.</b>	Flow Control:	<b>Not Controlled</b>
City:	<b>Hobart, IN</b>	Year Renewed:	
Location:	<b>Other</b>	Tape/Media #:	
Purpose:	<b>Not Known</b>	Dia/Height:	<b>12"</b>
Use:	<b>Sanitary</b>	Material:	<b>VCP</b>
Drain Area:	<b>NA</b>	Lining:	
Category:	<b>NA</b>		
Comment:

Location Details:		Direction of Survey:	<b>Downstream</b>
US MH:	<b>M-804-044</b>	DS MH:	<b>M-804-043</b>
		Total Length Surveyed (ft):	<b>17.0</b>

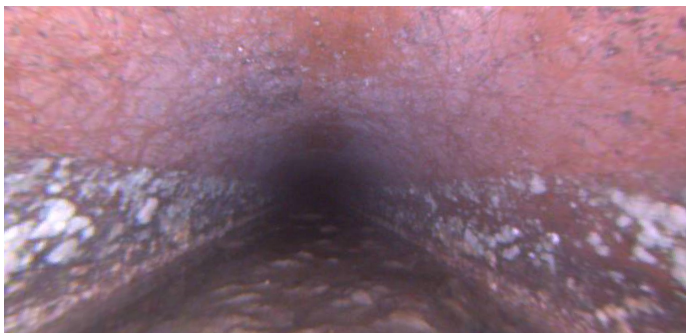
Code: **AMH**  
Description: **Manhole**

Distance (ft): **.0**  
Structural Grade: **0**  
O&M Grade: **0**  
Clock Start/From:  
Clock To:  
1st Value:  
2nd Value:  
Value Percent:  
Continuous Index:  
Within 8" of Joint: **NO**  
Remarks: **M-804-044**

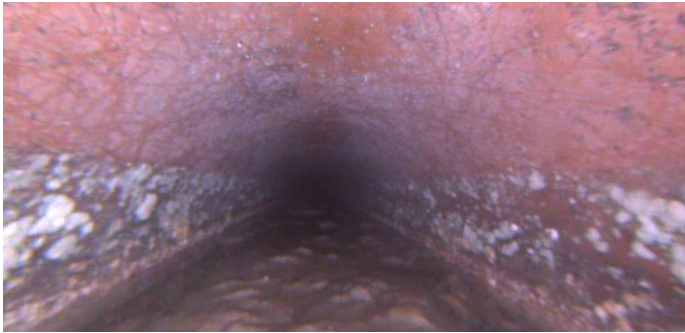
Code:	<b>MWL</b>
Description:	<b>Water Level</b>

Distance (ft):	<b>.0</b>
Structural Grade:	<b>0</b>
O&M Grade:	<b>0</b>
Clock Start/From:	
Clock To:	
1st Value:	
2nd Value:	
Value Percent:	<b>20.000</b>
Continuous Index:	
Within 8" of Joint:	<b>NO</b>
Remarks:

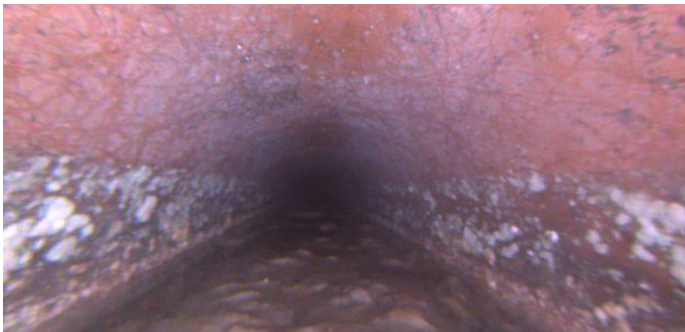
Code:	<b>DAGS</b>
Description:	<b>Deposits Attached Grease</b>

Distance (ft):	<b>.0</b>
Structural Grade:	<b>0</b>
O&M Grade:	<b>2</b>
Clock Start/From:	<b>8</b>
Clock To:	<b>4</b>
1st Value:	
2nd Value:	
Value Percent:	<b>5.000</b>
Continuous Index:	<b>S01</b>
Within 8" of Joint:	<b>NO</b>
Remarks:

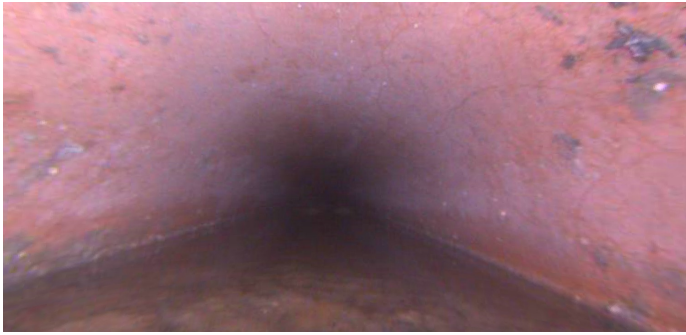
Code: **DAGS**  
Description: **Deposits Attached Grease**

Distance (ft): **10.4**  
Structural Grade: **0**  
O&M Grade: **2**  
Clock Start/From: **8**  
Clock To: **4**  
1st Value:  
2nd Value:  
Value Percent: **5.000**  
Continuous Index: **F01**  
Within 8" of Joint: **NO**  
Remarks:

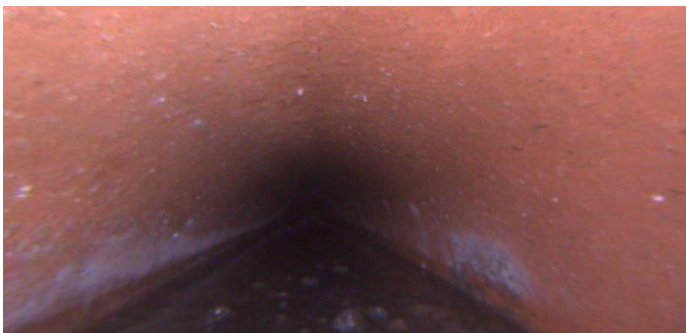
Code: **MSA**  
Description: **Abandoned Survey**

Distance (ft): **17.0**  
Structural Grade: **0**  
O&M Grade: **0**  
Clock Start/From:  
Clock To:  
1st Value:  
2nd Value:  
Value Percent:  
Continuous Index:  
Within 8" of Joint: **NO**  
Remarks: **debris under wataer**
