Profile/Photo Observation Report

Street:	ALLEY BETWEEN HIGH ST & SOUTH S	Flow Control:	Not Controlled
City:	Hobart, IN	Year Renewed:	
Location:	Other	Tape/Media #:	
Purpose:	Not Known	Dia/Height:	12"
Use:	Sanitary	Material:	VCP
Drain Area:	NA	Lining:	
Category:	NA		
Comment:

Location Details:		Direction of Survey:	Downstream
US MH:	M-804-044	DS MH:	M-804-046
		Total Length Surveyed (ft):	8.9

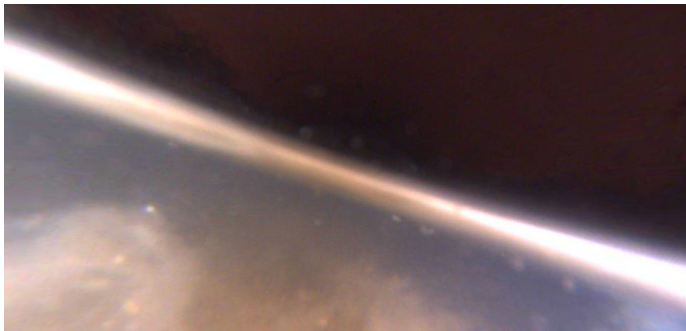
Code: **AMH**
Description: **Manhole**

Distance (ft): **.0**
Structural Grade: **0**
O&M Grade: **0**
Clock Start/From:
Clock To:
1st Value:
2nd Value:
Value Percent:
Continuous Index:
Within 8" of Joint: **NO**
Remarks: **M-804-044**

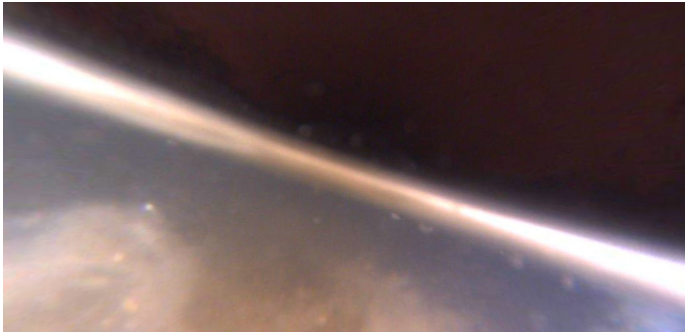
Code:	MWL
Description:	Water Level

Distance (ft):	.0
Structural Grade:	0
O&M Grade:	0
Clock Start/From:	
Clock To:	
1st Value:	
2nd Value:	
Value Percent:	40.000
Continuous Index:	
Within 8" of Joint:	NO
Remarks:

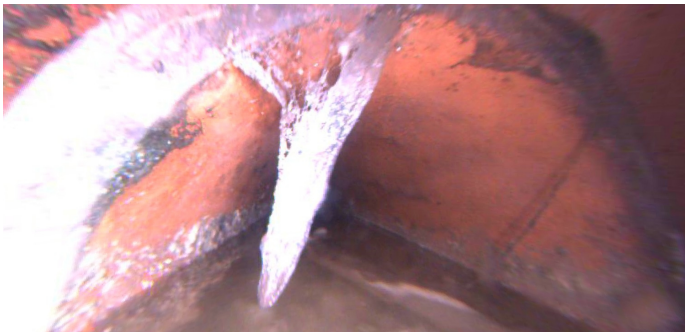
Code:	RMJ
Description:	Roots Medium Joint

Distance (ft):	2.7
Structural Grade:	0
O&M Grade:	3
Clock Start/From:	11
Clock To:	
1st Value:	
2nd Value:	
Value Percent:	10.000
Continuous Index:	
Within 8" of Joint:	YES
Remarks:

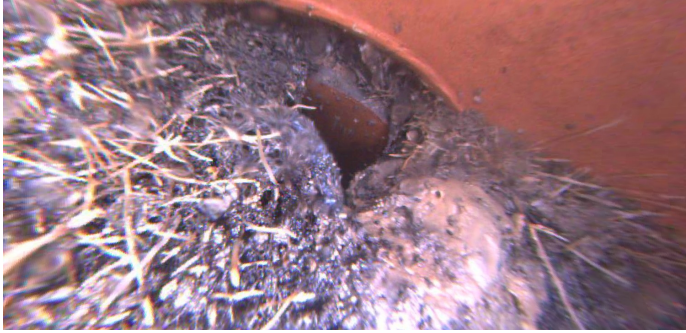
Code: **RBJ**
Description: **Roots Ball Joint**

Distance (ft): **7.5**
Structural Grade: **0**
O&M Grade: **4**
Clock Start/From: **8**
Clock To: **4**
1st Value:
2nd Value:
Value Percent: **90.000**
Continuous Index:
Within 8" of Joint: **YES**
Remarks:
