Profile/Photo Observation Report

Street:	ALLEY BETWEEN HIGH ST & SOUTH S	Flow Control:	Not Controlled
City:	Hobart, IN	Year Renewed:	
Location:	Other	Tape/Media #:	
Purpose:	Not Known	Dia/Height:	8"
Use:	Sanitary	Material:	VCP
Drain Area:	NA	Lining:	
Category:	NA		
Comment:

Location Details:		Direction of Survey:	Upstream
US MH:	M-804-044	DS MH:	M-804-046
		Total Length Surveyed (ft):	193.2

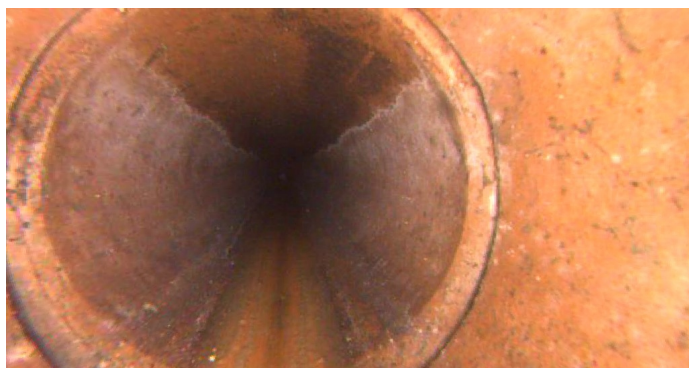
Code: **AMH**
Description: **Manhole**

Distance (ft): **.0**
Structural Grade: **0**
O&M Grade: **0**
Clock Start/From:
Clock To:
1st Value:
2nd Value:
Value Percent:
Continuous Index:
Within 8" of Joint: **NO**
Remarks: **M-804-046**

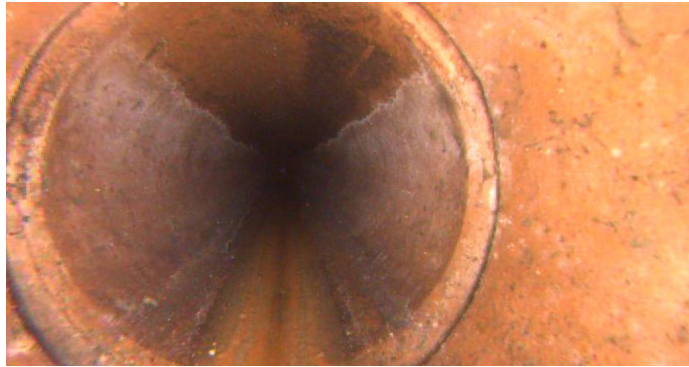
Code: **MWL**
Description: **Water Level**

Distance (ft): **.0**
Structural Grade: **0**
O&M Grade: **0**
Clock Start/From:
Clock To:
1st Value:
2nd Value:
Value Percent: **10.000**
Continuous Index:
Within 8" of Joint: **NO**
Remarks:

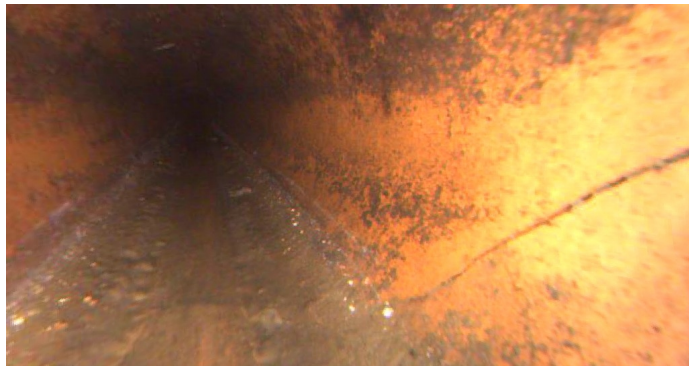
Code: **FS**
Description: **Fracture Spiral**

Distance (ft): **31.6**
Structural Grade: **3**
O&M Grade: **0**
Clock Start/From: **4**
Clock To: **5**
1st Value:
2nd Value:
Value Percent:
Continuous Index:
Within 8" of Joint: **YES**
Remarks:

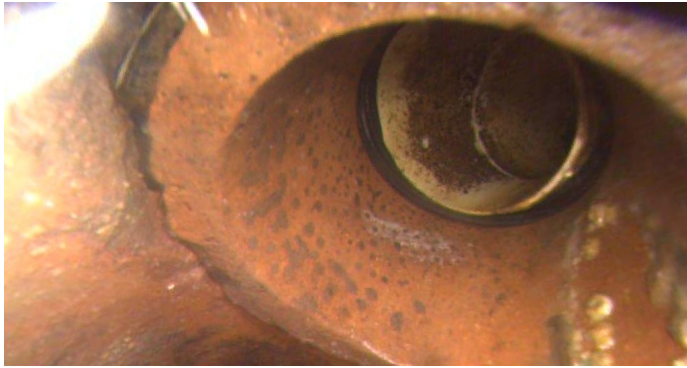
Code: **TBI**
Description: **Tap Break-in Intruding**

Distance (ft): **57.8**
Structural Grade: **0**
O&M Grade: **2**
Clock Start/From: **2**
Clock To:
1st Value: **4.000**
2nd Value: **1.000**
Value Percent:
Continuous Index:
Within 8" of Joint:
Remarks:

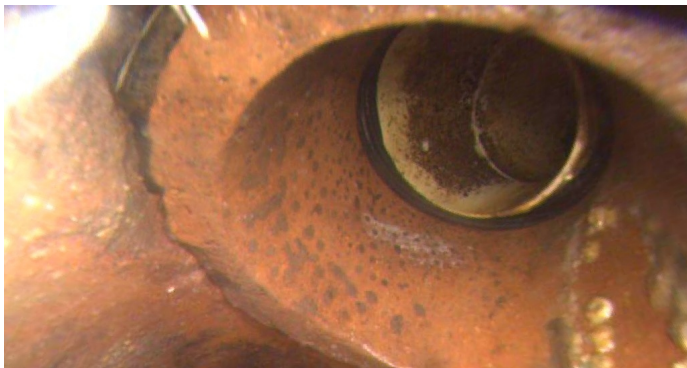
Code: **RFC**
Description: **Roots Fine Connection**

Distance (ft): **57.8**
Structural Grade: **0**
O&M Grade: **1**
Clock Start/From: **2**
Clock To:
1st Value:
2nd Value:
Value Percent:
Continuous Index:
Within 8" of Joint: **NO**
Remarks:

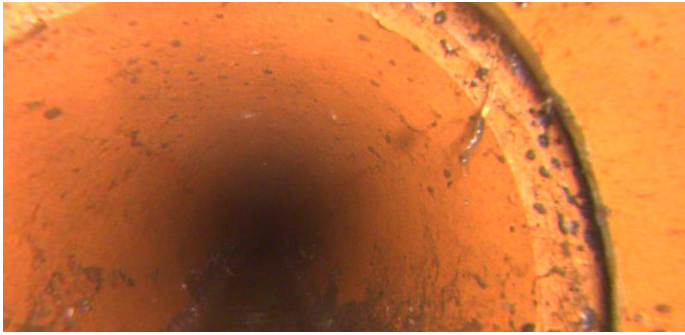
Code: **RFJ**
Description: **Roots Fine Joint**

Distance (ft): **106.4**
Structural Grade: **0**
O&M Grade: **1**
Clock Start/From: **2**
Clock To:
1st Value:
2nd Value:
Value Percent:
Continuous Index:
Within 8" of Joint: **YES**
Remarks:

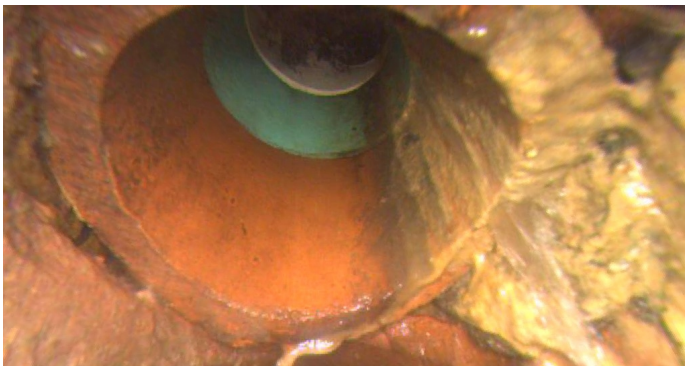
Code: **TBI**
Description: **Tap Break-in Intruding**

Distance (ft): **122.2**
Structural Grade: **0**
O&M Grade: **2**
Clock Start/From: **1**
Clock To:
1st Value: **4.000**
2nd Value: **1.000**
Value Percent:
Continuous Index:
Within 8" of Joint:
Remarks:

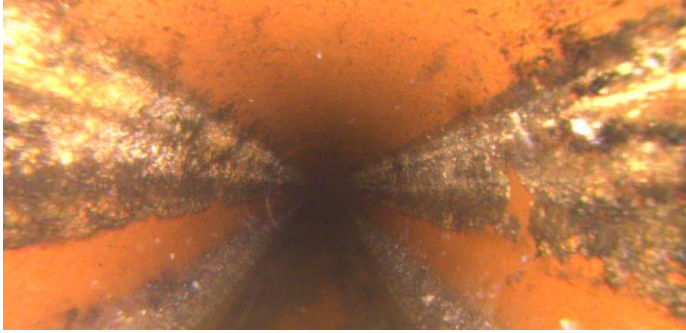
Code: **DAGS**
Description: **Deposits Attached Grease**

Distance (ft): **124.8**
Structural Grade: **0**
O&M Grade: **2**
Clock Start/From: **8**
Clock To: **4**
1st Value:
2nd Value:
Value Percent: **5.000**
Continuous Index: **S02**
Within 8" of Joint: **NO**
Remarks:

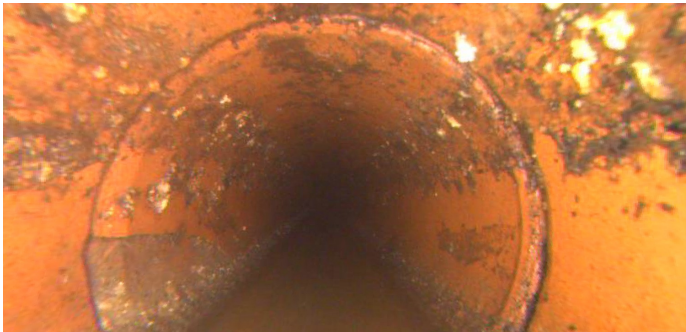
Code: **FL**
Description: **Fracture Longitudinal**

Distance (ft): **156.3**
Structural Grade: **3**
O&M Grade: **0**
Clock Start/From: **9**
Clock To:
1st Value:
2nd Value:
Value Percent:
Continuous Index:
Within 8" of Joint: **YES**
Remarks:

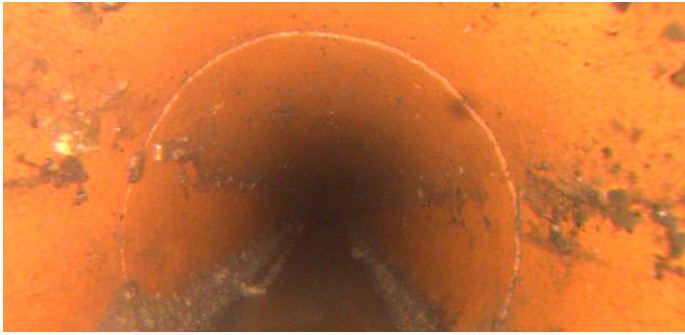
Code: **FC**
Description: **Fracture Circumferential**

Distance (ft): **162.6**
Structural Grade: **2**
O&M Grade: **0**
Clock Start/From: **12**
Clock To: **12**
1st Value:
2nd Value:
Value Percent:
Continuous Index:
Within 8" of Joint:
Remarks:

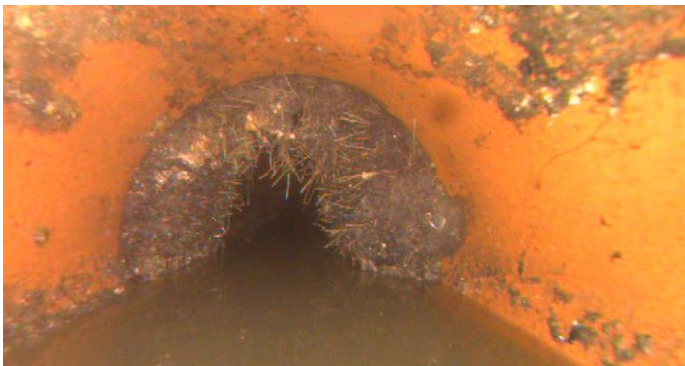
Code: **RMB**
Description: **Roots Medium Barrel**

Distance (ft): **181.0**
Structural Grade: **0**
O&M Grade: **4**
Clock Start/From: **7**
Clock To: **5**
1st Value:
2nd Value:
Value Percent: **15.000**
Continuous Index: **S01**
Within 8" of Joint: **NO**
Remarks:
