Profile/Photo Observation Report

Street:	N High St.	Flow Control:	Not Controlled
City:	Hobart, IN	Year Renewed:	
Location:	Other	Tape/Media #:	
Purpose:	Not Known	Dia/Height:	8"
Use:	Sanitary	Material:	VCP
Drain Area:	NA	Lining:	
Category:	NA		
Comment:

Location Details:		Direction of Survey:	Upstream
US MH:	M-804-044	DS MH:	M-804-046
		Total Length Surveyed (ft):	193.2

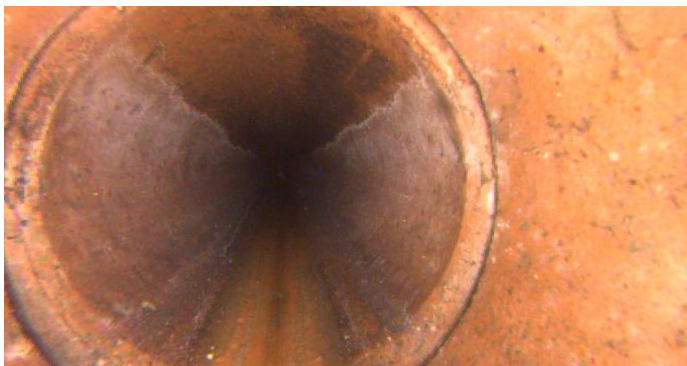
Code: **AMH**
 Description: **Manhole**

Distance (ft): **.0**
 Structural Grade: **0**
 O&M Grade: **0**
 Clock Start/From:
 Clock To:
 1st Value:
 2nd Value:
 Value Percent:
 Continuous Index:
 Within 8" of Joint: **NO**
 Remarks: **M-804-046**

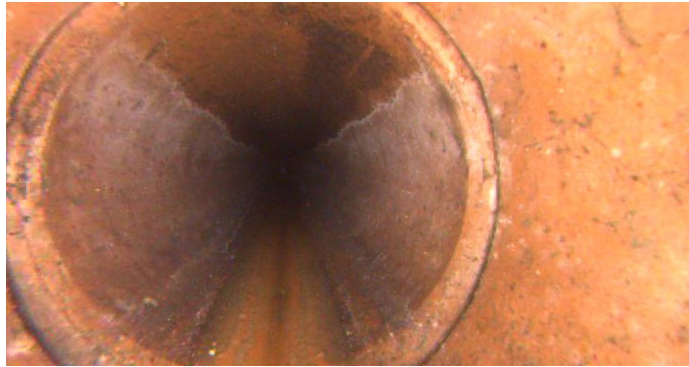
Code: **MWL**
Description: **Water Level**

Distance (ft): **.0**
Structural Grade: **0**
O&M Grade: **0**
Clock Start/From:
Clock To:
1st Value:
2nd Value:
Value Percent: **10.000**
Continuous Index:
Within 8" of Joint: **NO**
Remarks:

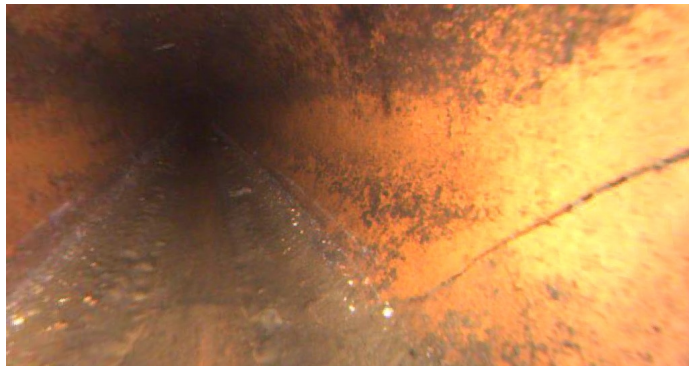
Code: **FS**
Description: **Fracture Spiral**

Distance (ft): **31.6**
Structural Grade: **3**
O&M Grade: **0**
Clock Start/From: **4**
Clock To: **5**
1st Value:
2nd Value:
Value Percent:
Continuous Index:
Within 8" of Joint: **YES**
Remarks:

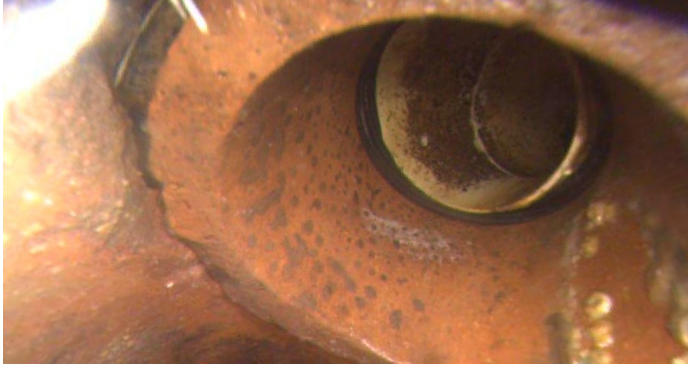
Code: **TBI**
Description: **Tap Break-in Intruding**

Distance (ft): **57.8**
Structural Grade: **0**
O&M Grade: **2**
Clock Start/From: **2**
Clock To:
1st Value: **4.000**
2nd Value: **1.000**
Value Percent:
Continuous Index:
Within 8" of Joint:
Remarks:

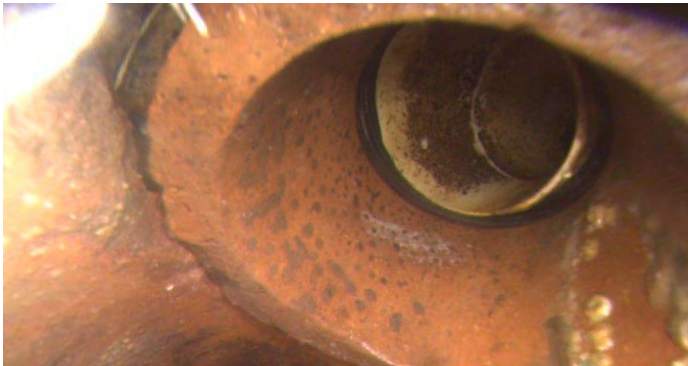
Code: **RFC**
Description: **Roots Fine Connection**

Distance (ft): **57.8**
Structural Grade: **0**
O&M Grade: **1**
Clock Start/From: **2**
Clock To:
1st Value:
2nd Value:
Value Percent:
Continuous Index:
Within 8" of Joint: **NO**
Remarks:

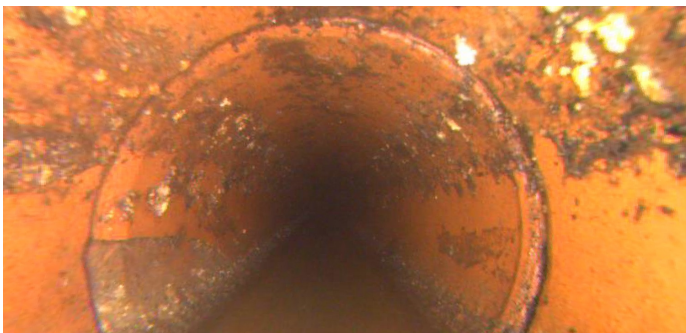
Code: **FL**
Description: **Fracture Longitudinal**

Distance (ft): **156.3**
Structural Grade: **3**
O&M Grade: **0**
Clock Start/From: **9**
Clock To:
1st Value:
2nd Value:
Value Percent:
Continuous Index:
Within 8" of Joint: **YES**
Remarks:

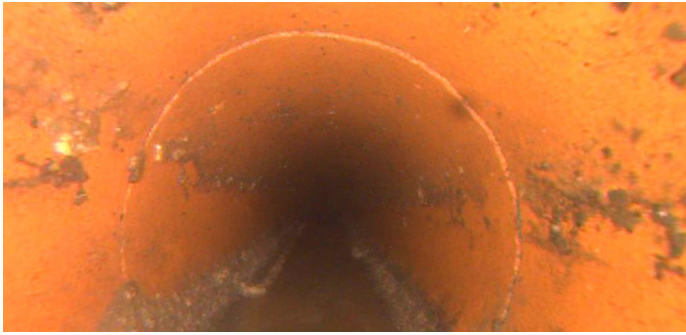
Code: **FC**
Description: **Fracture Circumferential**

Distance (ft): **162.6**
Structural Grade: **2**
O&M Grade: **0**
Clock Start/From: **12**
Clock To: **12**
1st Value:
2nd Value:
Value Percent:
Continuous Index:
Within 8" of Joint:
Remarks:

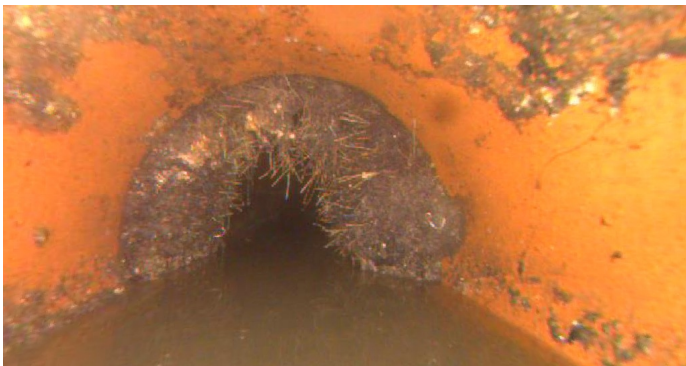
Code: **RMB**
Description: **Roots Medium Barrel**

Distance (ft): **181.0**
Structural Grade: **0**
O&M Grade: **4**
Clock Start/From: **7**
Clock To: **5**
1st Value:
2nd Value:
Value Percent: **15.000**
Continuous Index: **S01**
Within 8" of Joint: **NO**
Remarks:
