Profile/Photo Observation Report

Street:	N Ohio St.	Flow Control:	Not Controlled
City:	Hobart, IN	Year Renewed:	
Location:	Other	Tape/Media #:	
Purpose:	Not Known	Dia/Height:	10"
Use:	Sanitary	Material:	VCP
Drain Area:	NA	Lining:	
Category:	NA		
Comment:

Location Details:		Direction of Survey:	Downstream
US MH:	M-804-047	DS MH:	M-804-048
		Total Length Surveyed (ft):	27.7

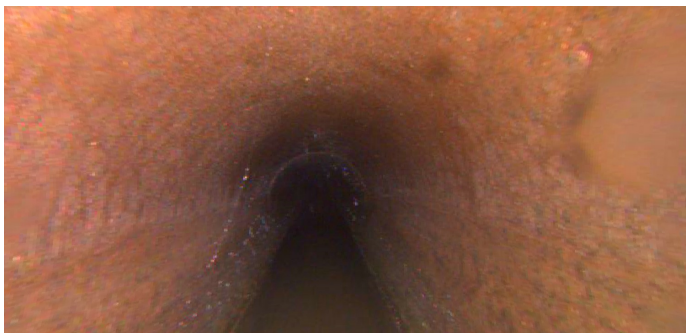
Code: **AMH**
 Description: **Manhole**
 Distance (ft): **.0**
 Structural Grade: **0**
 O&M Grade: **0**
 Clock Start/From:
 Clock To:
 1st Value:
 2nd Value:
 Value Percent:
 Continuous Index:
 Within 8" of Joint: **NO**
 Remarks: **M-804-047**

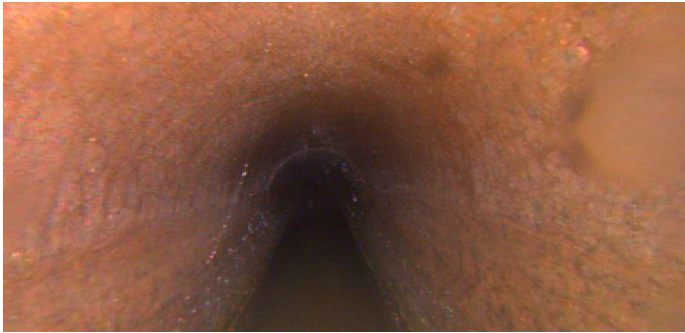
Code:	MWL
Description:	Water Level

Distance (ft):	.0
Structural Grade:	0
O&M Grade:	0
Clock Start/From:	
Clock To:	
1st Value:	
2nd Value:	
Value Percent:	5.000
Continuous Index:	
Within 8" of Joint:	NO
Remarks:
