Profile/Photo Observation Report

Date:	04/07/2018	Weather:		Coding:	PACP 6.0
Pipe Length (ft):	276.5	Owner:	NA	Pre Clean:	Not Known
P.O.#:		Surveyor:	Jen Costello	PSR:	P-804-048-047
Customer:		Clean Date:	01/01/1900	Shape:	C

Street:	N OHIO ST	Flow Control:	Not Controlled
City:	Hobart, IN	Year Renewed:	
Location:	Other	Tape/Media #:	
Purpose:	Not Known	Dia/Height:	10"
Use:	Sanitary	Material:	VCP
Drain Area:	NA	Lining:	
Category:	NA		
Comment:

Location Details:		Direction of Survey:	Downstream
US MH:	M-804-047	DS MH:	M-804-048
		Total Length Surveyed (ft):	14.9

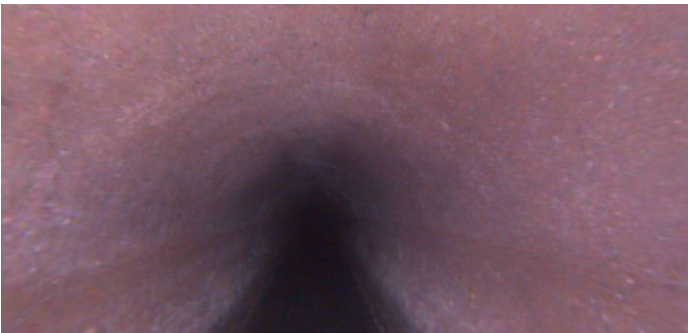
AMH

Manhole

.0

M-804-047

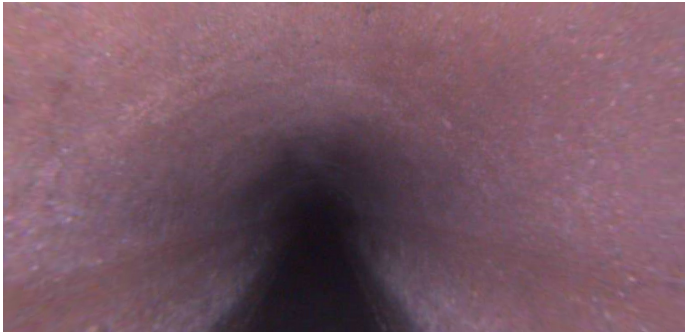
Code:	MWL
Description:	Water Level

Distance (ft):	.0
Structural Grade:	0
O&M Grade:	0
Clock Start/From:	
Clock To:	
1st Value:	
2nd Value:	
Value Percent:	5.000
Continuous Index:	
Within 8" of Joint:	NO
Remarks:

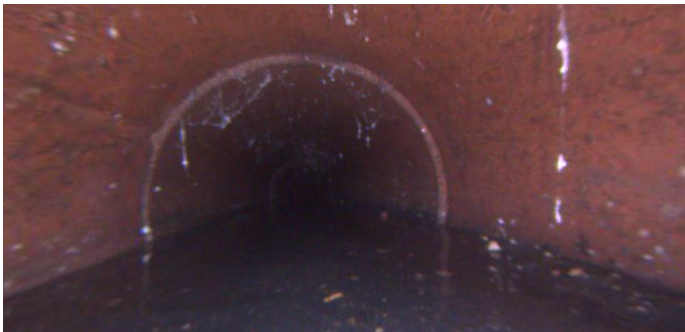
Code:	MSA
Description:	Abandoned Survey

Distance (ft):	14.9
Structural Grade:	0
O&M Grade:	0
Clock Start/From:	
Clock To:	
1st Value:	
2nd Value:	
Value Percent:	
Continuous Index:	
Within 8" of Joint:	NO
Remarks:	DEBRIS UNDER WATER
