Profile/Photo Observation Report

Street:	N OHIO ST	Flow Control:	Not Controlled
City:	Hobart, IN	Year Renewed:	
Location:	Other	Tape/Media #:	
Purpose:	Not Known	Dia/Height:	10"
Use:	Sanitary	Material:	VCP
Drain Area:	NA	Lining:	
Category:	NA		
Comment:

Location Details:		Direction of Survey:	Downstream
US MH:	M-804-048	DS MH:	M-804-049
		Total Length Surveyed (ft):	114.9

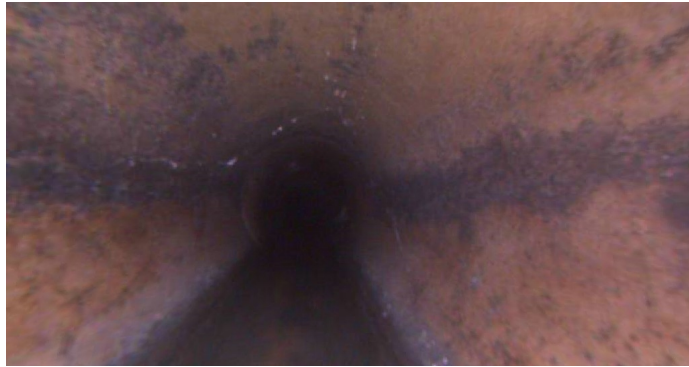
Code: **MWL**
Description: **Water Level**

Distance (ft): **.0**
Structural Grade: **0**
O&M Grade: **0**
Clock Start/From:
Clock To:
1st Value:
2nd Value:
Value Percent: **10.000**
Continuous Index:
Within 8" of Joint: **NO**
Remarks:

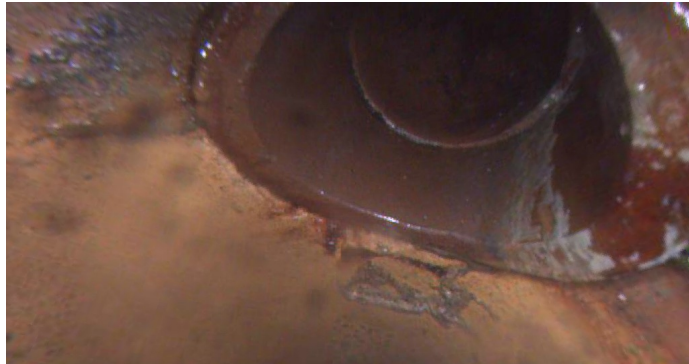
Code: **TB**
Description: **Tap Break-in**

Distance (ft): **5.2**
Structural Grade: **0**
O&M Grade: **0**
Clock Start/From: **11**
Clock To:
1st Value: **4.000**
2nd Value:
Value Percent:
Continuous Index:
Within 8" of Joint:
Remarks:

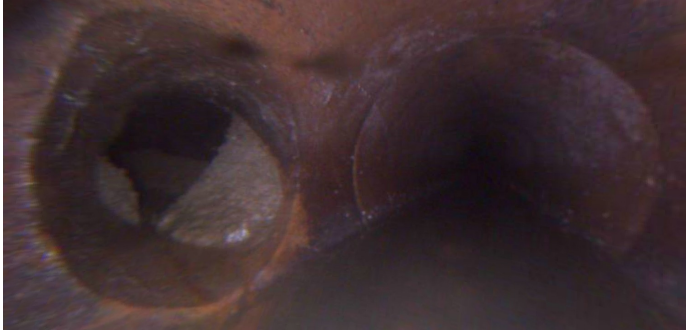
Code: **TF**
Description: **Tap Factory**

Distance (ft): **23.7**
Structural Grade: **0**
O&M Grade: **0**
Clock Start/From: **9**
Clock To:
1st Value: **4.000**
2nd Value:
Value Percent:
Continuous Index:
Within 8" of Joint:
Remarks:

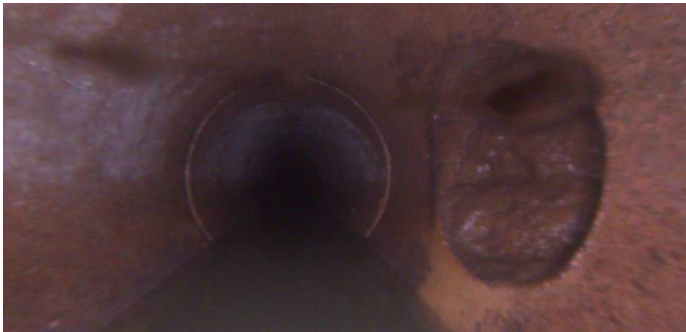
Code: **TF**
Description: **Tap Factory**

Distance (ft): **37.4**
Structural Grade: **0**
O&M Grade: **0**
Clock Start/From: **3**
Clock To:
1st Value: **4.000**
2nd Value:
Value Percent:
Continuous Index:
Within 8" of Joint:
Remarks:

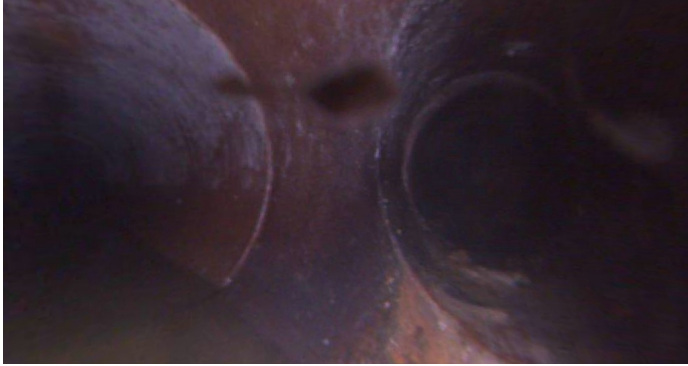
Code: **TF**
Description: **Tap Factory**

Distance (ft): **71.8**
Structural Grade: **0**
O&M Grade: **0**
Clock Start/From: **4**
Clock To:
1st Value: **4.000**
2nd Value:
Value Percent:
Continuous Index:
Within 8" of Joint:
Remarks:

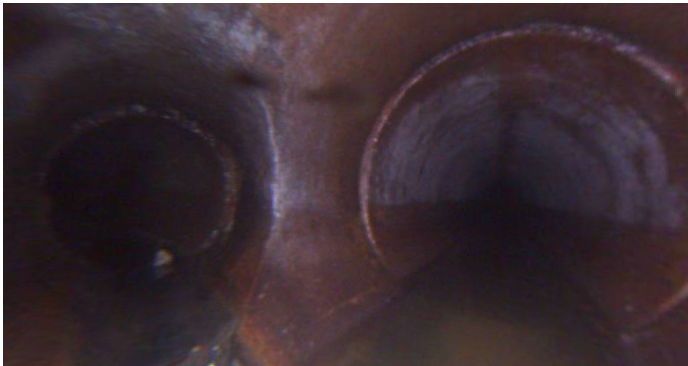
Code: **TF**
Description: **Tap Factory**

Distance (ft): **81.7**
Structural Grade: **0**
O&M Grade: **0**
Clock Start/From: **8**
Clock To:
1st Value: **4.000**
2nd Value:
Value Percent:
Continuous Index:
Within 8" of Joint:
Remarks:

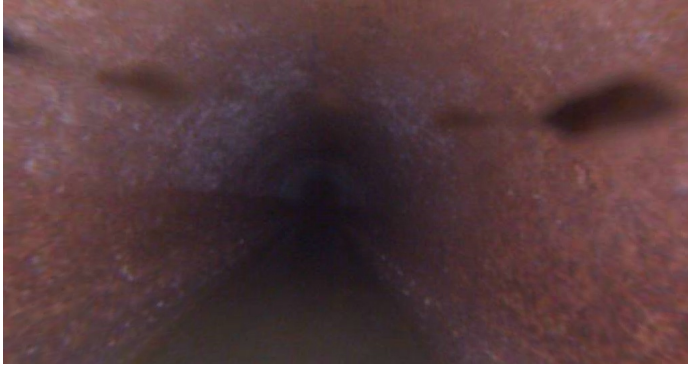
Code:	MSA
Description:	Abandoned Survey
Distance (ft):	114.9
Structural Grade:	0
O&M Grade:	0
Clock Start/From:	
Clock To:	
1st Value:	
2nd Value:	
Value Percent:	
Continuous Index:	
Within 8" of Joint:	NO
Remarks:	No blockage
