Profile/Photo Observation Report

Street:	N Ohio St.	Flow Control:	Not Controlled
City:	Hobart, IN	Year Renewed:	
Location:	Other	Tape/Media #:	
Purpose:	Not Known	Dia/Height:	10"
Use:	Sanitary	Material:	VCP
Drain Area:	NA	Lining:	
Category:	NA		
Comment:

Location Details:		Direction of Survey:	Downstream
US MH:	M-804-048	DS MH:	M-804-049
		Total Length Surveyed (ft):	114.9

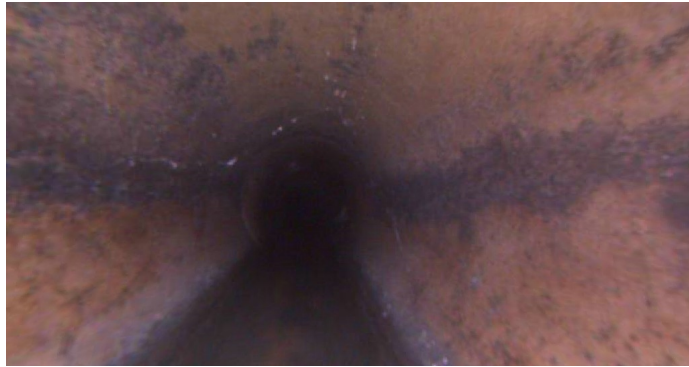
Code: **MWL**
Description: **Water Level**

Distance (ft): **.0**
Structural Grade: **0**
O&M Grade: **0**
Clock Start/From:
Clock To:
1st Value:
2nd Value:
Value Percent: **10.000**
Continuous Index:
Within 8" of Joint: **NO**
Remarks:

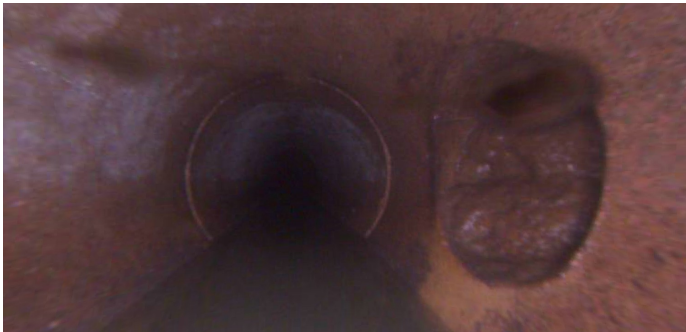
Code: **TF**
Description: **Tap Factory**

Distance (ft): **37.4**
Structural Grade: **0**
O&M Grade: **0**
Clock Start/From: **3**
Clock To:
1st Value: **4.000**
2nd Value:
Value Percent:
Continuous Index:
Within 8" of Joint:
Remarks:

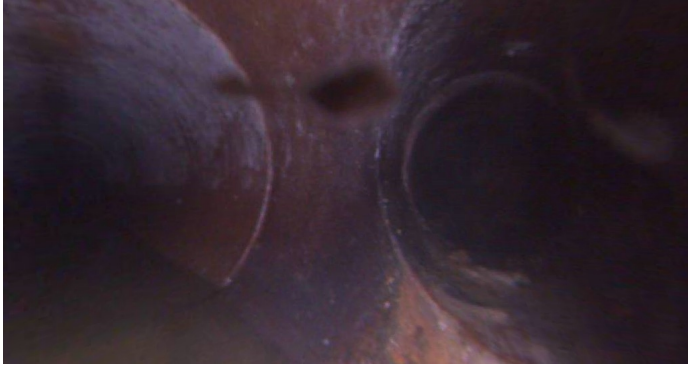
Code: **TF**
Description: **Tap Factory**

Distance (ft): **71.8**
Structural Grade: **0**
O&M Grade: **0**
Clock Start/From: **4**
Clock To:
1st Value: **4.000**
2nd Value:
Value Percent:
Continuous Index:
Within 8" of Joint:
Remarks:

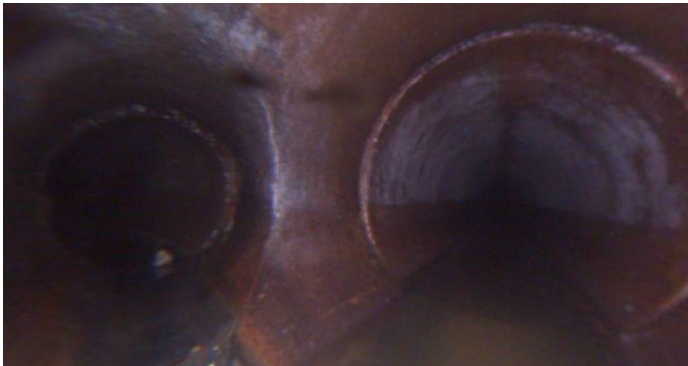
Code: **TF**
Description: **Tap Factory**

Distance (ft): **81.7**
Structural Grade: **0**
O&M Grade: **0**
Clock Start/From: **8**
Clock To:
1st Value: **4.000**
2nd Value:
Value Percent:
Continuous Index:
Within 8" of Joint:
Remarks:
