Profile/Photo Observation Report

Street:	N OHIO ST	Flow Control:	Not Controlled
City:	Hobart, IN	Year Renewed:	
Location:	Light Highway	Tape/Media #:	
Purpose:	Routine Assessment	Dia/Height:	12"
Use:	Sanitary	Material:	VCP
Drain Area:	NA	Lining:	
Category:	NA		
Comment:

Location Details:		Direction of Survey:	Upstream
US MH:	M-804-048	DS MH:	M-804-049
		Total Length Surveyed (ft):	263.1

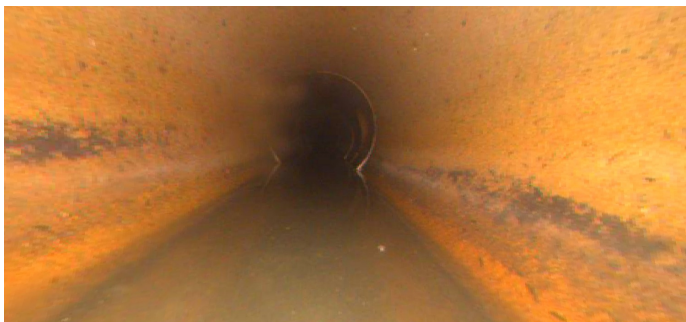
Code: **AMH**
Description: **Manhole**

Distance (ft): **.0**
Structural Grade: **0**
O&M Grade: **0**
Clock Start/From:
Clock To:
1st Value:
2nd Value:
Value Percent:
Continuous Index:
Within 8" of Joint: **NO**
Remarks: **M-804-049**

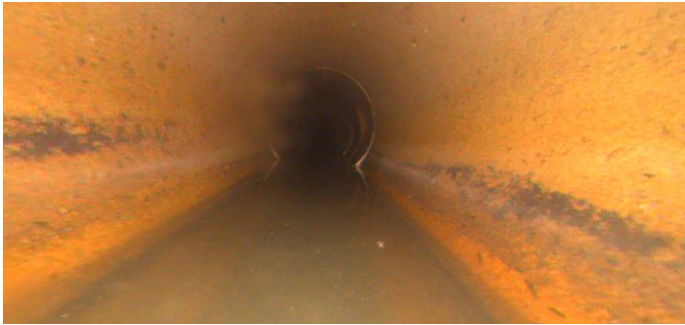
Code:	MWL
Description:	Water Level

Distance (ft):	.0
Structural Grade:	0
O&M Grade:	0
Clock Start/From:	
Clock To:	
1st Value:	
2nd Value:	
Value Percent:	10.000
Continuous Index:	
Within 8" of Joint:	NO
Remarks:

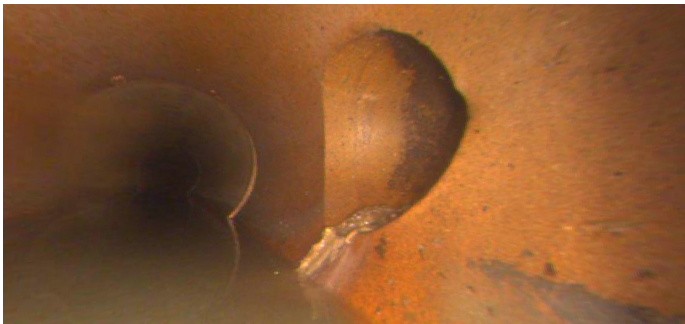
Code:	TF
Description:	Tap Factory

Distance (ft):	3.4
Structural Grade:	0
O&M Grade:	0
Clock Start/From:	3
Clock To:	
1st Value:	4.000
2nd Value:	
Value Percent:	
Continuous Index:	
Within 8" of Joint:	
Remarks:

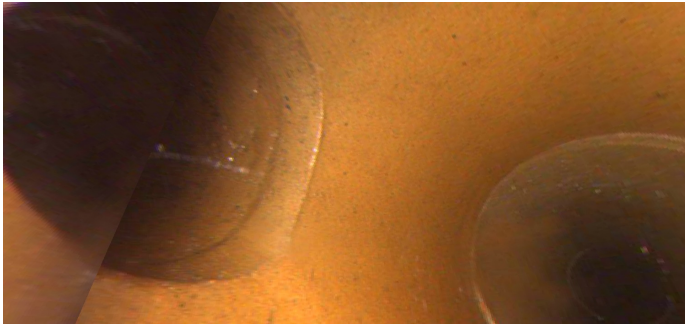
Code: **TF**
Description: **Tap Factory**

Distance (ft): **37.9**
Structural Grade: **0**
O&M Grade: **0**
Clock Start/From: **9**
Clock To:
1st Value: **4.000**
2nd Value:
Value Percent:
Continuous Index:
Within 8" of Joint:
Remarks:

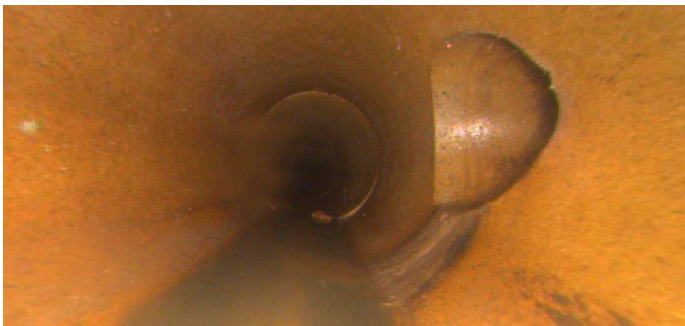
Code: **TF**
Description: **Tap Factory**

Distance (ft): **47.2**
Structural Grade: **0**
O&M Grade: **0**
Clock Start/From: **3**
Clock To:
1st Value: **4.000**
2nd Value:
Value Percent:
Continuous Index:
Within 8" of Joint:
Remarks:

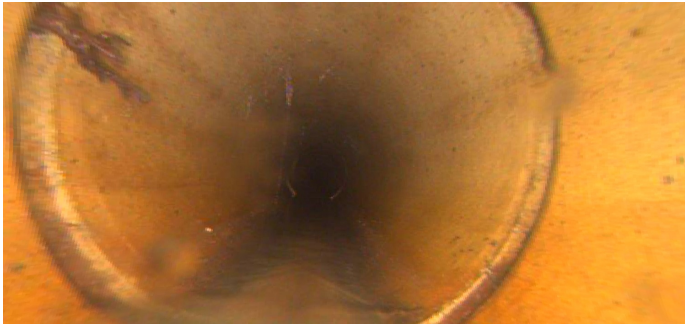
Code: **RFJ**
Description: **Roots Fine Joint**

Distance (ft): **88.8**
Structural Grade: **0**
O&M Grade: **1**
Clock Start/From: **9**
Clock To: **4**
1st Value:
2nd Value:
Value Percent:
Continuous Index:
Within 8" of Joint: **YES**
Remarks:

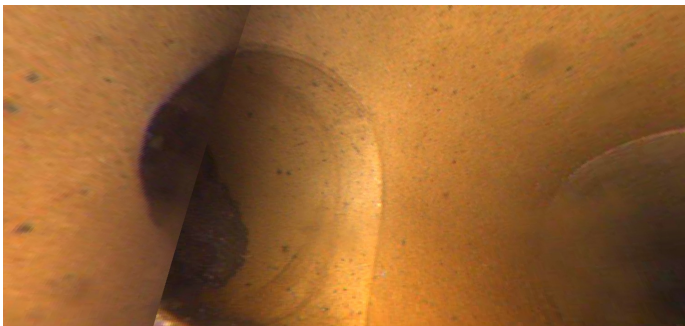
Code: **TFD**
Description: **Tap Factory Defective**

Distance (ft): **93.9**
Structural Grade: **0**
O&M Grade: **2**
Clock Start/From: **9**
Clock To:
1st Value: **4.000**
2nd Value:
Value Percent:
Continuous Index:
Within 8" of Joint:
Remarks: **DEPOSITS INSIDE TAP**

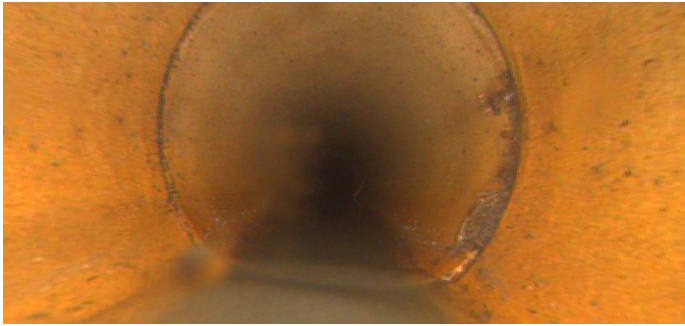
Code: **RFJ**
Description: **Roots Fine Joint**

Distance (ft): **94.6**
Structural Grade: **0**
O&M Grade: **1**
Clock Start/From: **3**
Clock To: **5**
1st Value:
2nd Value:
Value Percent:
Continuous Index:
Within 8" of Joint: **YES**
Remarks:

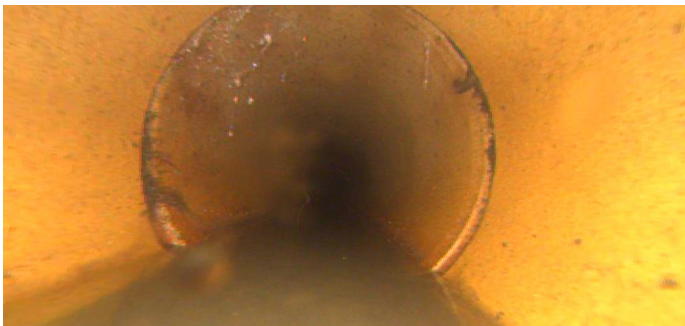
Code: **RFJ**
Description: **Roots Fine Joint**

Distance (ft): **98.6**
Structural Grade: **0**
O&M Grade: **1**
Clock Start/From: **7**
Clock To: **5**
1st Value:
2nd Value:
Value Percent:
Continuous Index:
Within 8" of Joint: **YES**
Remarks:

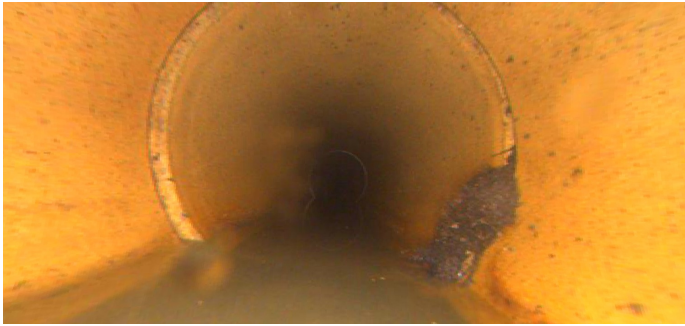
Code: **RFJ**
Description: **Roots Fine Joint**

Distance (ft): **102.7**
Structural Grade: **0**
O&M Grade: **1**
Clock Start/From: **7**
Clock To: **5**
1st Value:
2nd Value:
Value Percent:
Continuous Index: **S01**
Within 8" of Joint: **YES**
Remarks: **WANDER**

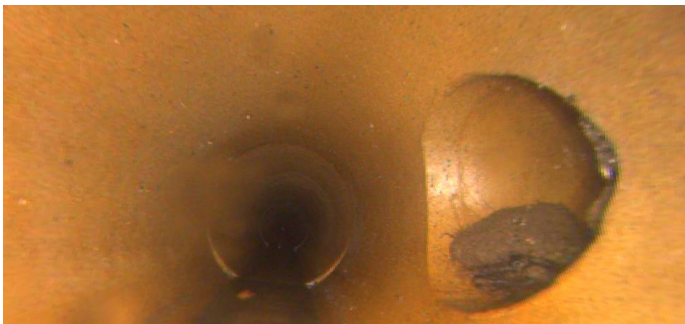
Code: **TFD**
Description: **Tap Factory Defective**

Distance (ft): **115.4**
Structural Grade: **0**
O&M Grade: **2**
Clock Start/From: **3**
Clock To:
1st Value: **4.000**
2nd Value:
Value Percent:
Continuous Index:
Within 8" of Joint:
Remarks: **DEPOSITS INSIDE TAP**

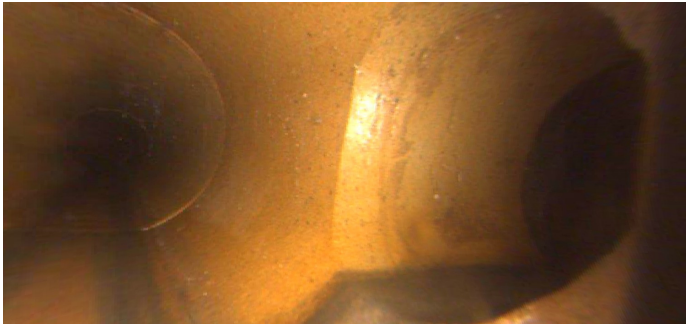
Code: **TF**
Description: **Tap Factory**

Distance (ft): **178.1**
Structural Grade: **0**
O&M Grade: **0**
Clock Start/From: **3**
Clock To:
1st Value: **4.000**
2nd Value:
Value Percent:
Continuous Index:
Within 8" of Joint:
Remarks:

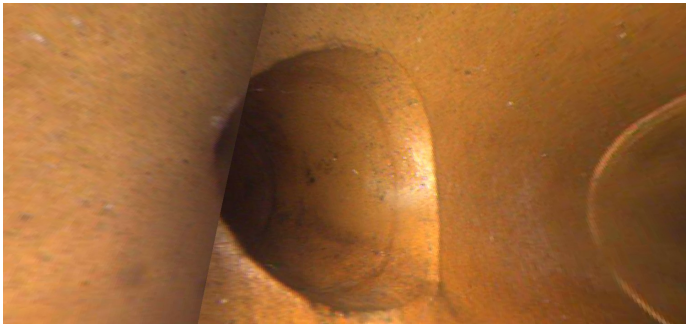
Code: **TF**
Description: **Tap Factory**

Distance (ft): **188.1**
Structural Grade: **0**
O&M Grade: **0**
Clock Start/From: **9**
Clock To:
1st Value: **4.000**
2nd Value:
Value Percent:
Continuous Index:
Within 8" of Joint:
Remarks:

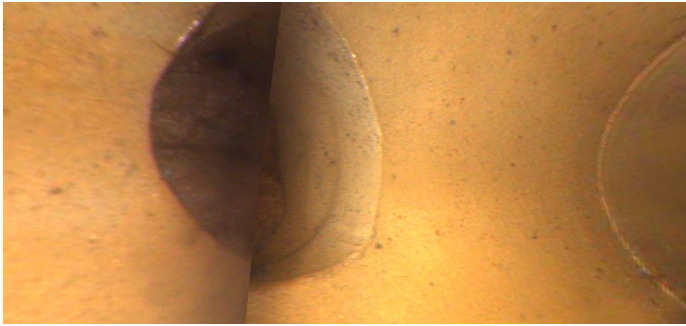
Code: **TFC**
Description: **Tap Factory Capped**

Distance (ft): **222.6**
Structural Grade: **0**
O&M Grade: **0**
Clock Start/From: **9**
Clock To:
1st Value: **4.000**
2nd Value:
Value Percent:
Continuous Index:
Within 8" of Joint:
Remarks:

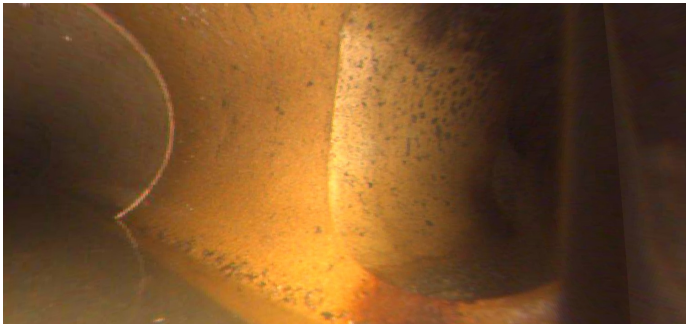
Code: **TF**
Description: **Tap Factory**

Distance (ft): **236.6**
Structural Grade: **0**
O&M Grade: **0**
Clock Start/From: **3**
Clock To:
1st Value: **4.000**
2nd Value:
Value Percent:
Continuous Index:
Within 8" of Joint:
Remarks:

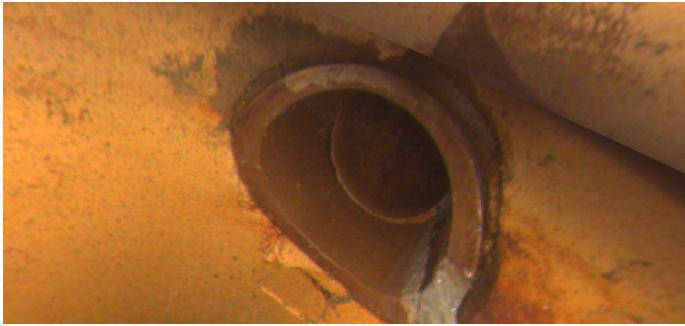
Code: **TFI**
Description: **Tap Factory Intruding**

Distance (ft): **255.9**
Structural Grade: **0**
O&M Grade: **2**
Clock Start/From: **1**
Clock To:
1st Value: **4.000**
2nd Value: **0.500**
Value Percent:
Continuous Index:
Within 8" of Joint:
Remarks:

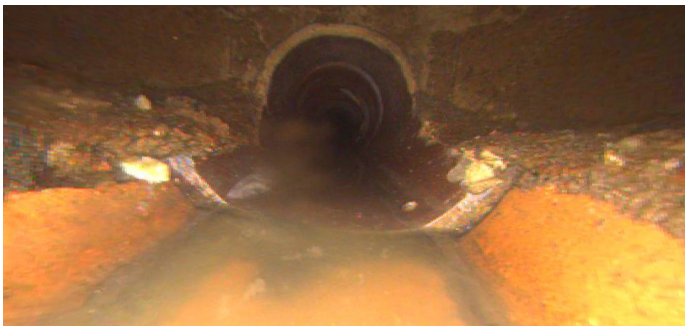
Code: **AMH**
Description: **Manhole**

Distance (ft): **263.1**
Structural Grade: **0**
O&M Grade: **0**
Clock Start/From:
Clock To:
1st Value:
2nd Value:
Value Percent:
Continuous Index:
Within 8" of Joint: **NO**
Remarks: **M-804-048**

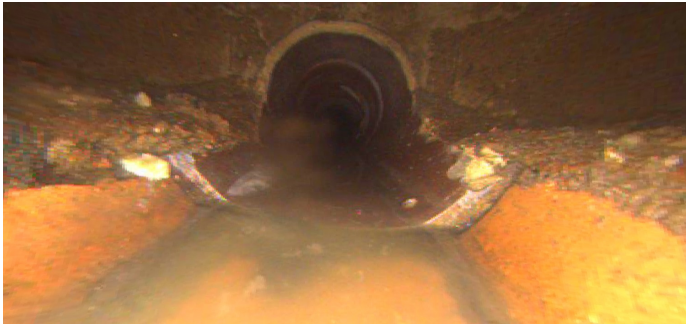
Code:	RFJ
Description:	Roots Fine Joint
Distance (ft):	263.1
Structural Grade:	0
O&M Grade:	1
Clock Start/From:	7
Clock To:	5
1st Value:	
2nd Value:	
Value Percent:	
Continuous Index:	F01
Within 8" of Joint:	YES
Remarks:	WANDER
