Profile/Photo Observation Report

Street:	Ohio St.	Flow Control:	Not Controlled
City:	Hobart, IN	Year Renewed:	
Location:	Light Highway	Tape/Media #:	
Purpose:	Routine Assessment	Dia/Height:	12"
Use:	Sanitary	Material:	VCP
Drain Area:	NA	Lining:	
Category:	NA		
Comment:

Location Details:		Direction of Survey:	Upstream
US MH:	M-804-048	DS MH:	M-804-049
		Total Length Surveyed (ft):	263.1

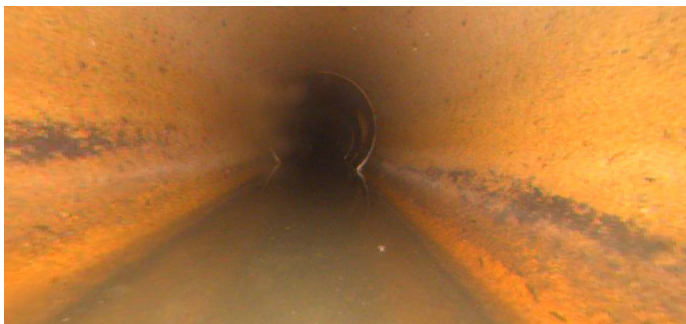
Code: **AMH**
Description: **Manhole**

Distance (ft): **.0**
Structural Grade: **0**
O&M Grade: **0**
Clock Start/From:
Clock To:
1st Value:
2nd Value:
Value Percent:
Continuous Index:
Within 8" of Joint: **NO**
Remarks: **M-804-049**

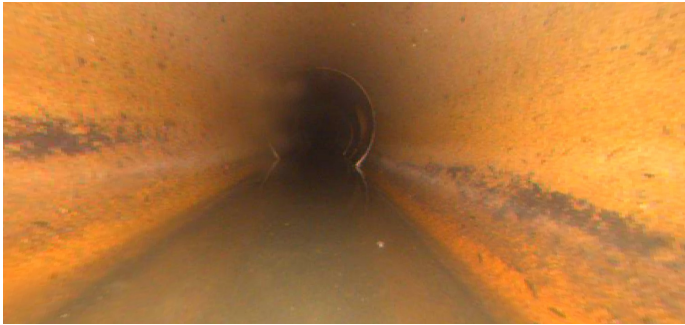
Code:	MWL
Description:	Water Level

Distance (ft):	.0
Structural Grade:	0
O&M Grade:	0
Clock Start/From:	
Clock To:	
1st Value:	
2nd Value:	
Value Percent:	10.000
Continuous Index:	
Within 8" of Joint:	NO
Remarks:

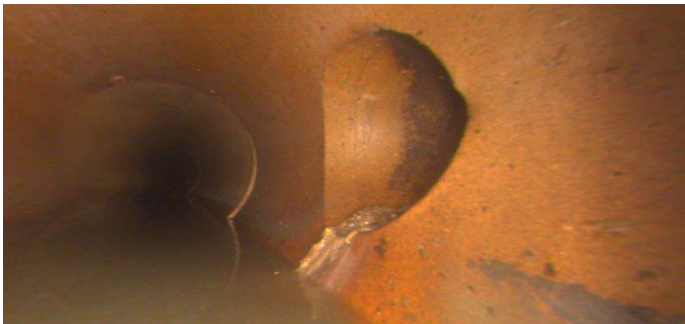
Code:	TF
Description:	Tap Factory

Distance (ft):	3.4
Structural Grade:	0
O&M Grade:	0
Clock Start/From:	3
Clock To:	
1st Value:	4.000
2nd Value:	
Value Percent:	
Continuous Index:	
Within 8" of Joint:	
Remarks:

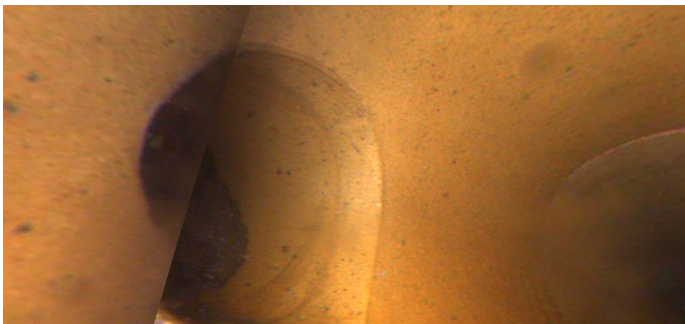
Code: **TFD**
Description: **Tap Factory Defective**

Distance (ft): **93.9**
Structural Grade: **0**
O&M Grade: **2**
Clock Start/From: **9**
Clock To:
1st Value: **4.000**
2nd Value:
Value Percent:
Continuous Index:
Within 8" of Joint:
Remarks: **DEPOSITS INSIDE TAP**

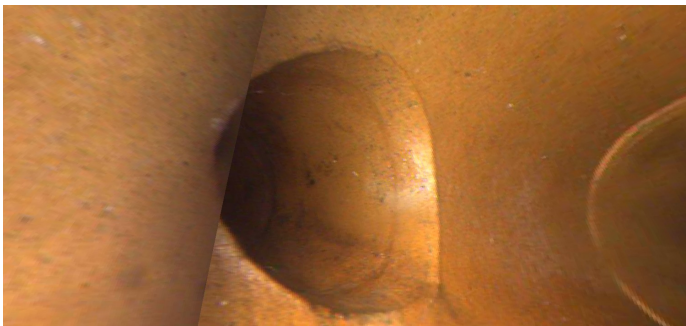
Code: **TF**
Description: **Tap Factory**

Distance (ft): **188.1**
Structural Grade: **0**
O&M Grade: **0**
Clock Start/From: **9**
Clock To:
1st Value: **4.000**
2nd Value:
Value Percent:
Continuous Index:
Within 8" of Joint:
Remarks:

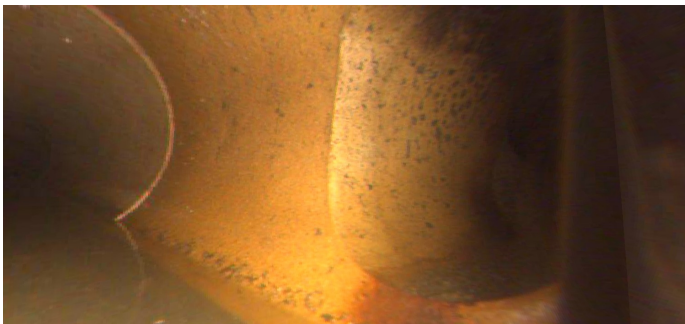
Code: **TF**
Description: **Tap Factory**

Distance (ft): **236.6**
Structural Grade: **0**
O&M Grade: **0**
Clock Start/From: **3**
Clock To:
1st Value: **4.000**
2nd Value:
Value Percent:
Continuous Index:
Within 8" of Joint:
Remarks:

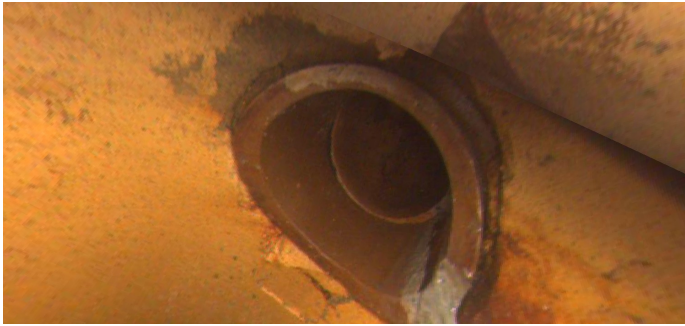
Code: **TFI**
Description: **Tap Factory Intruding**

Distance (ft): **255.9**
Structural Grade: **0**
O&M Grade: **2**
Clock Start/From: **1**
Clock To:
1st Value: **4.000**
2nd Value: **0.500**
Value Percent:
Continuous Index:
Within 8" of Joint:
Remarks:

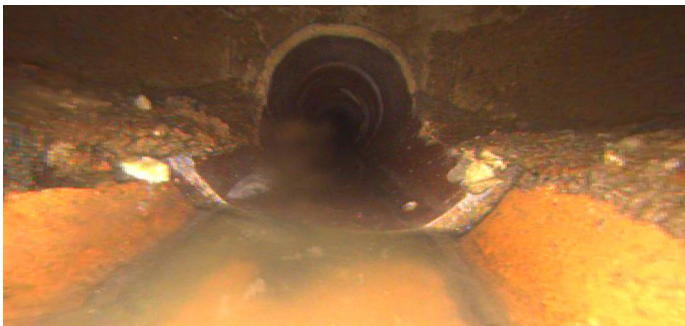
Code: **AMH**
Description: **Manhole**

Distance (ft): **263.1**
Structural Grade: **0**
O&M Grade: **0**
Clock Start/From:
Clock To:
1st Value:
2nd Value:
Value Percent:
Continuous Index:
Within 8" of Joint: **NO**
Remarks: **M-804-048**

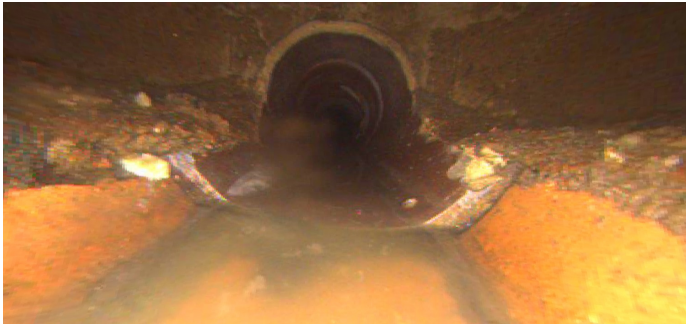
Code:	RFJ
Description:	Roots Fine Joint
Distance (ft):	263.1
Structural Grade:	0
O&M Grade:	1
Clock Start/From:	7
Clock To:	5
1st Value:	
2nd Value:	
Value Percent:	
Continuous Index:	F01
Within 8" of Joint:	YES
Remarks:	WANDER
