Profile/Photo Observation Report

Street:	N Ohio St.	Flow Control:	Not Controlled
City:	Hobart, IN	Year Renewed:	
Location:	Other	Tape/Media #:	
Purpose:	Not Known	Dia/Height:	10"
Use:	Sanitary	Material:	VCP
Drain Area:	NA	Lining:	
Category:	NA		
Comment:

Location Details:		Direction of Survey:	Upstream
US MH:	M-804-049	DS MH:	M-804-050
		Total Length Surveyed (ft):	3.2

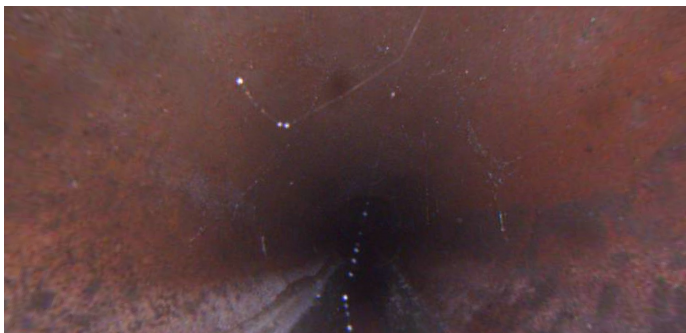
Code: **AMH**
Description: **Manhole**

Distance (ft): **.0**
Structural Grade: **0**
O&M Grade: **0**
Clock Start/From:
Clock To:
1st Value:
2nd Value:
Value Percent:
Continuous Index:
Within 8" of Joint: **NO**
Remarks: **M-804-050**

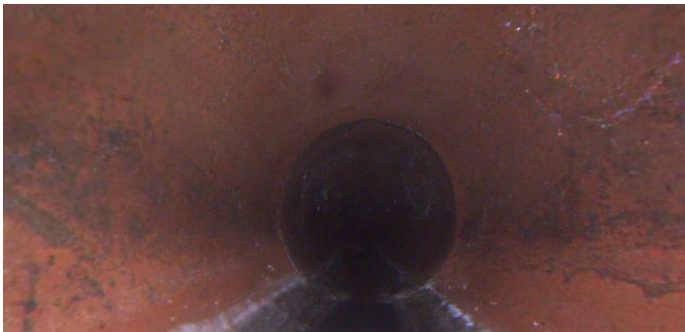
Code:	MSA
Description:	Abandoned Survey

Distance (ft):	3.2
Structural Grade:	0
O&M Grade:	0
Clock Start/From:	
Clock To:	
1st Value:	
2nd Value:	
Value Percent:	
Continuous Index:	
Within 8" of Joint:	NO
Remarks:	unknown
