Profile/Photo Observation Report

Street:	N Ohio St.	Flow Control:	Not Controlled
City:	Hobart, IN	Year Renewed:	
Location:	Other	Tape/Media #:	
Purpose:	Not Known	Dia/Height:	10"
Use:	Sanitary	Material:	VCP
Drain Area:	NA	Lining:	
Category:	NA		
Comment:

Location Details:		Direction of Survey:	Upstream
US MH:	M-804-049	DS MH:	M-804-050
		Total Length Surveyed (ft):	8.1

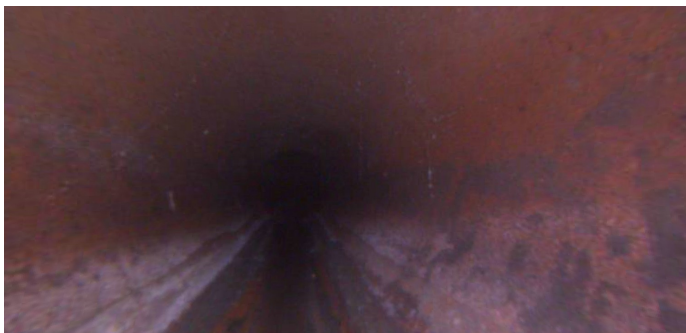
Code: **AMH**
Description: **Manhole**

Distance (ft): **.0**
Structural Grade: **0**
O&M Grade: **0**
Clock Start/From:
Clock To:
1st Value:
2nd Value:
Value Percent:
Continuous Index:
Within 8" of Joint: **NO**
Remarks: **M-804-050**

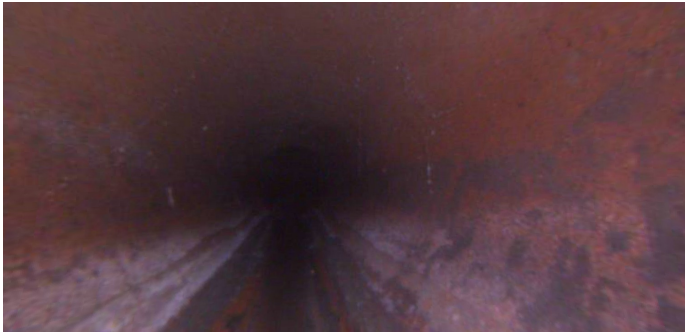
Code:	MWL
Description:	Water Level

Distance (ft):	.0
Structural Grade:	0
O&M Grade:	0
Clock Start/From:	
Clock To:	
1st Value:	
2nd Value:	
Value Percent:	5.000
Continuous Index:	
Within 8" of Joint:	NO
Remarks:

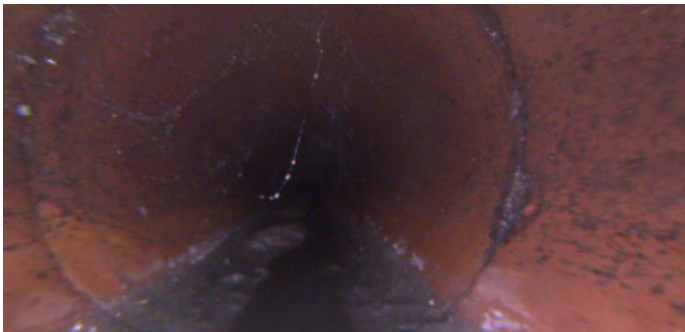
Code:	MSA
Description:	Abandoned Survey

Distance (ft):	8.1
Structural Grade:	0
O&M Grade:	0
Clock Start/From:	
Clock To:	
1st Value:	
2nd Value:	
Value Percent:	
Continuous Index:	
Within 8" of Joint:	NO
Remarks:	unknown
