Profile/Photo Observation Report

Date:	10/04/2018	Weather:		Coding:	PACP 6.0
Pipe Length (ft):	265.8	Owner:	NA	Pre Clean:	Not Known
P.O.#:		Surveyor:	Justin Gonzales	PSR:	P-804-050-049
Customer:		Clean Date:	01/01/1900	Shape:	C

Street:	Ohio St.	Flow Control:	Not Controlled
City:	Hobart, IN	Year Renewed:	
Location:	Light Highway	Tape/Media #:	
Purpose:	Routine Assessment	Dia/Height:	12"
Use:	Sanitary	Material:	VCP
Drain Area:	NA	Lining:	
Category:	NA		
Comment:

Location Details:		Direction of Survey:	Downstream
US MH:	M-804-049	DS MH:	M-804-050
		Total Length Surveyed (ft):	264.5

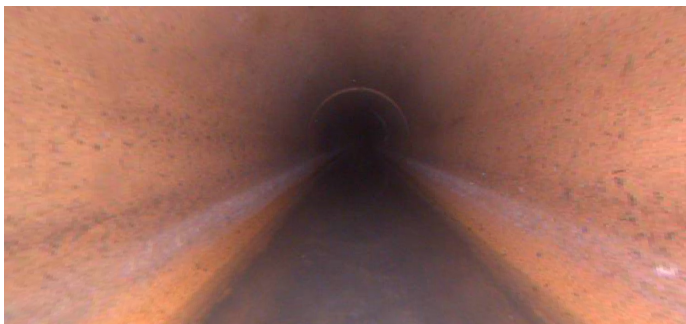
Code: **AMH**
Description: **Manhole**

Distance (ft): **.0**
Structural Grade: **0**
O&M Grade: **0**
Clock Start/From:
Clock To:
1st Value:
2nd Value:
Value Percent:
Continuous Index:
Within 8" of Joint: **NO**
Remarks: **M-804-049**

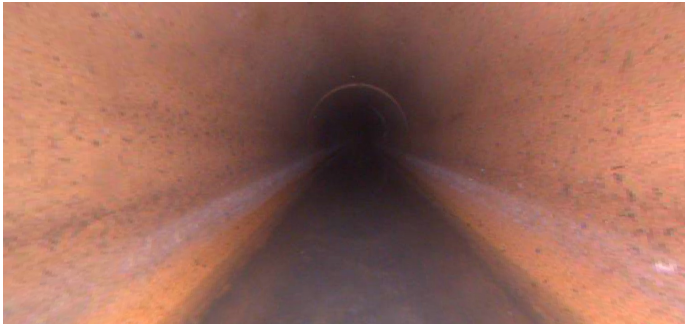
Code:	MWL
Description:	Water Level

Distance (ft):	.0
Structural Grade:	0
O&M Grade:	0
Clock Start/From:	
Clock To:	
1st Value:	
2nd Value:	
Value Percent:	10.000
Continuous Index:	
Within 8" of Joint:	NO
Remarks:

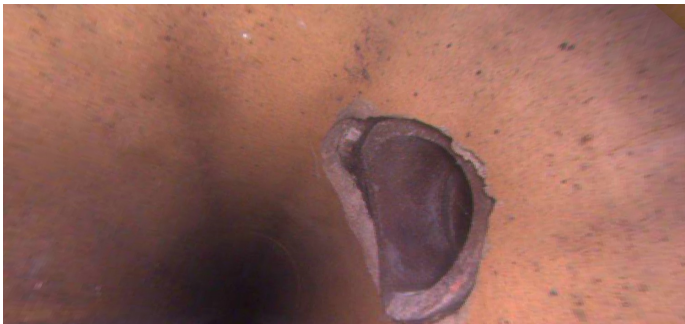
Code:	TB
Description:	Tap Break-in

Distance (ft):	4.9
Structural Grade:	0
O&M Grade:	0
Clock Start/From:	3
Clock To:	
1st Value:	4.000
2nd Value:	
Value Percent:	
Continuous Index:	
Within 8" of Joint:	
Remarks:

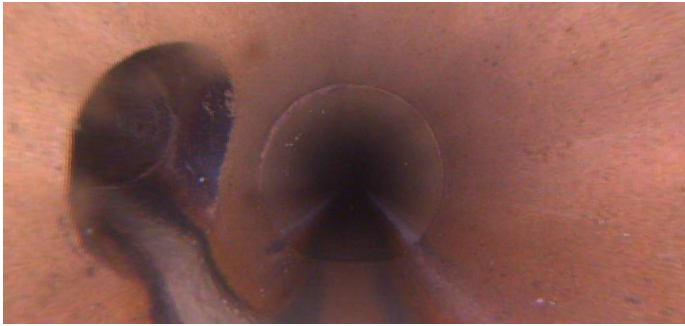
Code: **TF**
Description: **Tap Factory**

Distance (ft): **24.0**
Structural Grade: **0**
O&M Grade: **0**
Clock Start/From: **9**
Clock To:
1st Value: **4.000**
2nd Value:
Value Percent:
Continuous Index:
Within 8" of Joint:
Remarks:

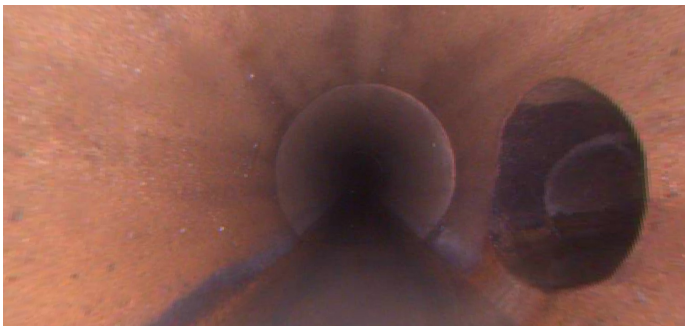
Code: **TF**
Description: **Tap Factory**

Distance (ft): **74.2**
Structural Grade: **0**
O&M Grade: **0**
Clock Start/From: **3**
Clock To:
1st Value: **4.000**
2nd Value:
Value Percent:
Continuous Index:
Within 8" of Joint:
Remarks:

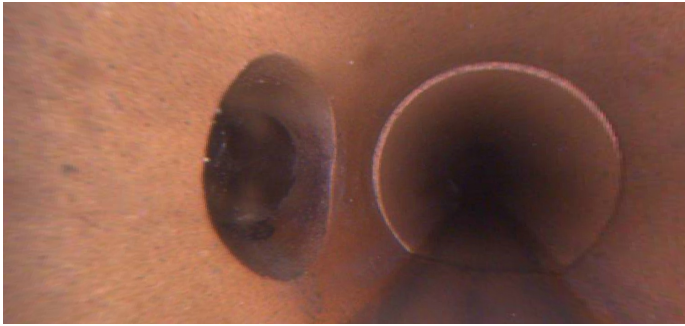
Code: **TF**
Description: **Tap Factory**

Distance (ft): **96.6**
Structural Grade: **0**
O&M Grade: **0**
Clock Start/From: **9**
Clock To:
1st Value: **4.000**
2nd Value:
Value Percent:
Continuous Index:
Within 8" of Joint:
Remarks:

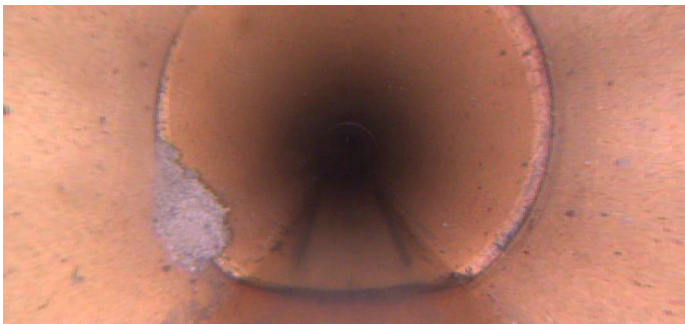
Code: **DAZ**
Description: **Deposits Attached Other**

Distance (ft): **101.2**
Structural Grade: **0**
O&M Grade: **2**
Clock Start/From: **7**
Clock To:
1st Value:
2nd Value:
Value Percent: **5.000**
Continuous Index:
Within 8" of Joint: **YES**
Remarks:

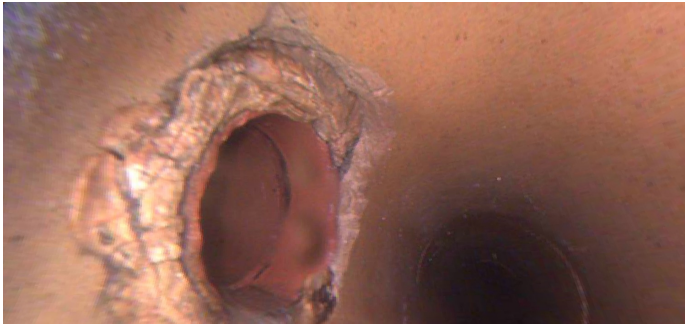
Code: **TB**
Description: **Tap Break-in**

Distance (ft): **123.9**
Structural Grade: **0**
O&M Grade: **0**
Clock Start/From: **9**
Clock To:
1st Value: **4.000**
2nd Value:
Value Percent:
Continuous Index:
Within 8" of Joint:
Remarks:

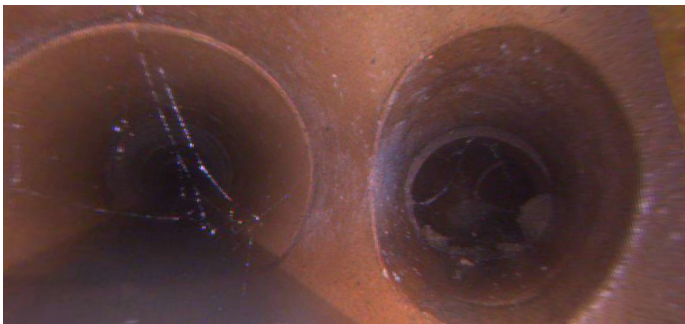
Code: **TF**
Description: **Tap Factory**

Distance (ft): **139.3**
Structural Grade: **0**
O&M Grade: **0**
Clock Start/From: **3**
Clock To:
1st Value: **4.000**
2nd Value:
Value Percent:
Continuous Index:
Within 8" of Joint:
Remarks:

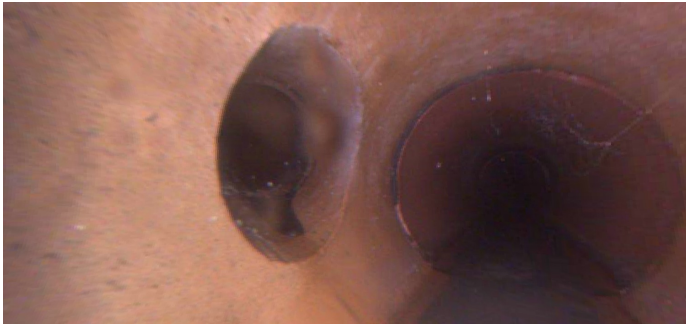
Code: **TF**
Description: **Tap Factory**

Distance (ft): **157.3**
Structural Grade: **0**
O&M Grade: **0**
Clock Start/From: **9**
Clock To:
1st Value: **4.000**
2nd Value:
Value Percent:
Continuous Index:
Within 8" of Joint:
Remarks:

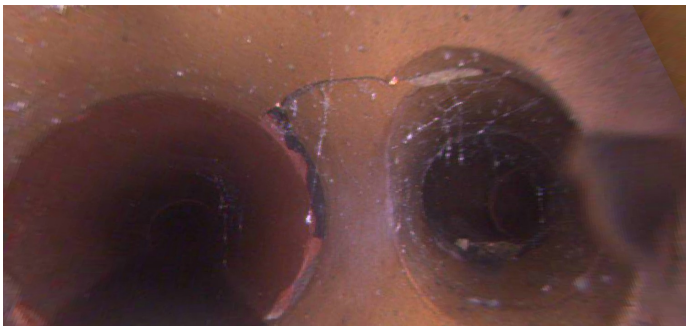
Code: **TF**
Description: **Tap Factory**

Distance (ft): **200.8**
Structural Grade: **0**
O&M Grade: **0**
Clock Start/From: **3**
Clock To:
1st Value: **4.000**
2nd Value:
Value Percent:
Continuous Index:
Within 8" of Joint:
Remarks:

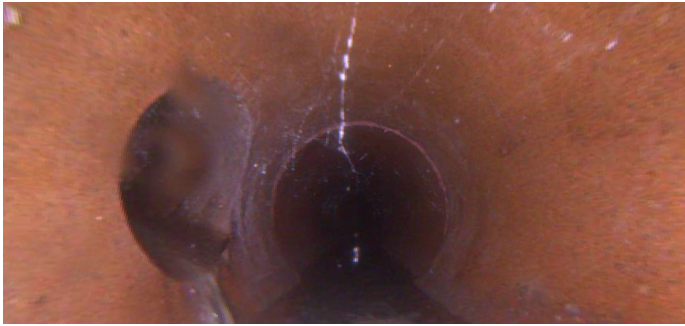
Code: **TFA**
Description: **Tap Factory Active**

Distance (ft): **219.2**
Structural Grade: **0**
O&M Grade: **0**
Clock Start/From: **9**
Clock To:
1st Value: **4.000**
2nd Value:
Value Percent:
Continuous Index:
Within 8" of Joint:
Remarks:

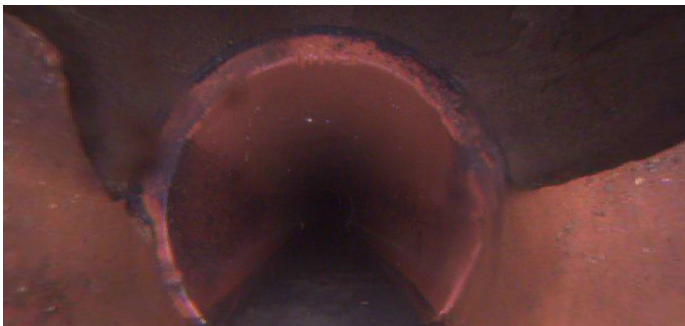
Code: **AMH**
Description: **Manhole**

Distance (ft): **264.5**
Structural Grade: **0**
O&M Grade: **0**
Clock Start/From:
Clock To:
1st Value:
2nd Value:
Value Percent:
Continuous Index:
Within 8" of Joint: **NO**
Remarks: **M-804-050**
