Profile/Photo Observation Report

Street:	N Ohio St.	Flow Control:	Not Controlled
City:	Hobart, IN	Year Renewed:	
Location:	Other	Tape/Media #:	
Purpose:	Not Known	Dia/Height:	10"
Use:	Sanitary	Material:	VCP
Drain Area:	NA	Lining:	
Category:	NA		
Comment:

Location Details:		Direction of Survey:	Downstream
US MH:	M-804-050	DS MH:	M-804-051
		Total Length Surveyed (ft):	6.8

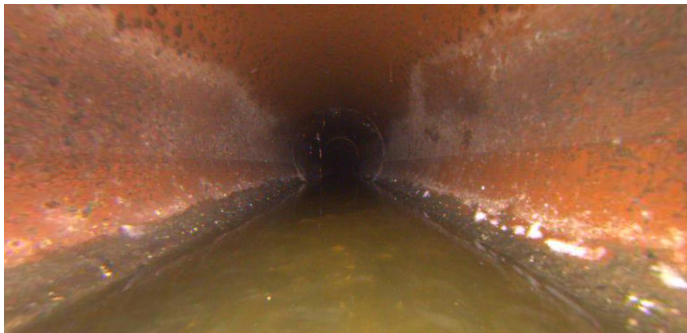
Code: **AMH**
Description: **Manhole**

Distance (ft): **.0**
Structural Grade: **0**
O&M Grade: **0**
Clock Start/From:
Clock To:
1st Value:
2nd Value:
Value Percent:
Continuous Index:
Within 8" of Joint: **NO**
Remarks: **M-804-050**

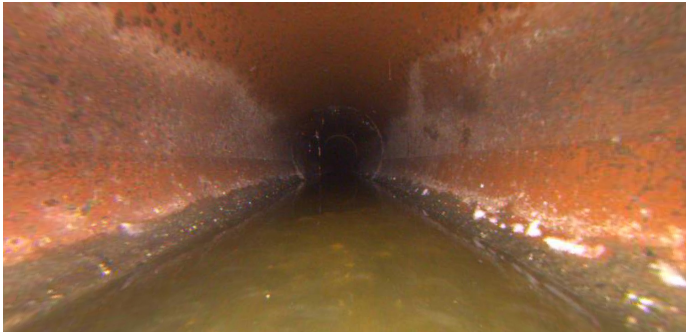
Code:	MWL
Description:	Water Level

Distance (ft):	.0
Structural Grade:	0
O&M Grade:	0
Clock Start/From:	
Clock To:	
1st Value:	
2nd Value:	
Value Percent:	10.000
Continuous Index:	
Within 8" of Joint:	NO
Remarks:

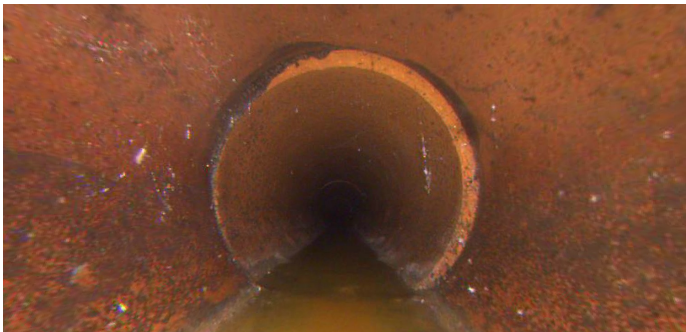
Code:	MSA
Description:	Abandoned Survey

Distance (ft):	6.8
Structural Grade:	0
O&M Grade:	0
Clock Start/From:	
Clock To:	
1st Value:	
2nd Value:	
Value Percent:	
Continuous Index:	
Within 8" of Joint:	NO
Remarks:	UNKNOWN
