Profile/Photo Observation Report

Street:	N OHIO ST	Flow Control:	Not Controlled
City:	Hobart, IN	Year Renewed:	
Location:	Other	Tape/Media #:	
Purpose:	Not Known	Dia/Height:	10"
Use:	Sanitary	Material:	VCP
Drain Area:	NA	Lining:	
Category:	NA		
Comment:

Location Details:		Direction of Survey:	Upstream
US MH:	M-804-050	DS MH:	M-804-051
		Total Length Surveyed (ft):	58.1

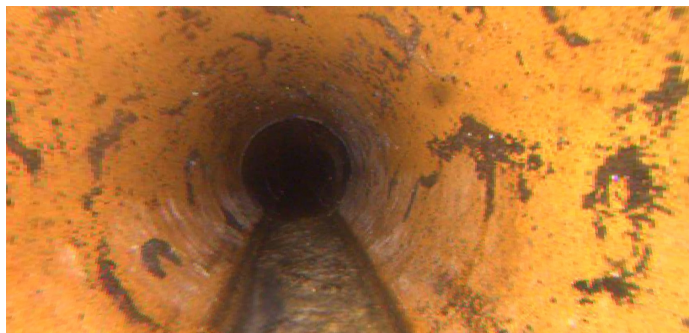
Code: **AMH**
 Description: **Manhole**
 Distance (ft): **.0**
 Structural Grade: **0**
 O&M Grade: **0**
 Clock Start/From:
 Clock To:
 1st Value:
 2nd Value:
 Value Percent:
 Continuous Index:
 Within 8" of Joint: **NO**
 Remarks: **M-804-051**

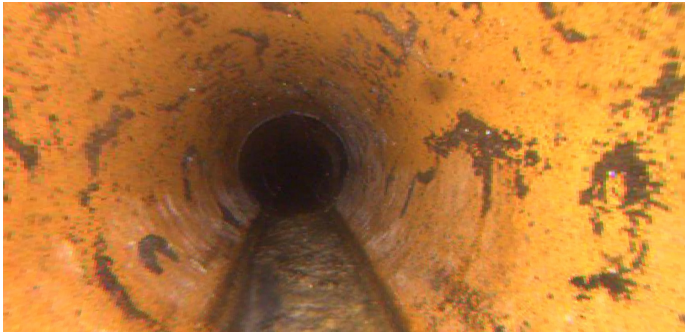
Code:	MWL
Description:	Water Level

Distance (ft):	.0
Structural Grade:	0
O&M Grade:	0
Clock Start/From:	
Clock To:	
1st Value:	
2nd Value:	
Value Percent:	5.000
Continuous Index:	
Within 8" of Joint:	NO
Remarks:

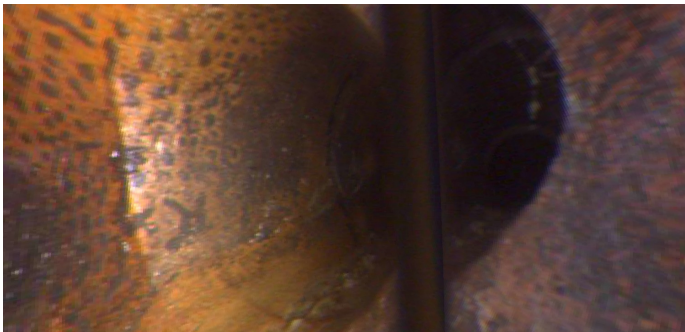
Code:	TF
Description:	Tap Factory

Distance (ft):	4.4
Structural Grade:	0
O&M Grade:	0
Clock Start/From:	3
Clock To:	
1st Value:	4.000
2nd Value:	
Value Percent:	
Continuous Index:	
Within 8" of Joint:	YES
Remarks:

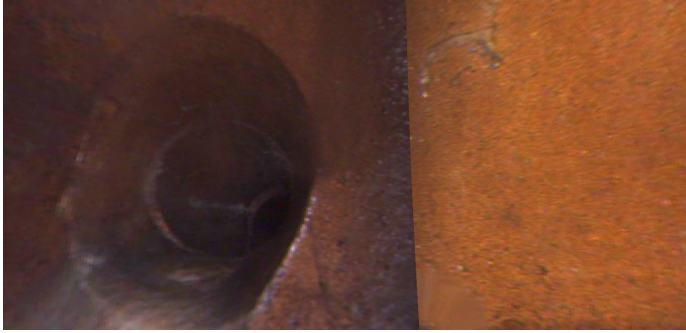
Code: **TF**
Description: **Tap Factory**

Distance (ft): **34.8**
Structural Grade: **0**
O&M Grade: **0**
Clock Start/From: **10**
Clock To:
1st Value: **4.000**
2nd Value:
Value Percent:
Continuous Index:
Within 8" of Joint: **YES**
Remarks:

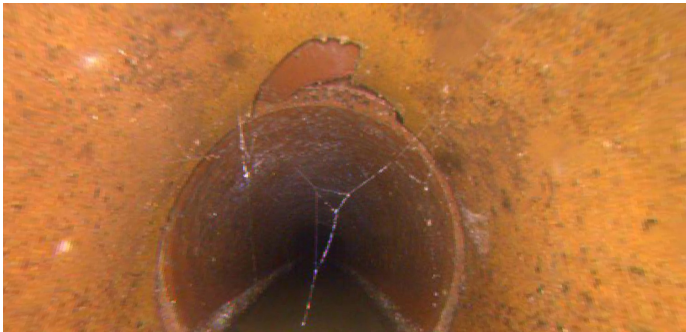
Code: **FS**
Description: **Fracture Spiral**

Distance (ft): **38.5**
Structural Grade: **3**
O&M Grade: **0**
Clock Start/From: **11**
Clock To: **1**
1st Value:
2nd Value:
Value Percent:
Continuous Index:
Within 8" of Joint: **YES**
Remarks:

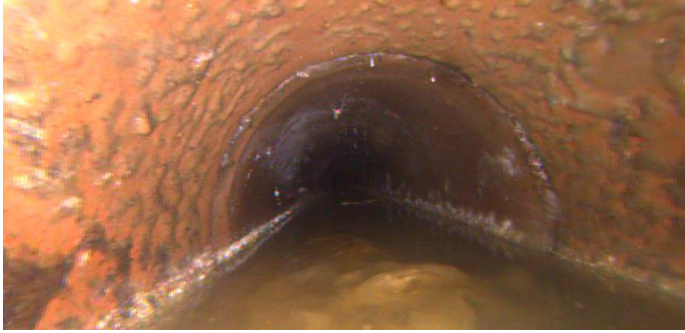
Code: **DSZ**
Description: **Deposits Settled Other**

Distance (ft): **55.2**
Structural Grade: **0**
O&M Grade: **2**
Clock Start/From: **6**
Clock To:
1st Value:
2nd Value:
Value Percent: **5.000**
Continuous Index:
Within 8" of Joint: **NO**
Remarks: **tissue**

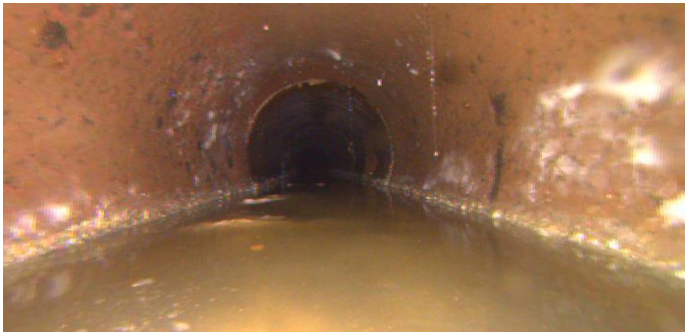
Code: **MSA**
Description: **Abandoned Survey**

Distance (ft): **58.1**
Structural Grade: **0**
O&M Grade: **0**
Clock Start/From:
Clock To:
1st Value:
2nd Value:
Value Percent:
Continuous Index:
Within 8" of Joint: **NO**
Remarks: **no blockage**
