Profile/Photo Observation Report

Date:	10/04/2018	Weather:		Coding:	PACP 6.0
Pipe Length (ft):	277.3	Owner:	NA	Pre Clean:	Not Known
P.O.#:		Surveyor:	Justin Gonzales	PSR:	P-804-051-050
Customer:		Clean Date:	01/01/1900	Shape:	C

Street:	N OHIO ST	Flow Control:	Not Controlled
City:	Hobart, IN	Year Renewed:	
Location:	Light Highway	Tape/Media #:	
Purpose:	Routine Assessment	Dia/Height:	12"
Use:	Sanitary	Material:	VCP
Drain Area:	NA	Lining:	
Category:	NA		
Comment:

Location Details:		Direction of Survey:	Upstream
US MH:	M-804-050	DS MH:	M-804-051
		Total Length Surveyed (ft):	278.2

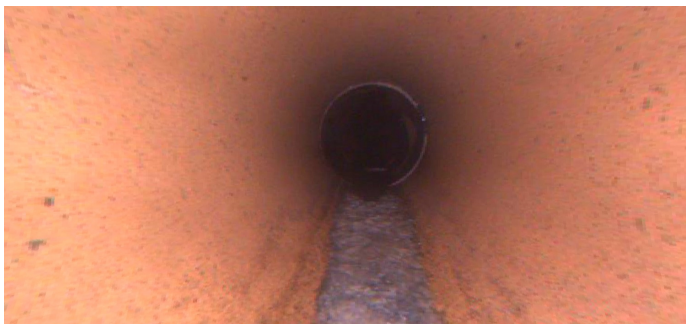
Code: **AMH**
Description: **Manhole**

Distance (ft): **.0**
Structural Grade: **0**
O&M Grade: **0**
Clock Start/From:
Clock To:
1st Value:
2nd Value:
Value Percent:
Continuous Index:
Within 8" of Joint: **NO**
Remarks: **M-804-051**

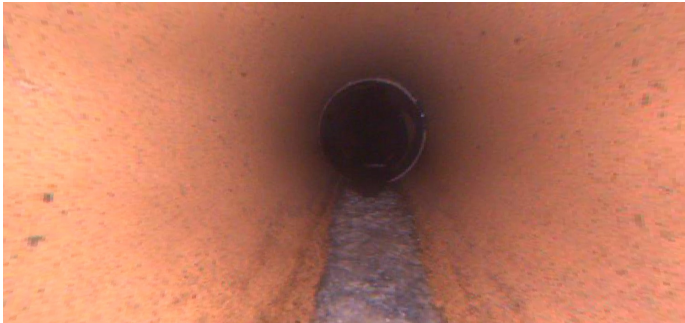
Code:	MWL
Description:	Water Level

Distance (ft):	.0
Structural Grade:	0
O&M Grade:	0
Clock Start/From:	
Clock To:	
1st Value:	
2nd Value:	
Value Percent:	5.000
Continuous Index:	
Within 8" of Joint:	NO
Remarks:

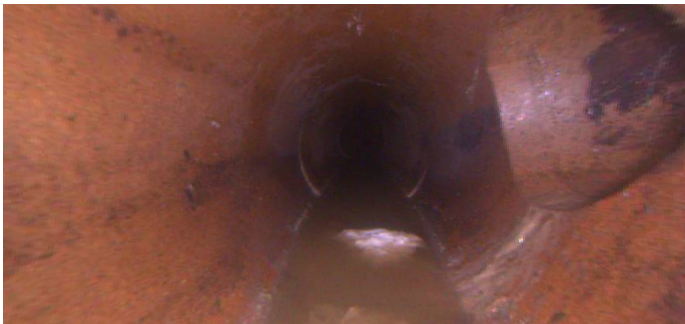
Code:	TF
Description:	Tap Factory

Distance (ft):	3.7
Structural Grade:	0
O&M Grade:	0
Clock Start/From:	3
Clock To:	
1st Value:	4.000
2nd Value:	
Value Percent:	
Continuous Index:	
Within 8" of Joint:	
Remarks:

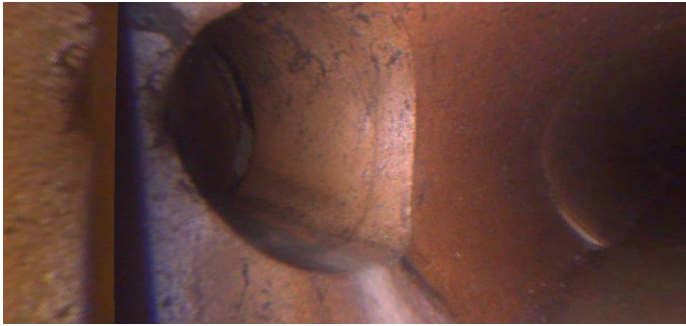
Code: **TF**
Description: **Tap Factory**

Distance (ft): **34.3**
Structural Grade: **0**
O&M Grade: **0**
Clock Start/From: **9**
Clock To:
1st Value: **4.000**
2nd Value:
Value Percent:
Continuous Index:
Within 8" of Joint:
Remarks:

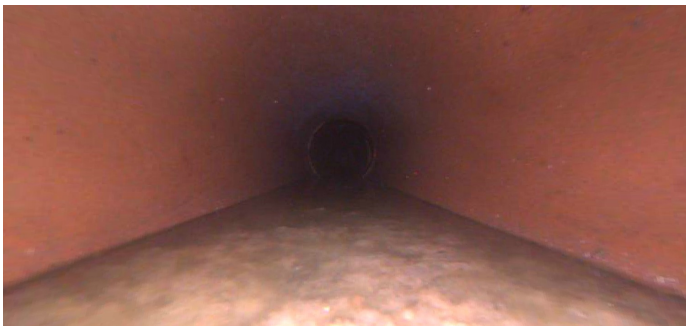
Code: **MWLS**
Description: **Water Level Sag**

Distance (ft): **56.6**
Structural Grade: **2**
O&M Grade: **3**
Clock Start/From:
Clock To:
1st Value:
2nd Value:
Value Percent: **10.000**
Continuous Index:
Within 8" of Joint: **NO**
Remarks:

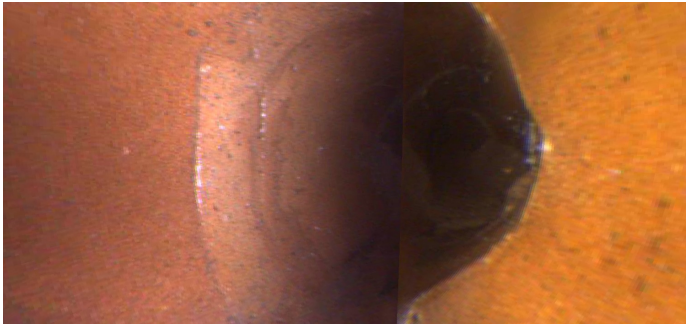
Code: **TF**
Description: **Tap Factory**

Distance (ft): **61.4**
Structural Grade: **0**
O&M Grade: **0**
Clock Start/From: **3**
Clock To:
1st Value: **4.000**
2nd Value:
Value Percent:
Continuous Index:
Within 8" of Joint:
Remarks:

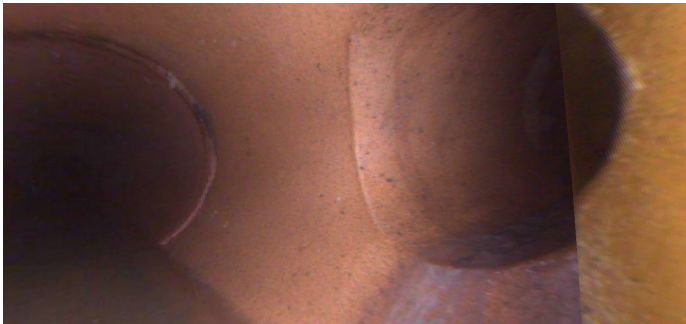
Code: **TF**
Description: **Tap Factory**

Distance (ft): **87.7**
Structural Grade: **0**
O&M Grade: **0**
Clock Start/From: **3**
Clock To:
1st Value: **4.000**
2nd Value:
Value Percent:
Continuous Index:
Within 8" of Joint:
Remarks:

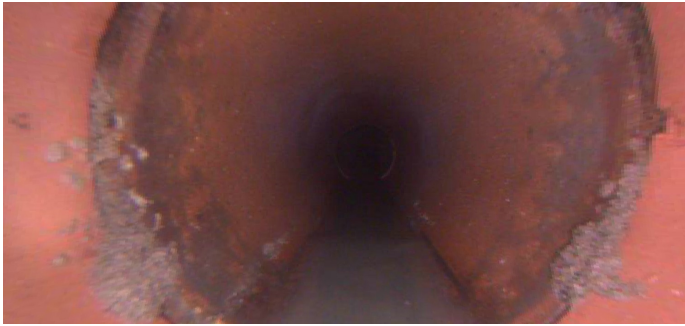
Code: **DAZ**
Description: **Deposits Attached Other**

Distance (ft): **97.0**
Structural Grade: **0**
O&M Grade: **2**
Clock Start/From: **7**
Clock To: **4**
1st Value:
2nd Value:
Value Percent: **5.000**
Continuous Index:
Within 8" of Joint: **YES**
Remarks: **MUD**

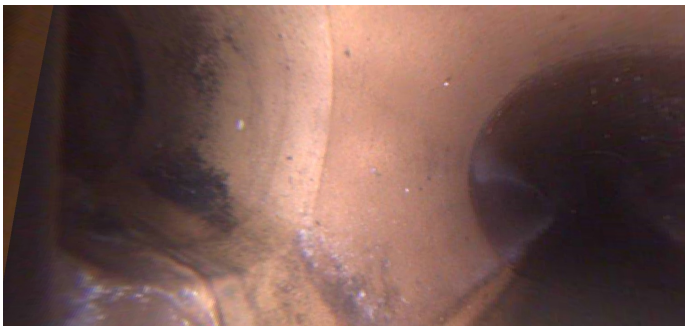
Code: **TFA**
Description: **Tap Factory Active**

Distance (ft): **139.4**
Structural Grade: **0**
O&M Grade: **0**
Clock Start/From: **9**
Clock To:
1st Value: **4.000**
2nd Value:
Value Percent:
Continuous Index:
Within 8" of Joint:
Remarks:

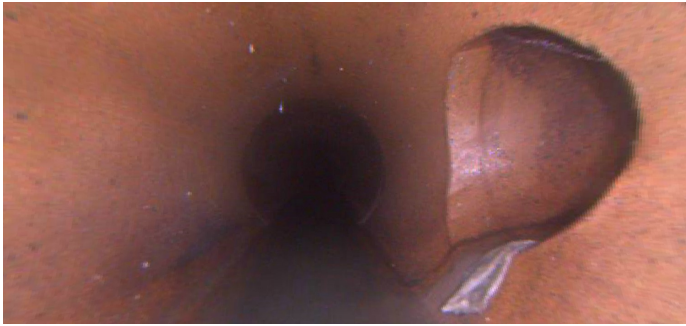
Code: **TF**
Description: **Tap Factory**

Distance (ft): **149.3**
Structural Grade: **0**
O&M Grade: **0**
Clock Start/From: **3**
Clock To:
1st Value: **4.000**
2nd Value:
Value Percent:
Continuous Index:
Within 8" of Joint:
Remarks:

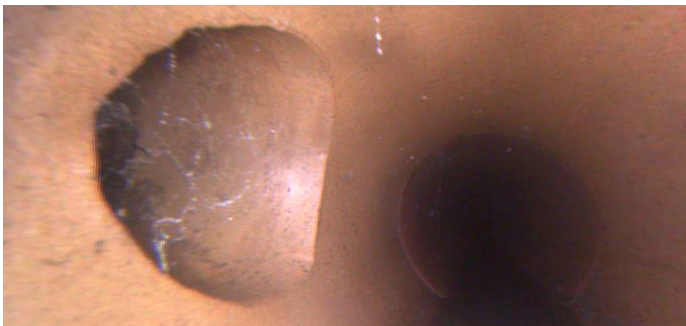
Code: **TF**
Description: **Tap Factory**

Distance (ft): **172.1**
Structural Grade: **0**
O&M Grade: **0**
Clock Start/From: **9**
Clock To:
1st Value: **4.000**
2nd Value:
Value Percent:
Continuous Index:
Within 8" of Joint:
Remarks:

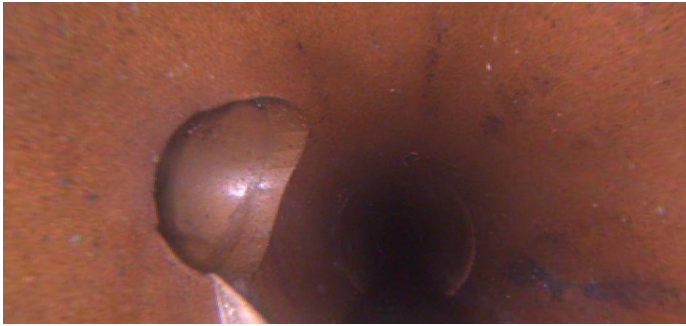
Code: **TF**
Description: **Tap Factory**

Distance (ft): **202.5**
Structural Grade: **0**
O&M Grade: **0**
Clock Start/From: **9**
Clock To:
1st Value: **4.000**
2nd Value:
Value Percent:
Continuous Index:
Within 8" of Joint:
Remarks:

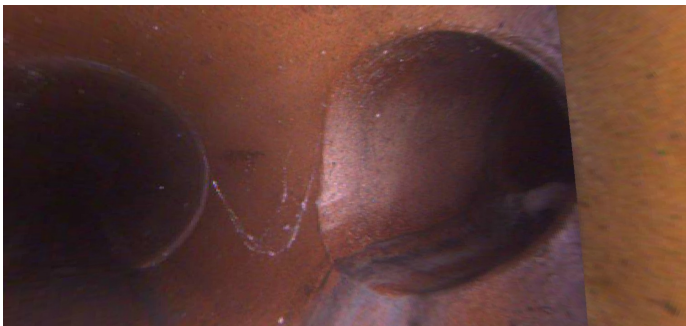
Code: **TF**
Description: **Tap Factory**

Distance (ft): **209.1**
Structural Grade: **0**
O&M Grade: **0**
Clock Start/From: **3**
Clock To:
1st Value: **4.000**
2nd Value:
Value Percent:
Continuous Index:
Within 8" of Joint:
Remarks:

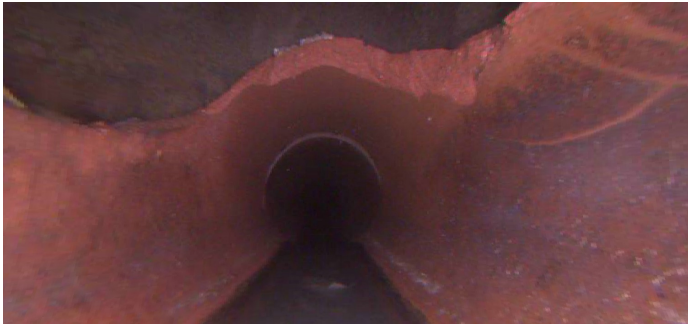
Code:	AMH
Description:	Manhole
Distance (ft):	278.2
Structural Grade:	0
O&M Grade:	0
Clock Start/From:	
Clock To:	
1st Value:	
2nd Value:	
Value Percent:	
Continuous Index:	
Within 8" of Joint:	NO
Remarks:	M-804-050
