## Profile/Photo Observation Report

| Street: | <b>Ohio St.</b> | Flow Control: | <b>Not Controlled</b> |
| City: | <b>Hobart, IN</b> | Year Renewed: | |

| US MH: | <b>M-804-050</b> | DS MH: | <b>M-804-051</b> |

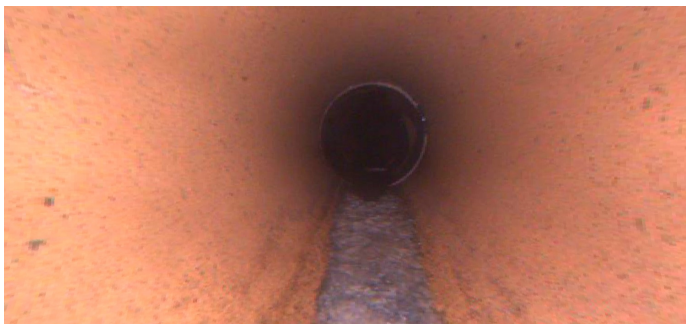
Code: **AMH**  
Description: **Manhole**

Distance (ft): **.0**  
Structural Grade: **0**  
O&M Grade: **0**  
Clock Start/From:  
Clock To:  
1st Value:  
2nd Value:  
Value Percent:  
Continuous Index:  
Within 8" of Joint: **NO**  
Remarks: **M-804-051**

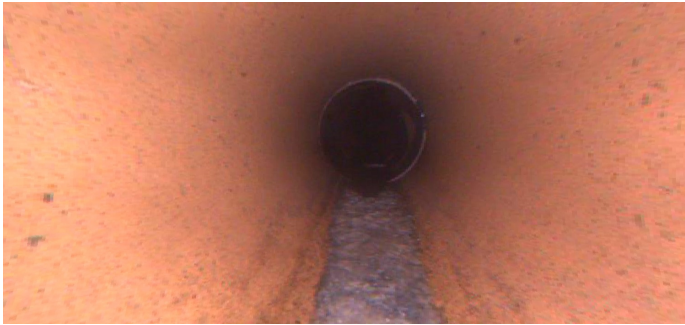
| Code: | <b>MWL</b> |
| Description: | <b>Water Level</b> |

| Distance (ft): | <b>.0</b> |
| Value Percent: | <b>5.000</b> |

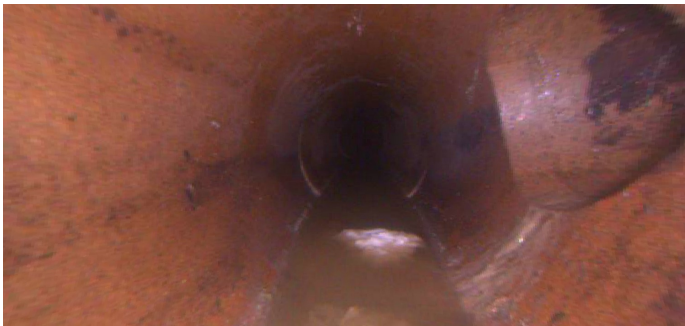
| Code: | <b>TF</b> |
| Description: | <b>Tap Factory</b> |

| Distance (ft): | <b>3.7</b> |
| Clock Start/From: | <b>3</b> |
| 1st Value: | <b>4.000</b> |

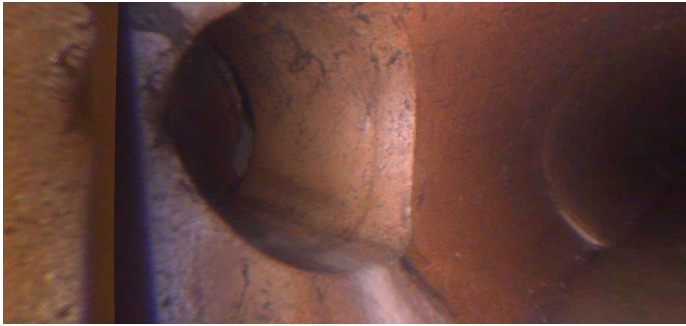
Code: **TF**  
Description: **Tap Factory**

Distance (ft): **34.3**  
Structural Grade: **0**  
O&M Grade: **0**  
Clock Start/From: **9**  
Clock To:  
1st Value: **4.000**  
2nd Value:  
Value Percent:  
Continuous Index:  
Within 8" of Joint:  
Remarks:

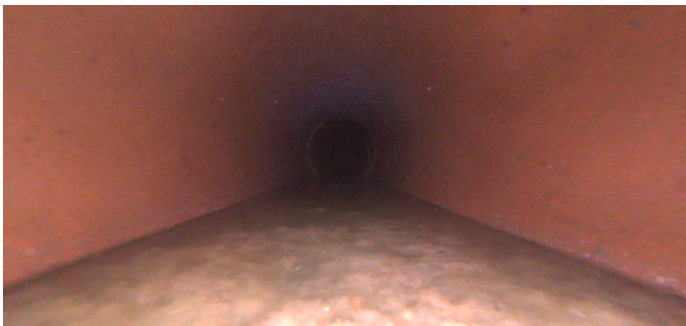
Code: **MWLS**  
Description: **Water Level Sag**

Distance (ft): **56.6**  
Structural Grade: **2**  
O&M Grade: **3**  
Clock Start/From:  
Clock To:  
1st Value:  
2nd Value:  
Value Percent: **10.000**  
Continuous Index:  
Within 8" of Joint: **NO**  
Remarks:

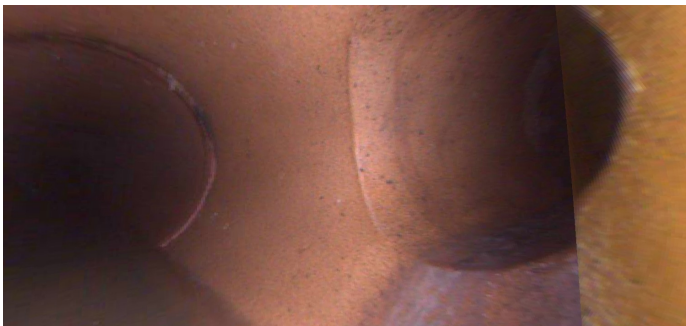
Code: **TF**  
Description: **Tap Factory**

Distance (ft): **87.7**  
Structural Grade: **0**  
O&M Grade: **0**  
Clock Start/From: **3**  
Clock To:  
1st Value: **4.000**  
2nd Value:  
Value Percent:  
Continuous Index:  
Within 8" of Joint:  
Remarks:

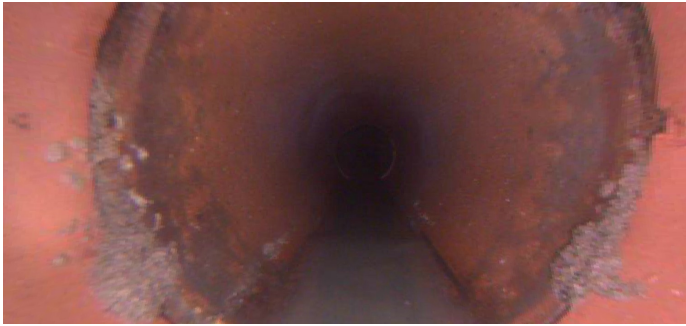
Code: **DAZ**  
Description: **Deposits Attached Other**

Distance (ft): **97.0**  
Structural Grade: **0**  
O&M Grade: **2**  
Clock Start/From: **7**  
Clock To: **4**  
1st Value:  
2nd Value:  
Value Percent: **5.000**  
Continuous Index:  
Within 8" of Joint: **YES**  
Remarks: **MUD**

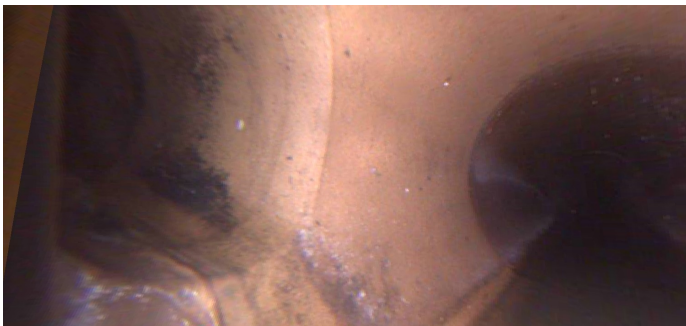
Code: **TFA**  
Description: **Tap Factory Active**

Distance (ft): **139.4**  
Structural Grade: **0**  
O&M Grade: **0**  
Clock Start/From: **9**  
Clock To:  
1st Value: **4.000**  
2nd Value:  
Value Percent:  
Continuous Index:  
Within 8" of Joint:  
Remarks:

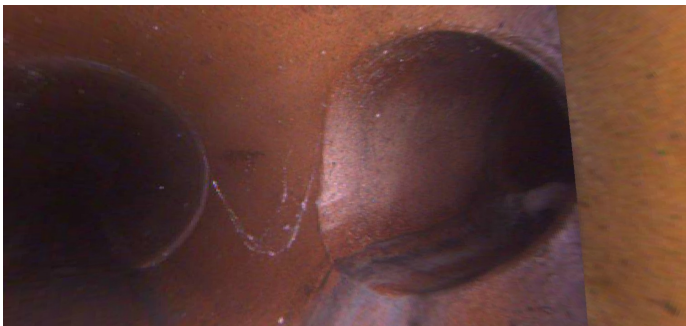
Code: **TF**  
Description: **Tap Factory**

Distance (ft): **209.1**  
Structural Grade: **0**  
O&M Grade: **0**  
Clock Start/From: **3**  
Clock To:  
1st Value: **4.000**  
2nd Value:  
Value Percent:  
Continuous Index:  
Within 8" of Joint:  
Remarks:
