## Profile/Photo Observation Report

Street:	<b>N KELLY ST</b>	Flow Control:	<b>Not Controlled</b>
City:	<b>Hobart, IN</b>	Year Renewed:	
Location:	<b>Other</b>	Tape/Media #:	
Purpose:	<b>Not Known</b>	Dia/Height:	<b>12"</b>
Use:	<b>Sanitary</b>	Material:	<b>VCP</b>
Drain Area:	<b>NA</b>	Lining:	
Category:	<b>NA</b>		
Comment:

Location Details:		Direction of Survey:	<b>Downstream</b>
US MH:	<b>M-804-052</b>	DS MH:	<b>M-804-023</b>
		Total Length Surveyed (ft):	<b>175.3</b>

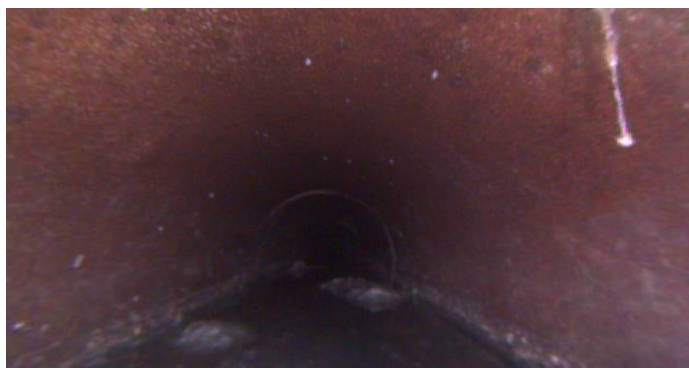
Code: **AMH**  
 Description: **Manhole**  
 Distance (ft): **.0**  
 Structural Grade: **0**  
 O&M Grade: **0**  
 Clock Start/From:  
 Clock To:  
 1st Value:  
 2nd Value:  
 Value Percent:  
 Continuous Index:  
 Within 8" of Joint: **NO**  
 Remarks: **M-804-052**

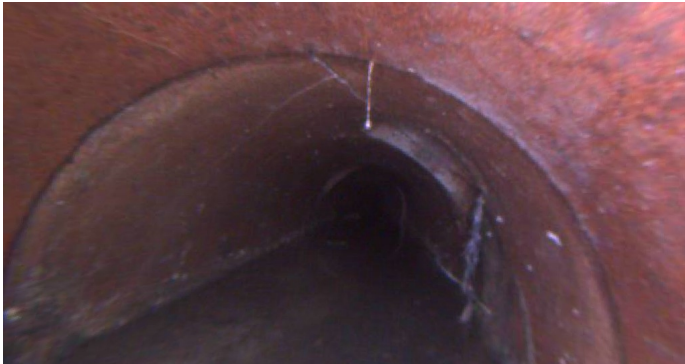
Code:	<b>FM</b>
Description:	<b>Fracture Multiple</b>

Distance (ft):	<b>4.7</b>
Structural Grade:	<b>4</b>
O&M Grade:	<b>0</b>
Clock Start/From:	<b>8</b>
Clock To:	<b>4</b>
1st Value:	
2nd Value:	
Value Percent:	
Continuous Index:	
Within 8" of Joint:	<b>YES</b>
Remarks:

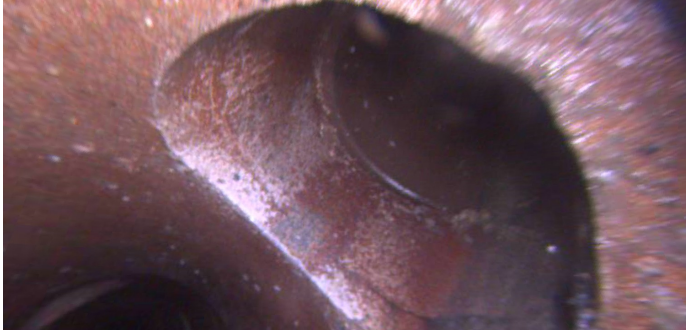
Code: **TF**  
Description: **Tap Factory**

Distance (ft): **5.5**  
Structural Grade: **0**  
O&M Grade: **0**  
Clock Start/From: **2**  
Clock To:  
1st Value: **4.000**  
2nd Value:  
Value Percent:  
Continuous Index:  
Within 8" of Joint:  
Remarks:

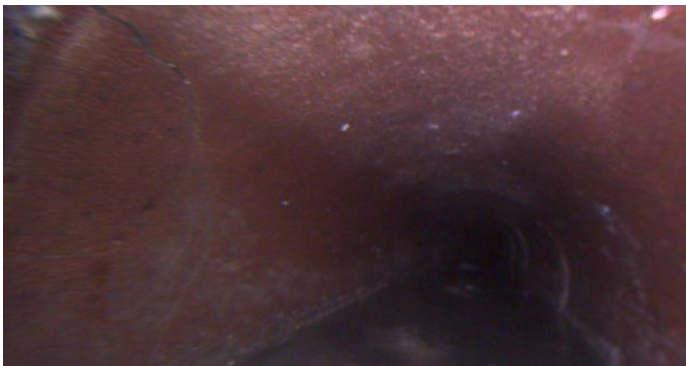
Code: **FS**  
Description: **Fracture Spiral**

Distance (ft): **9.1**  
Structural Grade: **3**  
O&M Grade: **0**  
Clock Start/From: **8**  
Clock To: **11**  
1st Value:  
2nd Value:  
Value Percent:  
Continuous Index:  
Within 8" of Joint:  
Remarks:

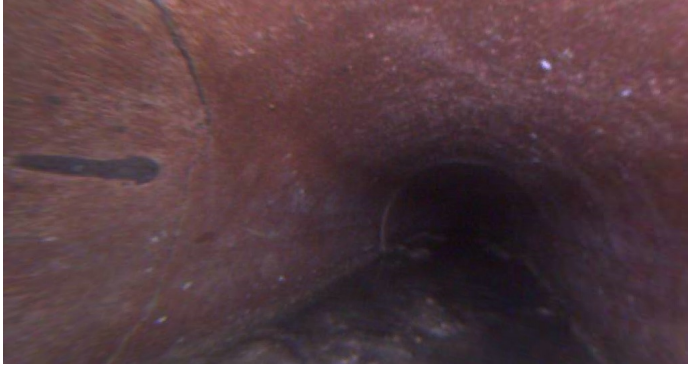
Code:	<b>FS</b>
Description:	<b>Fracture Spiral</b>
Distance (ft):	<b>15.3</b>
Structural Grade:	<b>3</b>
O&M Grade:	<b>0</b>
Clock Start/From:	<b>7</b>
Clock To:	<b>11</b>
1st Value:	
2nd Value:	
Value Percent:	
Continuous Index:	
Within 8" of Joint:	<b>YES</b>
Remarks:

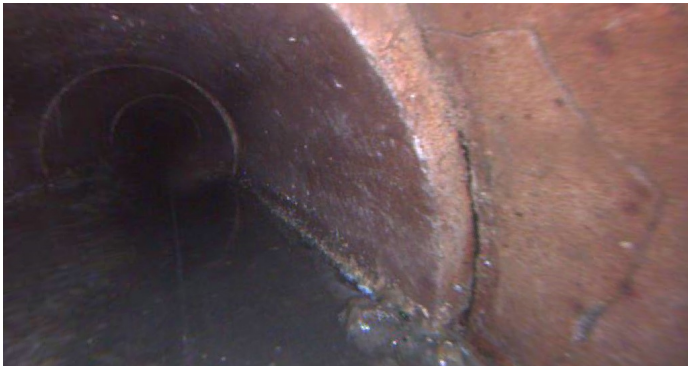
Code:	<b>FM</b>
Description:	<b>Fracture Multiple</b>
Distance (ft):	<b>21.7</b>
Structural Grade:	<b>4</b>
O&M Grade:	<b>0</b>
Clock Start/From:	<b>7</b>
Clock To:	<b>5</b>
1st Value:	
2nd Value:	
Value Percent:	
Continuous Index:	<b>S01</b>
Within 8" of Joint:	
Remarks:

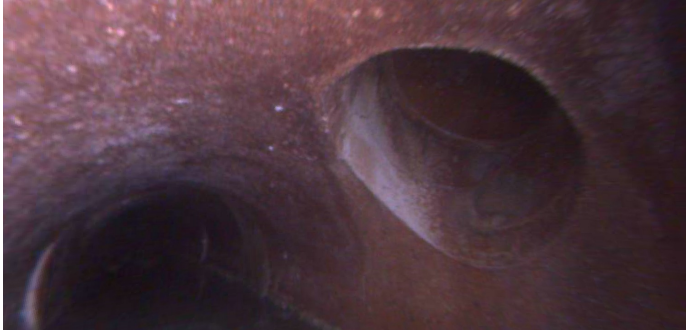
Code: **TF**  
Description: **Tap Factory**

Distance (ft): **58.6**  
Structural Grade: **0**  
O&M Grade: **0**  
Clock Start/From: **2**  
Clock To:  
1st Value: **4.000**  
2nd Value:  
Value Percent:  
Continuous Index:  
Within 8" of Joint:  
Remarks:

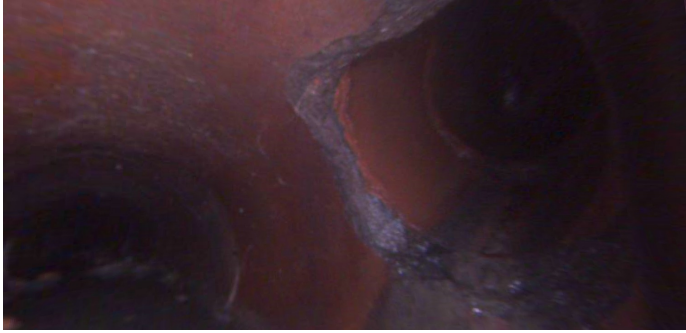
Code: **TBA**  
Description: **Tap Break-in Active**

Distance (ft): **69.1**  
Structural Grade: **0**  
O&M Grade: **0**  
Clock Start/From: **3**  
Clock To:  
1st Value: **4.000**  
2nd Value:  
Value Percent:  
Continuous Index:  
Within 8" of Joint:  
Remarks:

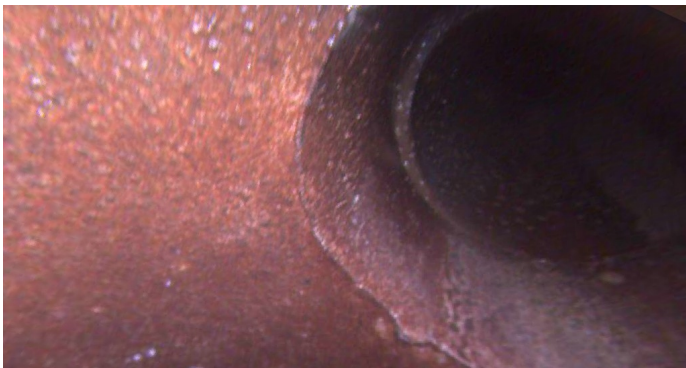
Code: **TF**  
Description: **Tap Factory**

Distance (ft): **105.9**  
Structural Grade: **0**  
O&M Grade: **0**  
Clock Start/From: **2**  
Clock To:  
1st Value: **4.000**  
2nd Value:  
Value Percent:  
Continuous Index:  
Within 8" of Joint:  
Remarks:

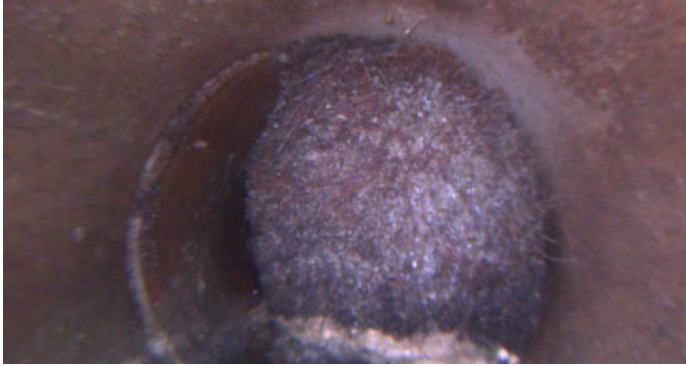
Code: **RBB**  
Description: **Roots Ball Barrel**

Distance (ft): **174.3**  
Structural Grade: **0**  
O&M Grade: **5**  
Clock Start/From: **12**  
Clock To: **12**  
1st Value:  
2nd Value:  
Value Percent: **55.000**  
Continuous Index:  
Within 8" of Joint: **NO**  
Remarks:
