## Profile/Photo Observation Report

Date:	<b>10/18/2021</b>	Weather:		Coding:	<b>PACP 7.0</b>
Pipe Length (ft):	<b>216.7</b>	Owner:	<b>City of Hobart</b>	Pre Clean:	<b>Heavy Cleaning</b>
P.O.#:	<b>YES502259</b>	Surveyor:	<b>S. Bucklin</b>	PSR:	<b>P-804-054-053</b>
Customer:	<b>City of Hobart</b>	Clean Date:	<b>10/14/2021</b>	Shape:	<b>C</b>

Street:	<b>North Kelly Street</b>	Flow Control:	<b>Not Controlled</b>
City:	<b>Hobart, IN</b>	Year Renewed:	
Location:	<b>Local rural streets with light traffic, t</b>	Tape/Media #:	
Purpose:	<b>Routine Assessment</b>	Dia/Height:	<b>12"</b>
Use:	<b>Sanitary Sewage Pipe</b>	Material:	<b>VCP</b>
Drain Area:		Lining:	
Category:	<b>NA</b>		
Comment:			
Location Details:		Direction of Survey:	<b>Upstream</b>
US MH:	<b>M-804-054</b>	DS MH:	<b>M-804-053</b>
		Total Length Surveyed (ft):	<b>216.7</b>

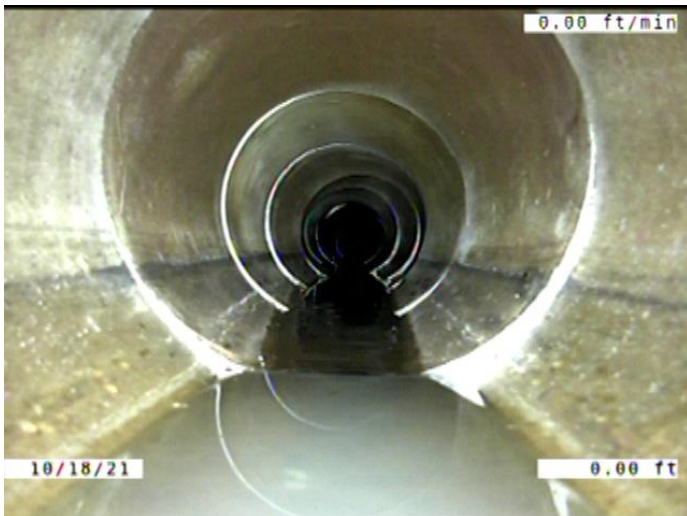
Code: **MWL**  
 Description: **Miscellaneous Water Level**

Distance (ft): **.0**  
 Structural Grade: **0**  
 O&M Grade: **0**  
 Clock Start/From:  
 Clock To:  
 1st Value:  
 2nd Value:  
 Value Percent: **5.000**  
 Continuous Index:  
 Within 8" of Joint: **NO**  
 Remarks:

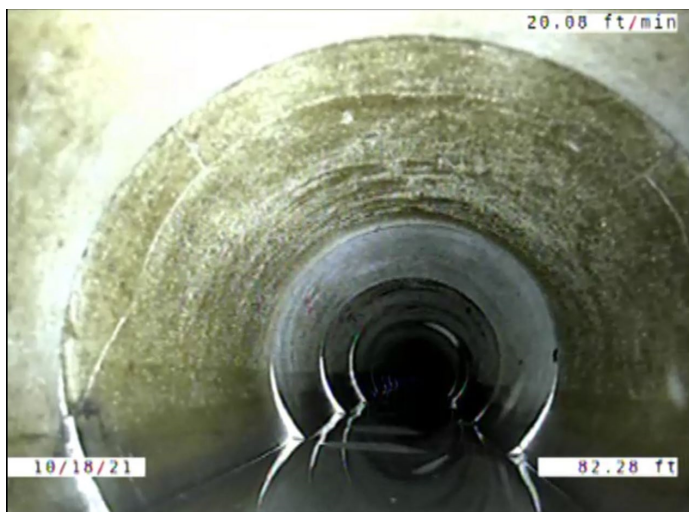
Code: **B**  
 Description: **Broken**

Distance (ft): **82.3**  
 Structural Grade: **4**  
 O&M Grade: **0**  
 Clock Start/From: **9**  
 Clock To: **4**  
 1st Value:  
 2nd Value:  
 Value Percent:  
 Continuous Index: **F02**  
 Within 8" of Joint: **YES**  
 Remarks:

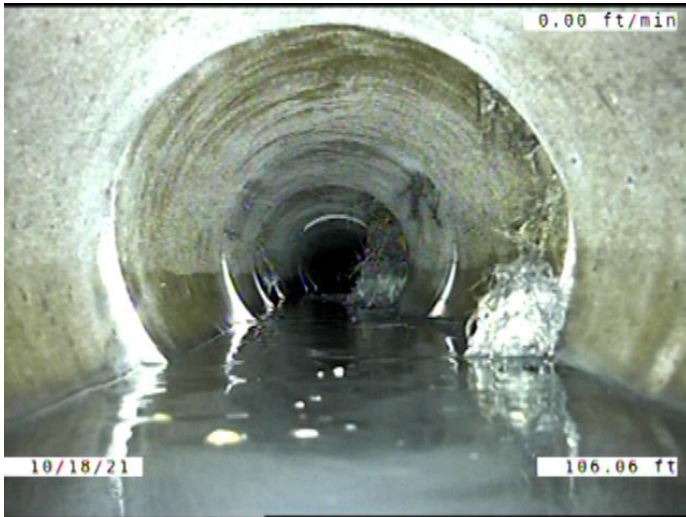
Code: **DSF**  
 Description: **Deposits Settled Fine**

Distance (ft): **106.1**  
 Structural Grade: **0**  
 O&M Grade: **2**  
 Clock Start/From: **5**  
 Clock To: **7**  
 1st Value:  
 2nd Value:  
 Value Percent: **5.000**  
 Continuous Index: **S05**  
 Within 8" of Joint: **YES**  
 Remarks:

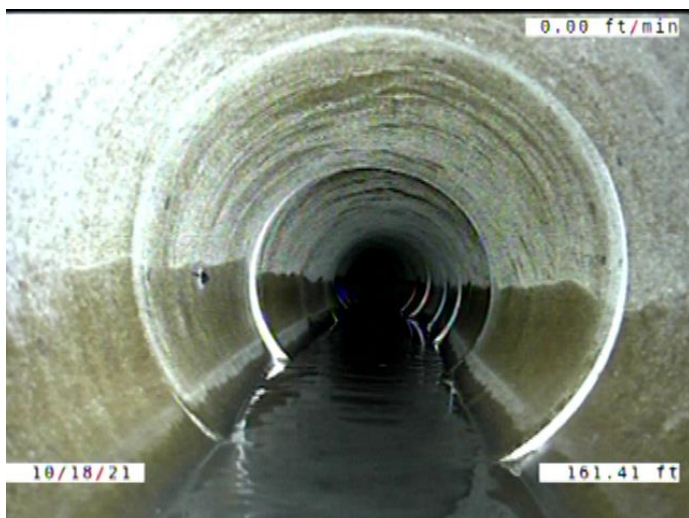
Code:	<b>RFJ</b>
Description:	<b>Roots Fine Joint</b>
Distance (ft):	<b>161.4</b>
Structural Grade:	<b>0</b>
O&M Grade:	<b>1</b>
Clock Start/From:	<b>12</b>
Clock To:	<b>4</b>
1st Value:	
2nd Value:	
Value Percent:	
Continuous Index:	<b>F03</b>
Within 8" of Joint:	<b>YES</b>
Remarks:

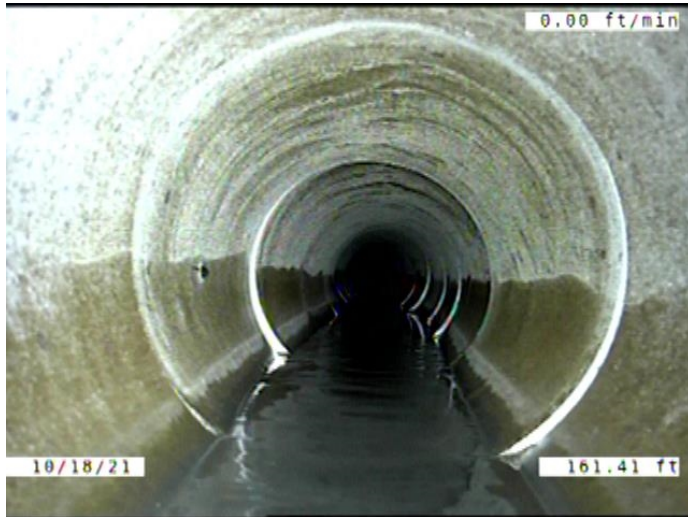
Code: **RFJ**  
Description: **Roots Fine Joint**

Distance (ft): **161.4**  
Structural Grade: **0**  
O&M Grade: **1**  
Clock Start/From: **8**  
Clock To: **10**  
1st Value:  
2nd Value:  
Value Percent:  
Continuous Index: **F04**  
Within 8" of Joint: **YES**  
Remarks:
