Profile/Photo Observation Report

Date:	10/18/2021	Weather:		Coding:	PACP 7.0
Pipe Length (ft):	216.7	Owner:	City of Hobart	Pre Clean:	Heavy Cleaning
P.O.#:	YES502259	Surveyor:	S. Bucklin	PSR:	P-804-054-053
Customer:	City of Hobart	Clean Date:	10/14/2021	Shape:	C

Street:	North Kelly Street	Flow Control:	Not Controlled
City:	Hobart, IN	Year Renewed:	
Location:	Local rural streets with light traffic, t	Tape/Media #:	
Purpose:	Routine Assessment	Dia/Height:	12"
Use:	Sanitary Sewage Pipe	Material:	VCP
Drain Area:		Lining:	
Category:	NA		
Comment:			
Location Details:		Direction of Survey:	Upstream
US MH:	M-804-054	DS MH:	M-804-053
		Total Length Surveyed (ft):	216.7

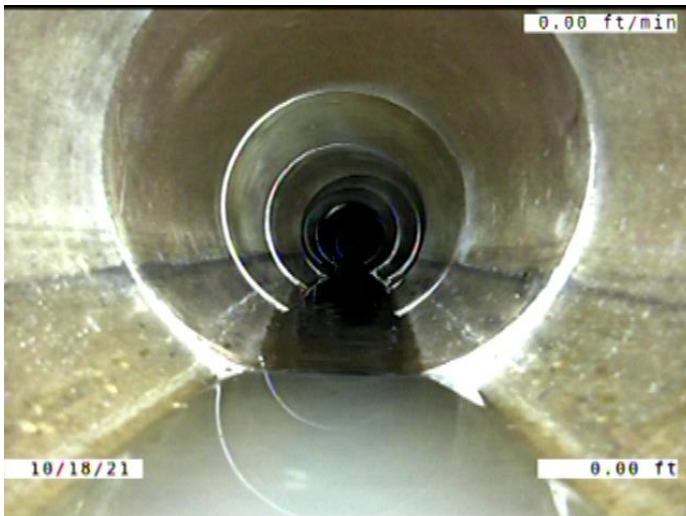
Code: **MWL**
 Description: **Miscellaneous Water Level**

Distance (ft): **.0**
 Structural Grade: **0**
 O&M Grade: **0**
 Clock Start/From:
 Clock To:
 1st Value:
 2nd Value:
 Value Percent: **5.000**
 Continuous Index:
 Within 8" of Joint: **NO**
 Remarks:

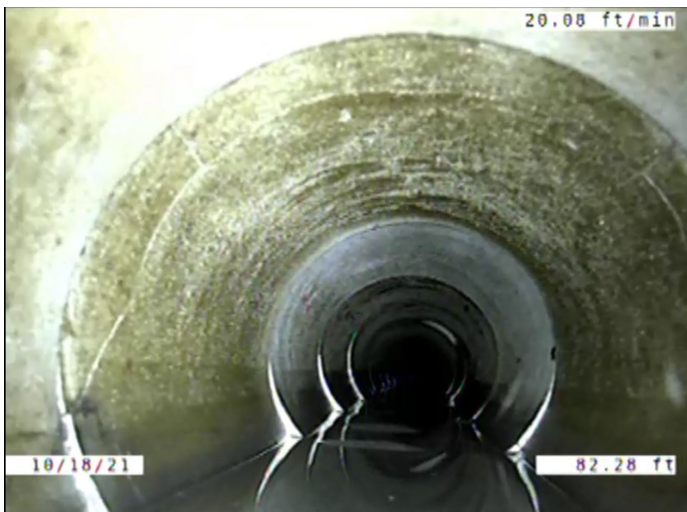
Code: **B**
 Description: **Broken**

Distance (ft): **82.3**
 Structural Grade: **4**
 O&M Grade: **0**
 Clock Start/From: **9**
 Clock To: **4**
 1st Value:
 2nd Value:
 Value Percent:
 Continuous Index: **F02**
 Within 8" of Joint: **YES**
 Remarks:

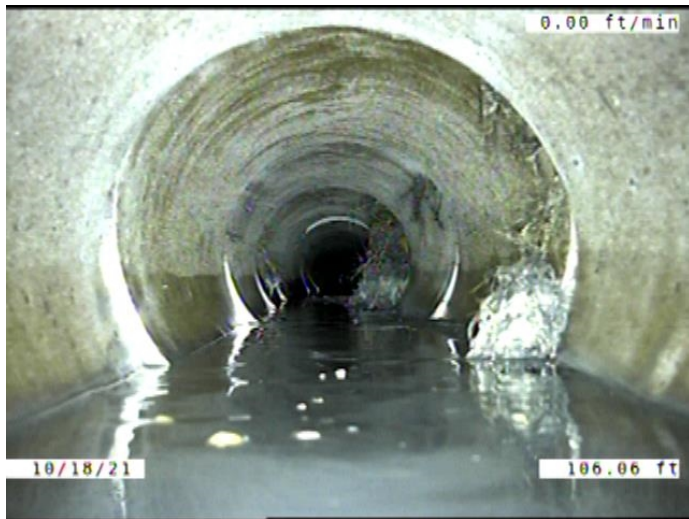
Code: **DSF**
 Description: **Deposits Settled Fine**

Distance (ft): **106.1**
 Structural Grade: **0**
 O&M Grade: **2**
 Clock Start/From: **5**
 Clock To: **7**
 1st Value:
 2nd Value:
 Value Percent: **5.000**
 Continuous Index: **S05**
 Within 8" of Joint: **YES**
 Remarks:

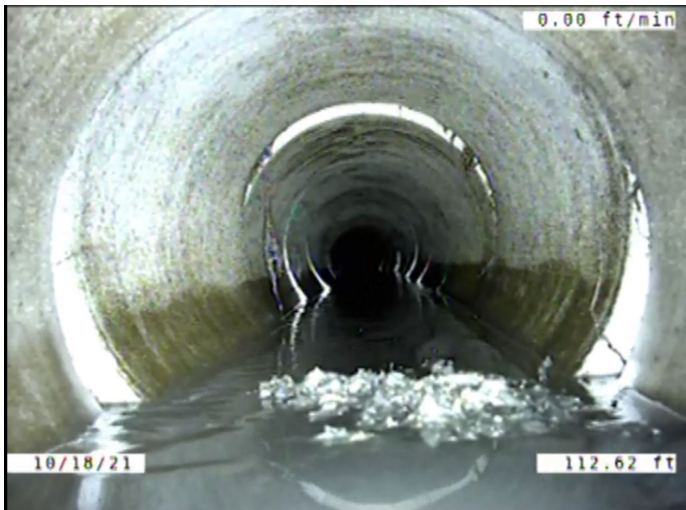
Code: **FM**
 Description: **Fracture Multiple**

Distance (ft): **112.6**
 Structural Grade: **4**
 O&M Grade: **0**
 Clock Start/From: **8**
 Clock To: **4**
 1st Value:
 2nd Value:
 Value Percent:
 Continuous Index: **F01**
 Within 8" of Joint: **YES**
 Remarks:

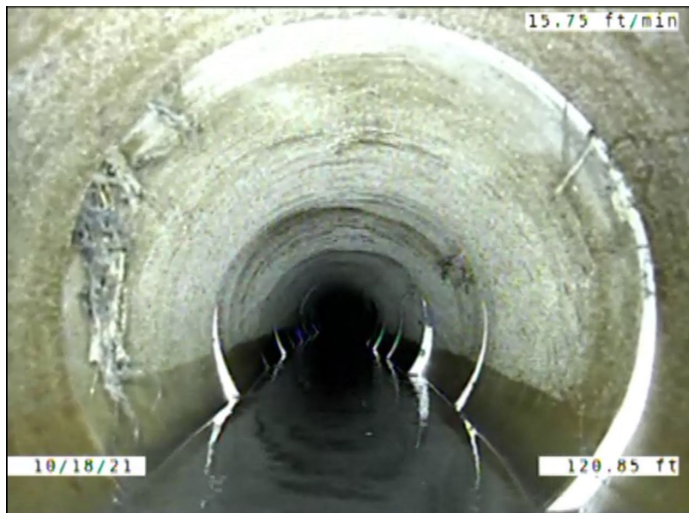
Code: **CM**
 Description: **Crack Multiple**

Distance (ft): **120.9**
 Structural Grade: **3**
 O&M Grade: **0**
 Clock Start/From: **8**
 Clock To: **4**
 1st Value:
 2nd Value:
 Value Percent:
 Continuous Index: **S06**
 Within 8" of Joint: **YES**
 Remarks: **Wandering**

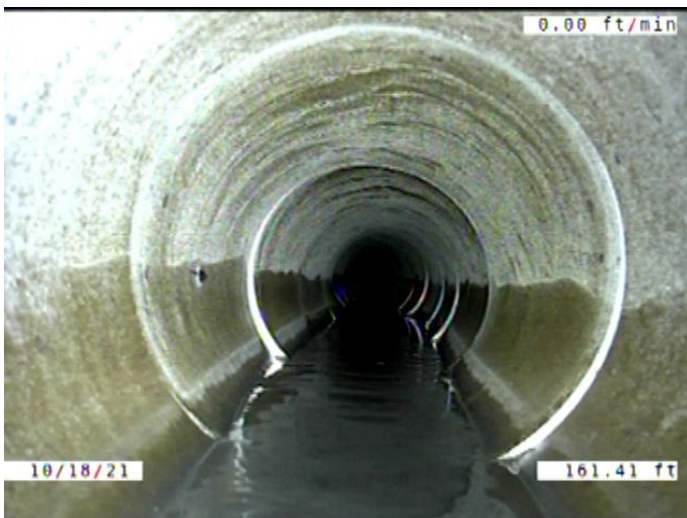
Code:	RFJ
Description:	Roots Fine Joint
Distance (ft):	161.4
Structural Grade:	0
O&M Grade:	1
Clock Start/From:	12
Clock To:	4
1st Value:	
2nd Value:	
Value Percent:	
Continuous Index:	F03
Within 8" of Joint:	YES
Remarks:

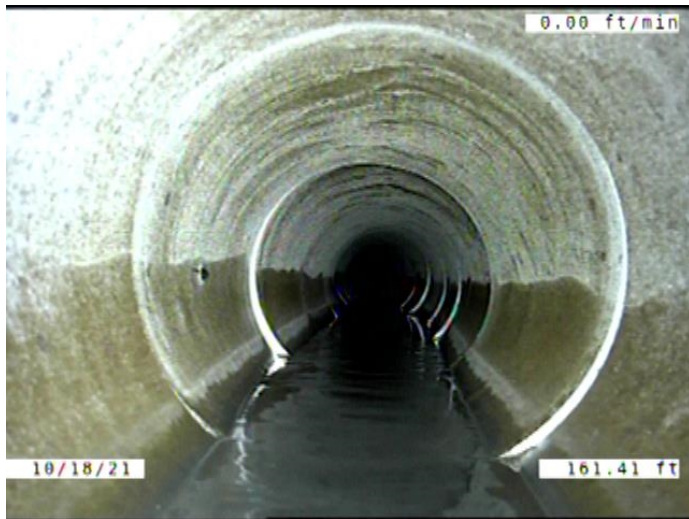
Code: **RFJ**
 Description: **Roots Fine Joint**

Distance (ft): **161.4**
 Structural Grade: **0**
 O&M Grade: **1**
 Clock Start/From: **8**
 Clock To: **10**
 1st Value:
 2nd Value:
 Value Percent:
 Continuous Index: **F04**
 Within 8" of Joint: **YES**
 Remarks:

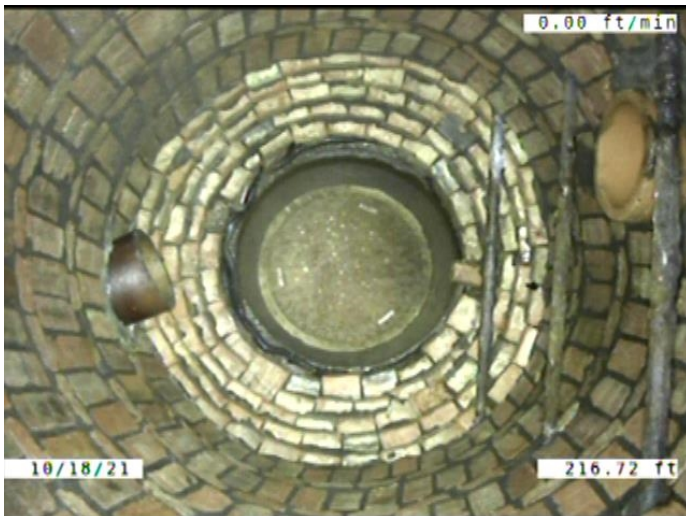
Code: **AMH**
 Description: **Manhole**

Distance (ft): **216.7**
 Structural Grade: **0**
 O&M Grade: **0**
 Clock Start/From:
 Clock To:
 1st Value:
 2nd Value:
 Value Percent:
 Continuous Index:
 Within 8" of Joint: **NO**
 Remarks: **M-804-054**
