## Profile/Photo Observation Report

Date:	<b>10/17/2021</b>	Weather:		Coding:	<b>PACP 7.0</b>
Pipe Length (ft):	<b>221.6</b>	Owner:	<b>City of Hobart</b>	Pre Clean:	<b>Heavy Cleaning</b>
P.O.#:	<b>YES502259</b>	Surveyor:	<b>S. Bucklin</b>	PSR:	<b>P-804-055-054</b>
Customer:	<b>City of Hobart</b>	Clean Date:	<b>10/13/2021</b>	Shape:	<b>C</b>

Street:	<b>North Kelly Street</b>	Flow Control:	<b>Not Controlled</b>
City:	<b>Hobart, IN</b>	Year Renewed:	
Location:	<b>Local rural streets with light traffic, t</b>	Tape/Media #:	
Purpose:	<b>Routine Assessment</b>	Dia/Height:	<b>12"</b>
Use:	<b>Sanitary Sewage Pipe</b>	Material:	<b>VCP</b>
Drain Area:		Lining:	
Category:	<b>NA</b>		
Comment:			
Location Details:		Direction of Survey:	<b>Downstream</b>
US MH:	<b>M-804-055</b>	DS MH:	<b>M-804-054</b>
		Total Length Surveyed (ft):	<b>221.6</b>

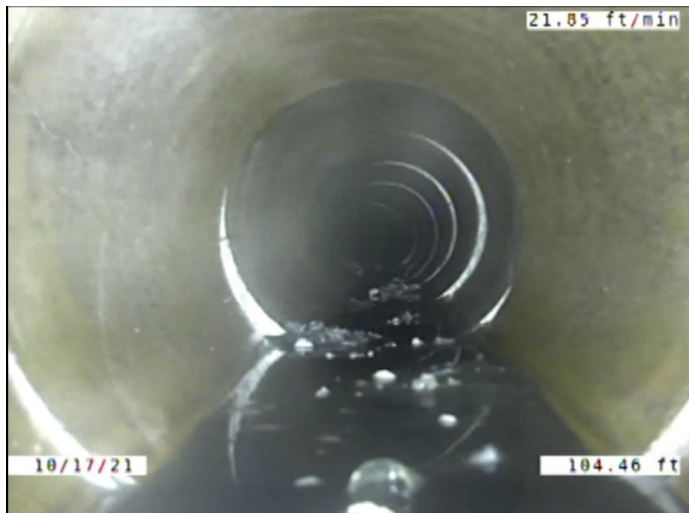
Code: **DSGV**  
 Description: **Deposits Settled Gravel**

Distance (ft): **104.5**  
 Structural Grade: **0**  
 O&M Grade: **2**  
 Clock Start/From: **5**  
 Clock To: **7**  
 1st Value:  
 2nd Value:  
 Value Percent: **10.000**  
 Continuous Index: **S05**  
 Within 8" of Joint: **NO**  
 Remarks:

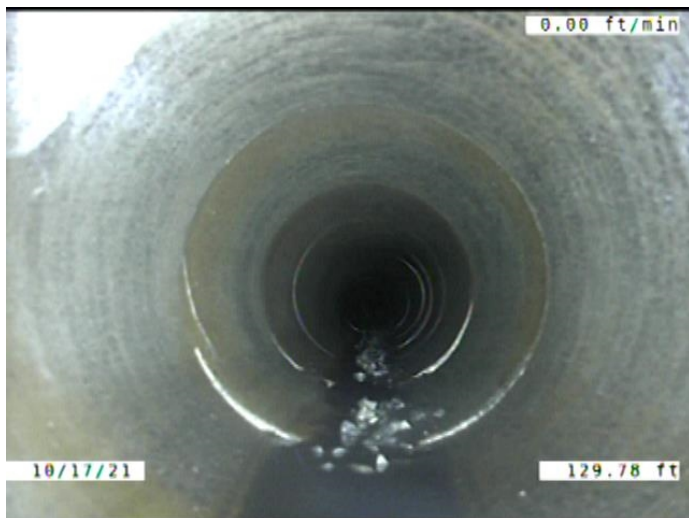
Code: **DSGV**  
 Description: **Deposits Settled Gravel**

Distance (ft): **129.8**  
 Structural Grade: **0**  
 O&M Grade: **2**  
 Clock Start/From: **5**  
 Clock To: **7**  
 1st Value:  
 2nd Value:  
 Value Percent: **5.000**  
 Continuous Index: **S04**  
 Within 8" of Joint: **YES**  
 Remarks:

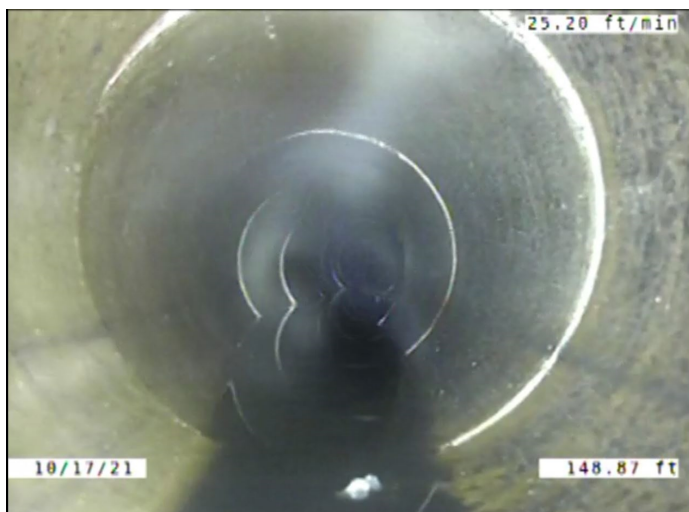
Code: **DSGV**  
 Description: **Deposits Settled Gravel**

Distance (ft): **148.9**  
 Structural Grade: **0**  
 O&M Grade: **2**  
 Clock Start/From: **5**  
 Clock To: **7**  
 1st Value:  
 2nd Value:  
 Value Percent: **10.000**  
 Continuous Index: **F05**  
 Within 8" of Joint: **NO**  
 Remarks:

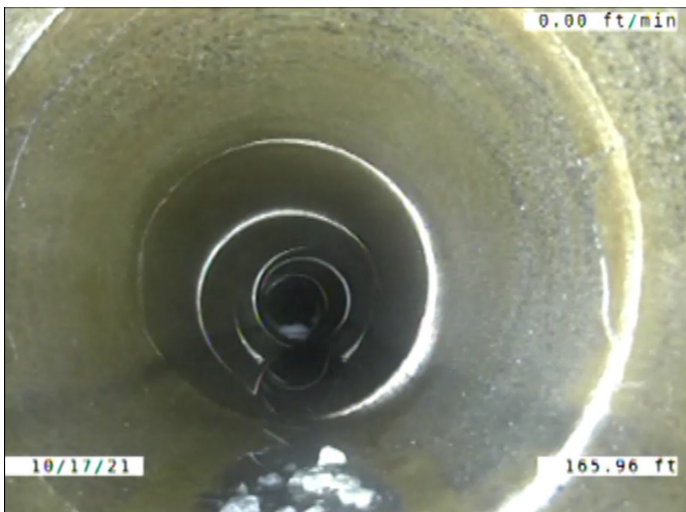
Code: **DSGV**  
 Description: **Deposits Settled Gravel**

Distance (ft): **166.0**  
 Structural Grade: **0**  
 O&M Grade: **2**  
 Clock Start/From: **5**  
 Clock To: **7**  
 1st Value:  
 2nd Value:  
 Value Percent: **10.000**  
 Continuous Index: **F06**  
 Within 8" of Joint: **NO**  
 Remarks:

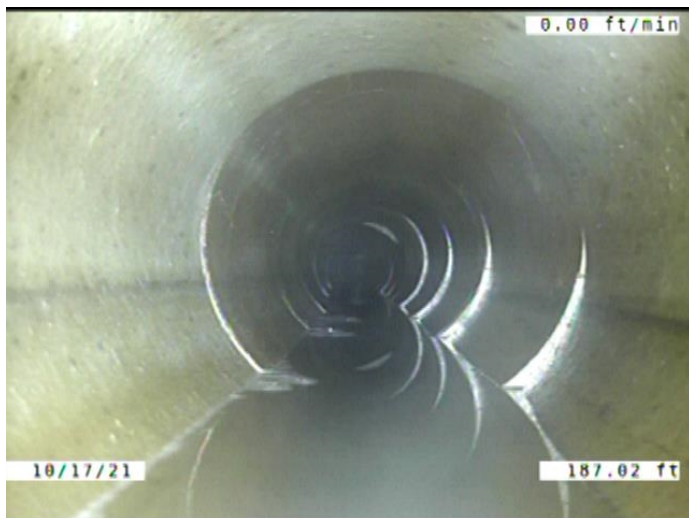
Code: **DSGV**  
 Description: **Deposits Settled Gravel**

Distance (ft): **187.0**  
 Structural Grade: **0**  
 O&M Grade: **2**  
 Clock Start/From: **5**  
 Clock To: **7**  
 1st Value:  
 2nd Value:  
 Value Percent: **5.000**  
 Continuous Index: **F04**  
 Within 8" of Joint: **YES**  
 Remarks:
