Profile/Photo Observation Report

Date:	10/17/2021	Weather:		Coding:	PACP 7.0
Pipe Length (ft):	221.6	Owner:	City of Hobart	Pre Clean:	Heavy Cleaning
P.O.#:	YES502259	Surveyor:	S. Bucklin	PSR:	P-804-055-054
Customer:	City of Hobart	Clean Date:	10/13/2021	Shape:	C

Street:	North Kelly Street	Flow Control:	Not Controlled
City:	Hobart, IN	Year Renewed:	
Location:	Local rural streets with light traffic, t	Tape/Media #:	
Purpose:	Routine Assessment	Dia/Height:	12"
Use:	Sanitary Sewage Pipe	Material:	VCP
Drain Area:		Lining:	
Category:	NA		
Comment:			
Location Details:		Direction of Survey:	Downstream
US MH:	M-804-055	DS MH:	M-804-054
		Total Length Surveyed (ft):	221.6

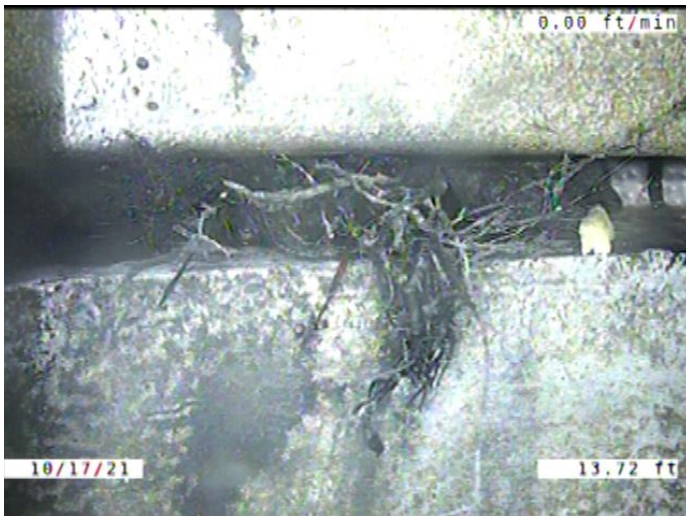
Code: **RFJ**
Description: **Roots Fine Joint**

Distance (ft): **13.7**
Structural Grade: **0**
O&M Grade: **1**
Clock Start/From: **8**
Clock To: **9**
1st Value:
2nd Value:
Value Percent:
Continuous Index:
Within 8" of Joint: **YES**
Remarks:

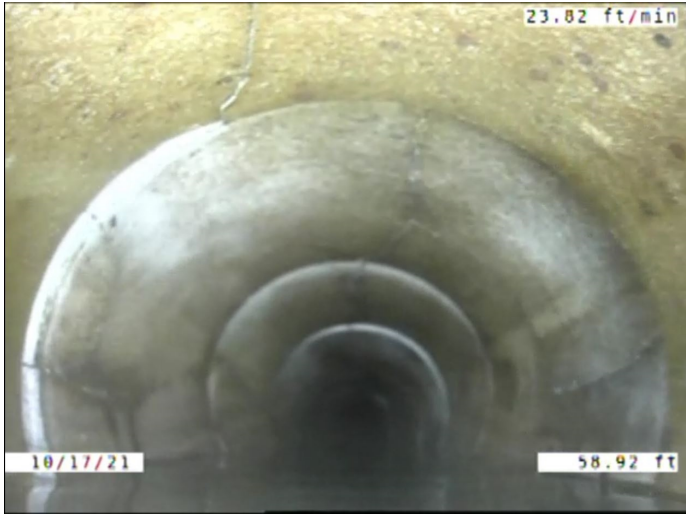
Code: **B**
Description: **Broken**

Distance (ft): **58.9**
Structural Grade: **4**
O&M Grade: **0**
Clock Start/From: **8**
Clock To: **10**
1st Value:
2nd Value:
Value Percent:
Continuous Index:
Within 8" of Joint: **YES**
Remarks:

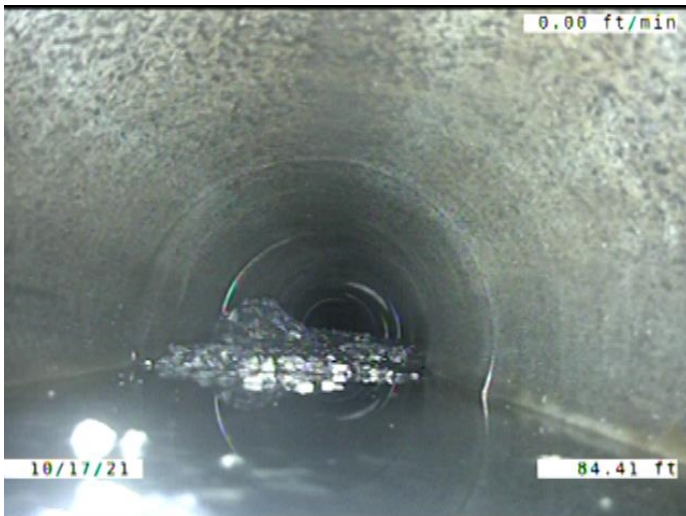
Code: **DSGV**
 Description: **Deposits Settled Gravel**

Distance (ft): **84.4**
 Structural Grade: **0**
 O&M Grade: **5**
 Clock Start/From: **3**
 Clock To: **10**
 1st Value:
 2nd Value:
 Value Percent: **55.000**
 Continuous Index: **S03**
 Within 8" of Joint: **YES**
 Remarks:

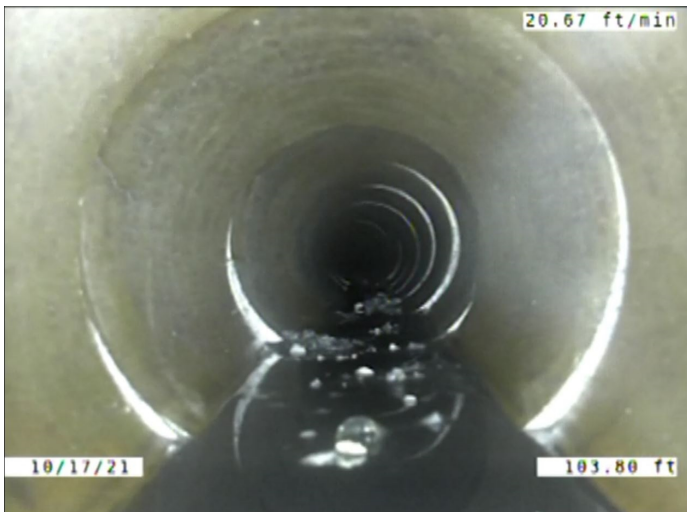
Code: **DSGV**
 Description: **Deposits Settled Gravel**

Distance (ft): **103.8**
 Structural Grade: **0**
 O&M Grade: **5**
 Clock Start/From: **3**
 Clock To: **10**
 1st Value:
 2nd Value:
 Value Percent: **55.000**
 Continuous Index: **F03**
 Within 8" of Joint: **YES**
 Remarks:

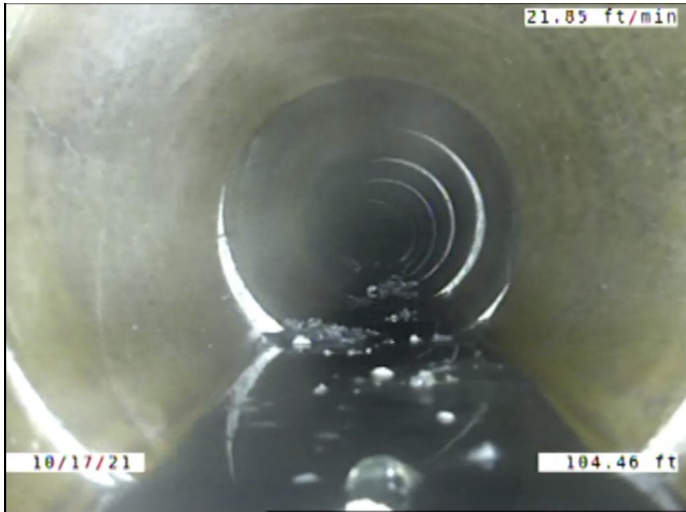
Code: **DSGV**
 Description: **Deposits Settled Gravel**

Distance (ft): **104.5**
 Structural Grade: **0**
 O&M Grade: **2**
 Clock Start/From: **5**
 Clock To: **7**
 1st Value:
 2nd Value:
 Value Percent: **10.000**
 Continuous Index: **S05**
 Within 8" of Joint: **NO**
 Remarks:

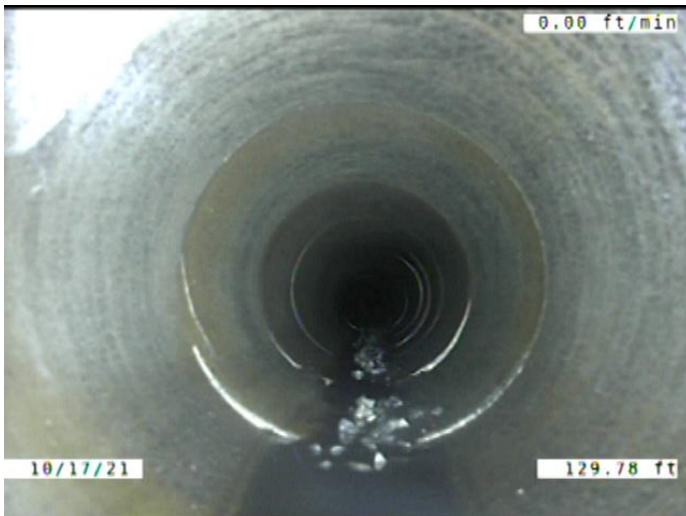
Code: **DSGV**
 Description: **Deposits Settled Gravel**

Distance (ft): **129.8**
 Structural Grade: **0**
 O&M Grade: **2**
 Clock Start/From: **5**
 Clock To: **7**
 1st Value:
 2nd Value:
 Value Percent: **5.000**
 Continuous Index: **S04**
 Within 8" of Joint: **YES**
 Remarks:

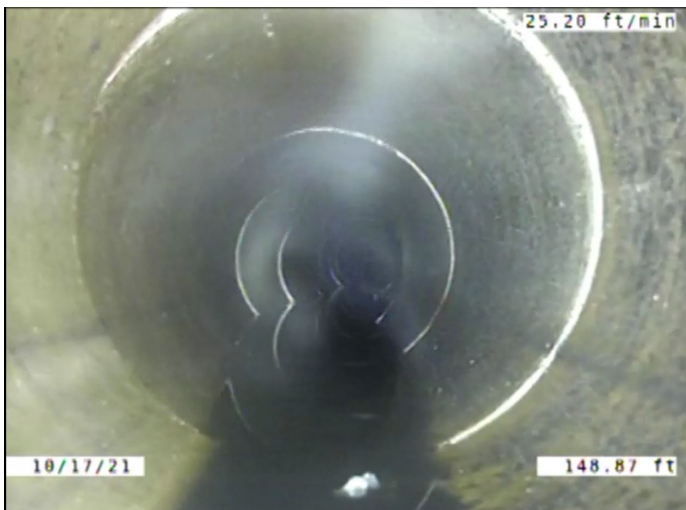
Code: **DSGV**
 Description: **Deposits Settled Gravel**

Distance (ft): **148.9**
 Structural Grade: **0**
 O&M Grade: **2**
 Clock Start/From: **5**
 Clock To: **7**
 1st Value:
 2nd Value:
 Value Percent: **10.000**
 Continuous Index: **F05**
 Within 8" of Joint: **NO**
 Remarks:

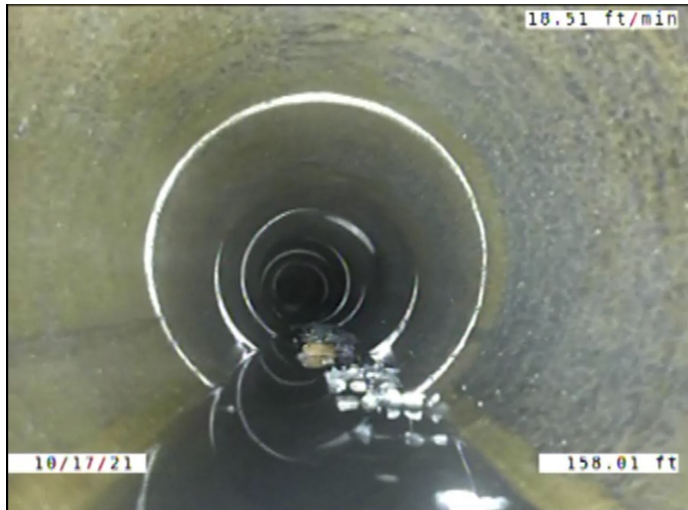
Code: **DSGV**
 Description: **Deposits Settled Gravel**

Distance (ft): **158.0**
 Structural Grade: **0**
 O&M Grade: **2**
 Clock Start/From: **5**
 Clock To: **7**
 1st Value:
 2nd Value:
 Value Percent: **10.000**
 Continuous Index: **S06**
 Within 8" of Joint: **NO**
 Remarks:

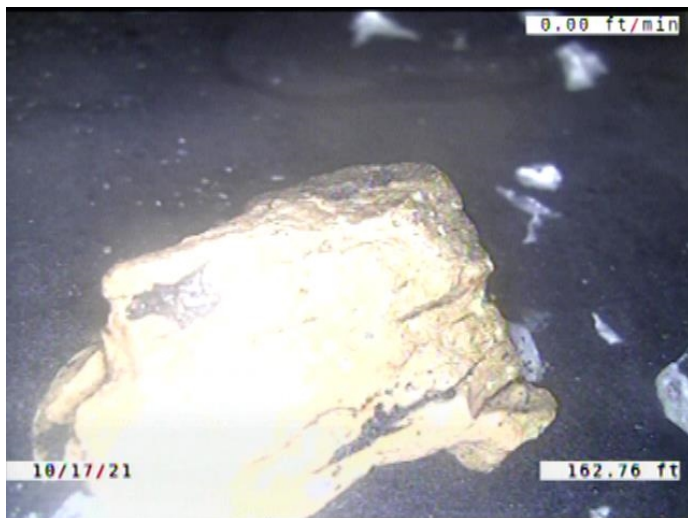
Code: **OBM**
 Description: **Obstruction Pipe Material in Invert**

Distance (ft): **162.8**
 Structural Grade: **0**
 O&M Grade: **2**
 Clock Start/From: **6**
 Clock To:
 1st Value:
 2nd Value:
 Value Percent: **5.000**
 Continuous Index:
 Within 8" of Joint: **YES**
 Remarks:

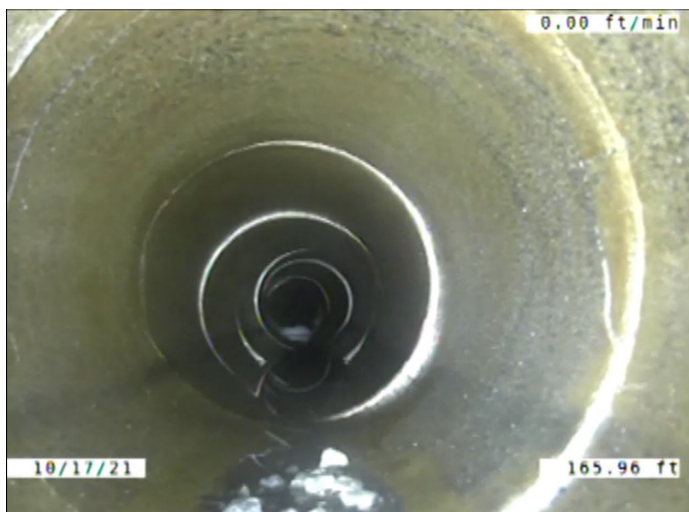
Code: **DSGV**
 Description: **Deposits Settled Gravel**

Distance (ft): **166.0**
 Structural Grade: **0**
 O&M Grade: **2**
 Clock Start/From: **5**
 Clock To: **7**
 1st Value:
 2nd Value:
 Value Percent: **10.000**
 Continuous Index: **F06**
 Within 8" of Joint: **NO**
 Remarks:
