Profile/Photo Observation Report

Date:	05/03/2018	Weather:		Coding:	PACP 4.2
Pipe Length (ft):	271.8	Owner:	City of Hobart	Pre Clean:	No Pre-Cleaning
P.O.#:	2004	Surveyor:	SAN	PSR:	P-804-075-058
Customer:	Red Zone	Clean Date:		Shape:	C

Street:	243 N Linda St	Flow Control:	Not Controlled
City:	Hobart In	Year Renewed:	
Location:	Light Highway	Tape/Media #:	Deliverable 1
Purpose:	Routine Assessment	Dia/Height:	15"
Use:	Sanitary	Material:	VCP
Drain Area:	Northeast	Lining:	
Category:	NA		
Comment:	440-1		
Location Details:	Edge of street	Direction of Survey:	Downstream
US MH:	M-804-075	DS MH:	M-804-058
		Total Length Surveyed (ft):	271.8

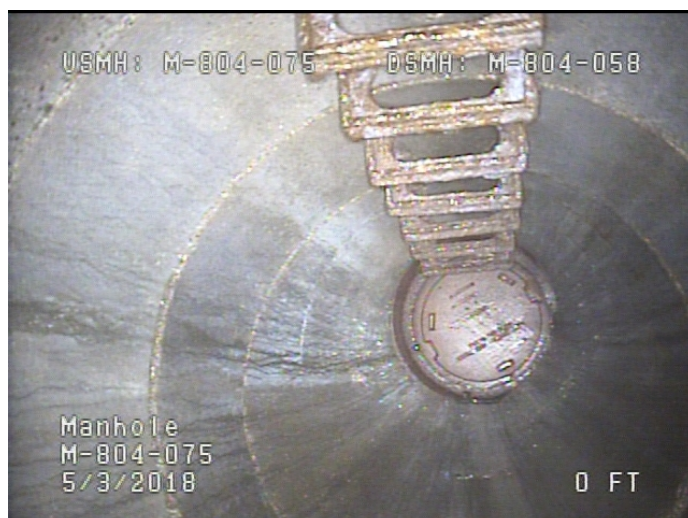
Code: **AMH**
 Description: **Manhole**

Distance (ft): **.0**
 Structural Grade: **0**
 O&M Grade: **0**
 Clock Start/From:
 Clock To:
 1st Value:
 2nd Value:
 Value Percent:
 Continuous Index:
 Within 8" of Joint: **NO**
 Remarks: **M-804-075**

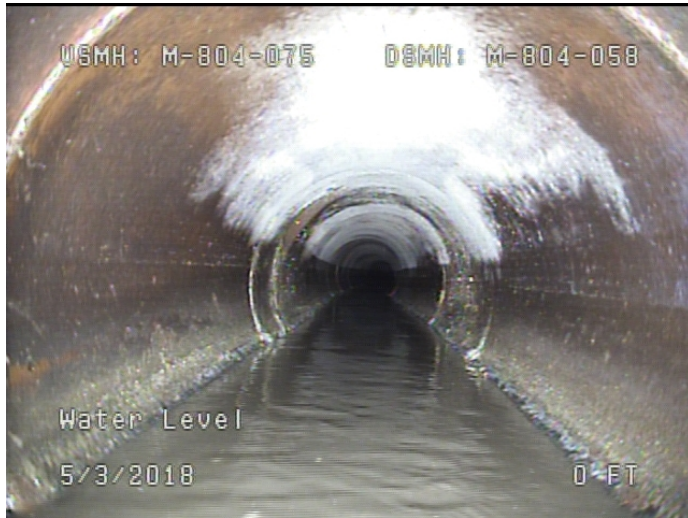
Code: **MWL**
 Description: **Water Level**

Distance (ft): **.0**
 Structural Grade: **0**
 O&M Grade: **0**
 Clock Start/From:
 Clock To:
 1st Value:
 2nd Value:
 Value Percent: **15.000**
 Continuous Index:
 Within 8" of Joint: **NO**
 Remarks:

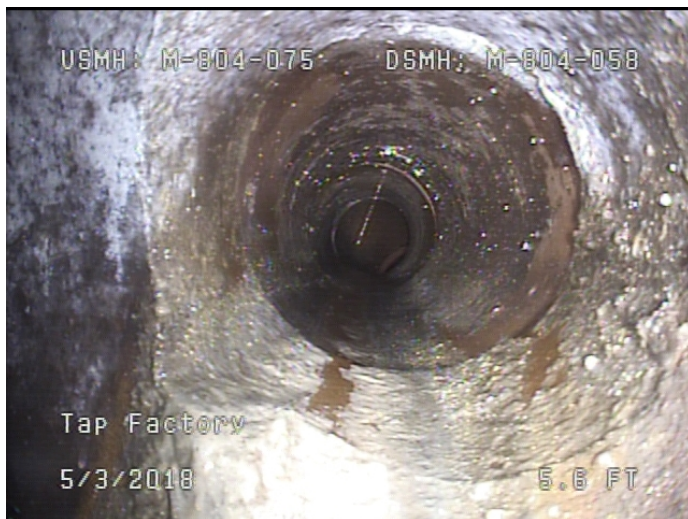
Code: **TF**
 Description: **Tap Factory**

Distance (ft): **5.6**
 Structural Grade: **0**
 O&M Grade: **0**
 Clock Start/From: **10**
 Clock To:
 1st Value: **6.000**
 2nd Value:
 Value Percent:
 Continuous Index:
 Within 8" of Joint: **NO**
 Remarks:

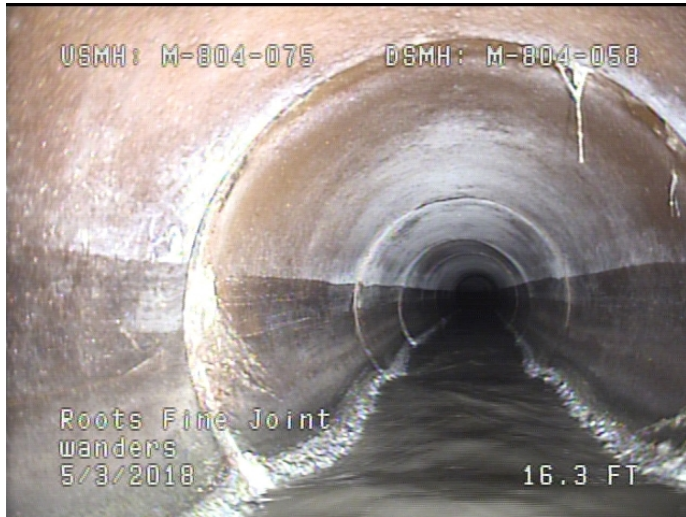
Code:	RFJ
Description:	Roots Fine Joint
Distance (ft):	16.3
Structural Grade:	0
O&M Grade:	1
Clock Start/From:	8
Clock To:	5
1st Value:	
2nd Value:	
Value Percent:	
Continuous Index:	S01
Within 8" of Joint:	YES
Remarks:	wanders

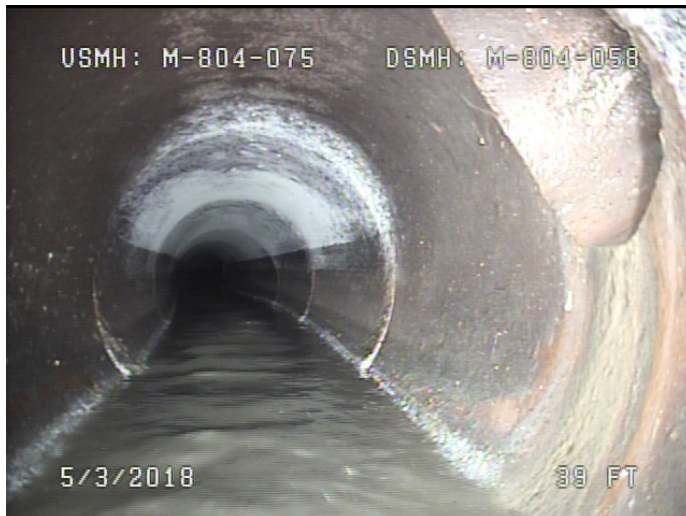
Code:	TFD
Description:	Tap Factory Defective
Distance (ft):	39.0
Structural Grade:	0
O&M Grade:	2
Clock Start/From:	2
Clock To:	
1st Value:	6.000
2nd Value:	
Value Percent:	
Continuous Index:	
Within 8" of Joint:	NO
Remarks:	roots in tap

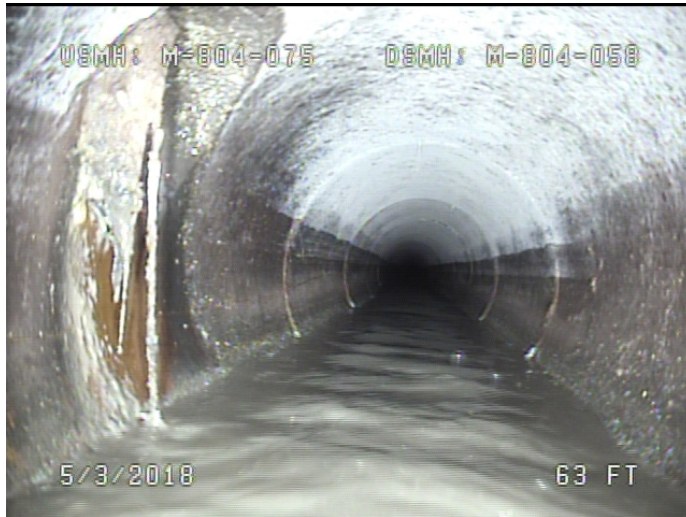
Code:	TFD
Description:	Tap Factory Defective
Distance (ft):	63.0
Structural Grade:	0
O&M Grade:	2
Clock Start/From:	10
Clock To:	
1st Value:	6.000
2nd Value:	
Value Percent:	
Continuous Index:	
Within 8" of Joint:	NO
Remarks:	roots in tap

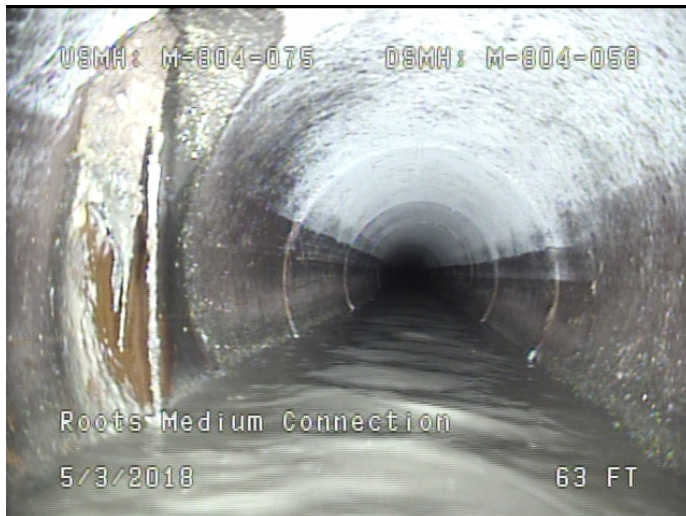
Code:	RMC
Description:	Roots Medium Connection
Distance (ft):	63.0
Structural Grade:	0
O&M Grade:	3
Clock Start/From:	7
Clock To:	11
1st Value:	
2nd Value:	
Value Percent:	10.000
Continuous Index:	
Within 8" of Joint:	NO
Remarks:

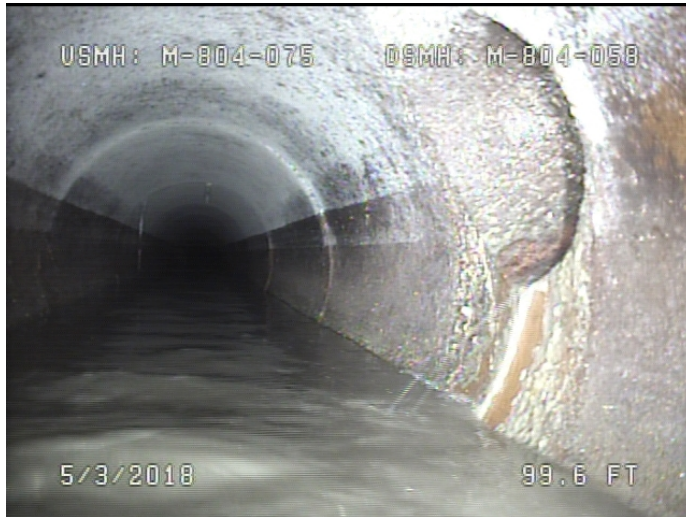
Code: **TFA**
 Description: **Tap Factory Active**

Distance (ft): **99.6**
 Structural Grade: **0**
 O&M Grade: **0**
 Clock Start/From: **2**
 Clock To:
 1st Value: **6.000**
 2nd Value:
 Value Percent:
 Continuous Index:
 Within 8" of Joint: **NO**
 Remarks:

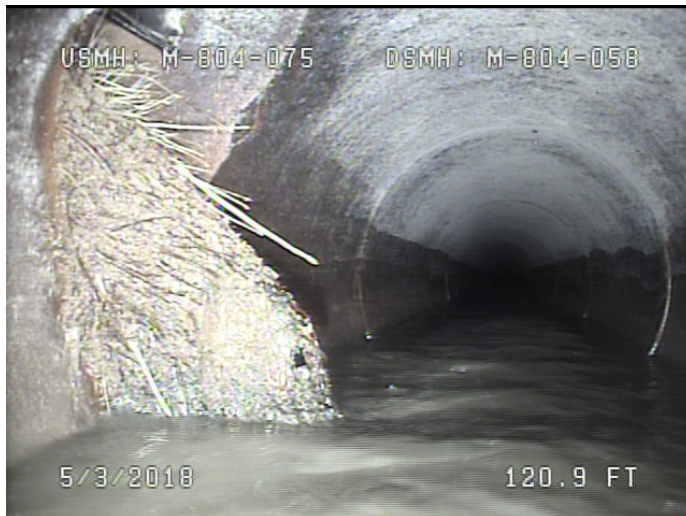
Code: **TFD**
 Description: **Tap Factory Defective**

Distance (ft): **120.9**
 Structural Grade: **0**
 O&M Grade: **2**
 Clock Start/From: **2**
 Clock To:
 1st Value: **6.000**
 2nd Value:
 Value Percent:
 Continuous Index:
 Within 8" of Joint: **NO**
 Remarks: **roots in tap**

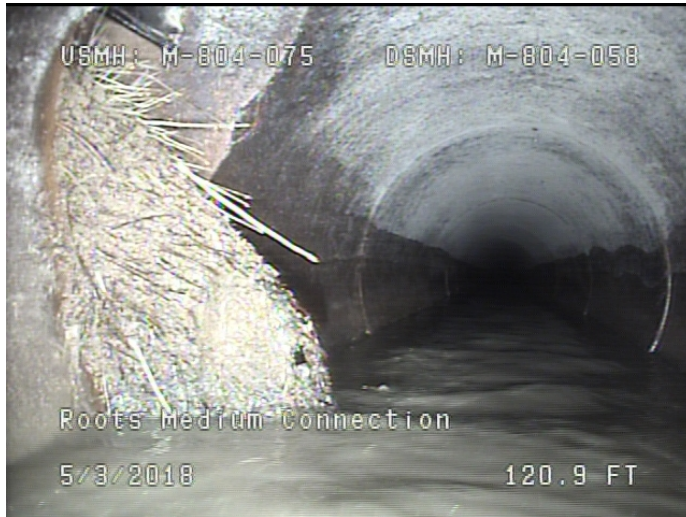
Code:	RMC
Description:	Roots Medium Connection
Distance (ft):	120.9
Structural Grade:	0
O&M Grade:	3
Clock Start/From:	8
Clock To:	10
1st Value:	
2nd Value:	
Value Percent:	25.000
Continuous Index:	
Within 8" of Joint:	NO
Remarks:

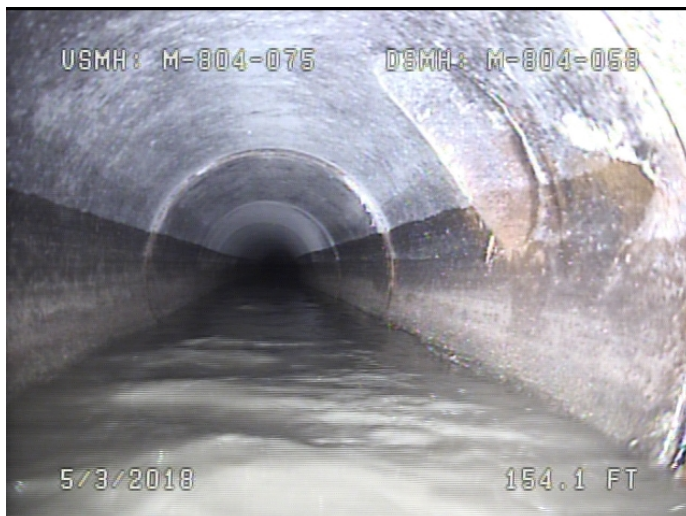
Code:	TFD
Description:	Tap Factory Defective
Distance (ft):	154.1
Structural Grade:	0
O&M Grade:	2
Clock Start/From:	2
Clock To:	
1st Value:	6.000
2nd Value:	
Value Percent:	
Continuous Index:	
Within 8" of Joint:	NO
Remarks:	soil in tap

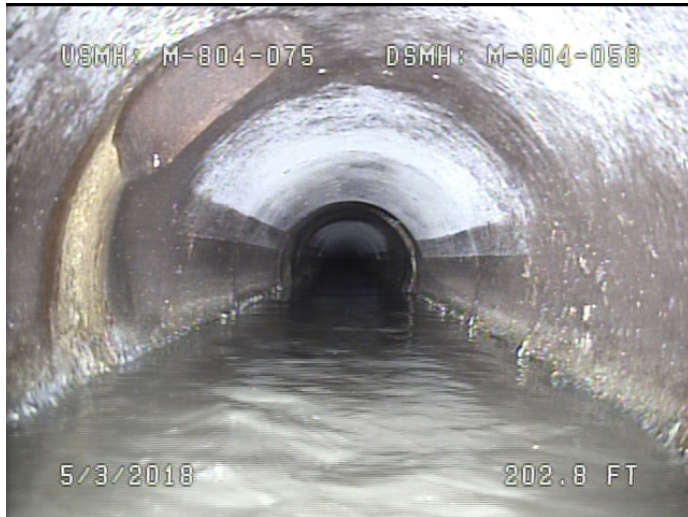
Code: **TF**
 Description: **Tap Factory**

Distance (ft): **202.8**
 Structural Grade: **0**
 O&M Grade: **0**
 Clock Start/From: **10**
 Clock To:
 1st Value: **6.000**
 2nd Value:
 Value Percent:
 Continuous Index:
 Within 8" of Joint: **NO**
 Remarks:

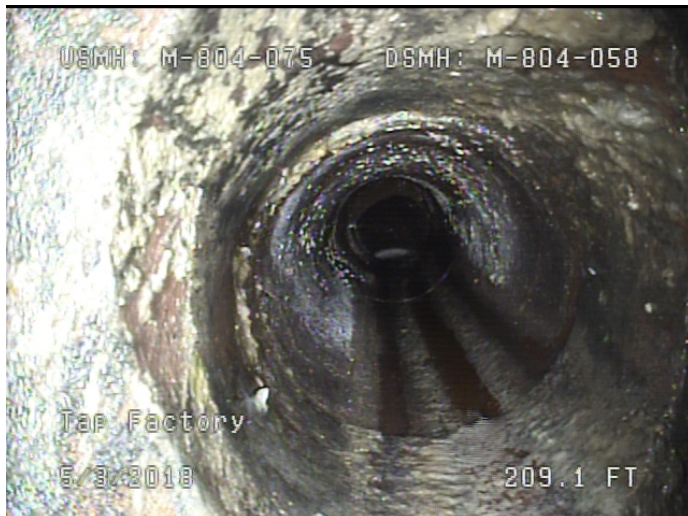
Code: **TF**
 Description: **Tap Factory**

Distance (ft): **209.1**
 Structural Grade: **0**
 O&M Grade: **0**
 Clock Start/From: **2**
 Clock To:
 1st Value: **6.000**
 2nd Value:
 Value Percent:
 Continuous Index:
 Within 8" of Joint: **NO**
 Remarks:

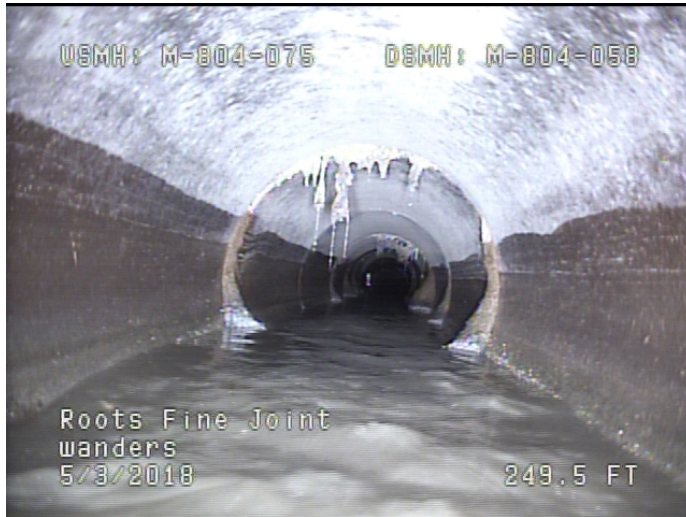
Code: **RFJ**
 Description: **Roots Fine Joint**

Distance (ft): **249.5**
 Structural Grade: **0**
 O&M Grade: **1**
 Clock Start/From: **8**
 Clock To: **5**
 1st Value:
 2nd Value:
 Value Percent:
 Continuous Index: **F01**
 Within 8" of Joint: **YES**
 Remarks: **wanders**

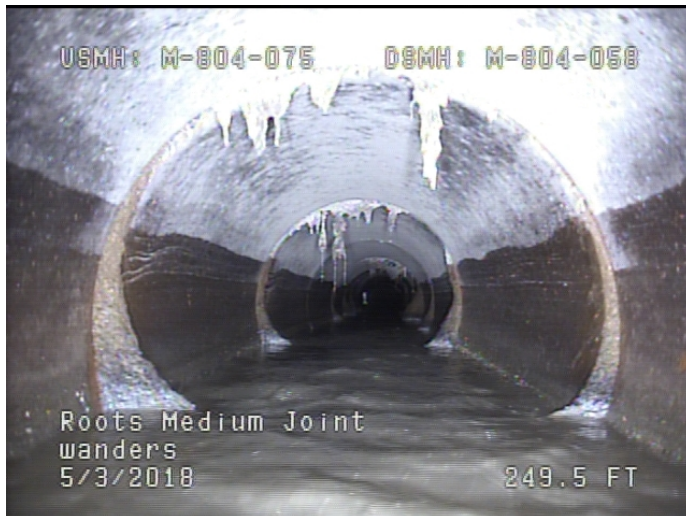
Code: **RMJ**
 Description: **Roots Medium Joint**

Distance (ft): **249.5**
 Structural Grade: **0**
 O&M Grade: **3**
 Clock Start/From: **7**
 Clock To: **5**
 1st Value:
 2nd Value:
 Value Percent: **15.000**
 Continuous Index: **S02**
 Within 8" of Joint: **YES**
 Remarks: **wanders**

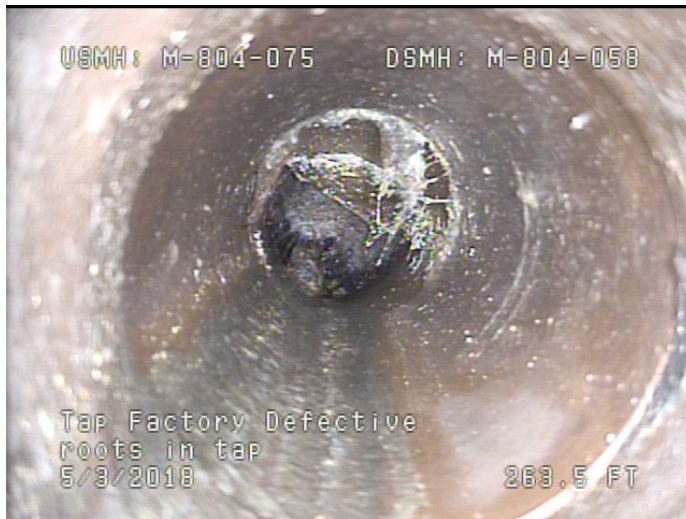
Code:	TFD
Description:	Tap Factory Defective
Distance (ft):	263.5
Structural Grade:	0
O&M Grade:	2
Clock Start/From:	10
Clock To:	
1st Value:	6.000
2nd Value:	
Value Percent:	
Continuous Index:	
Within 8" of Joint:	NO
Remarks:	roots in tap

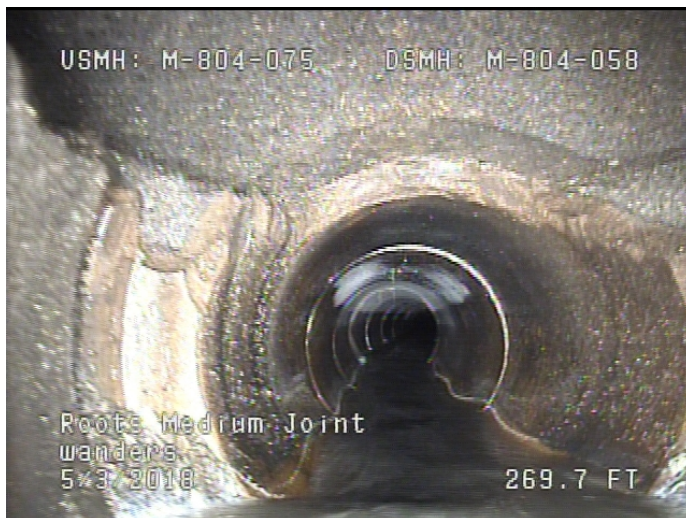
Code:	RMJ
Description:	Roots Medium Joint
Distance (ft):	269.7
Structural Grade:	0
O&M Grade:	3
Clock Start/From:	7
Clock To:	5
1st Value:	
2nd Value:	
Value Percent:	15.000
Continuous Index:	F02
Within 8" of Joint:	YES
Remarks:	wanders

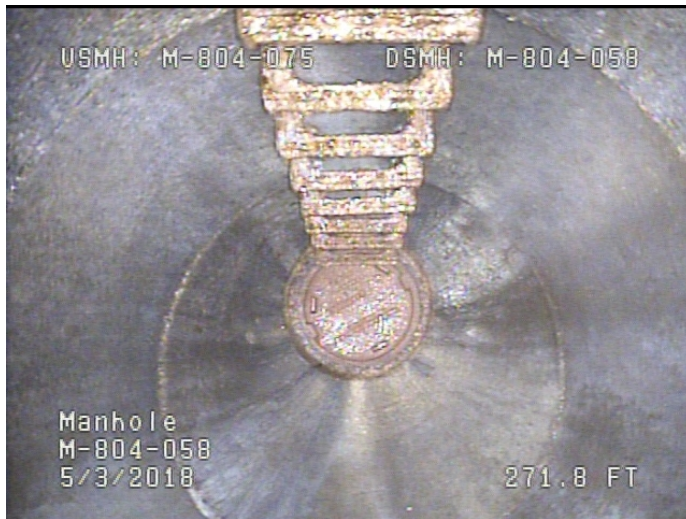
Code:	AMH
Description:	Manhole
Distance (ft):	271.8
Structural Grade:	0
O&M Grade:	0
Clock Start/From:	
Clock To:	
1st Value:	
2nd Value:	
Value Percent:	
Continuous Index:	
Within 8" of Joint:	NO
Remarks:	M-804-058
