Profile/Photo Observation Report

Date:	05/03/2018	Weather:		Coding:	PACP 4.2
Pipe Length (ft):	225.7	Owner:	City of Hobart	Pre Clean:	No Pre-Cleaning
P.O.#:	2004	Surveyor:	SAN	PSR:	P-804-061-060
Customer:	Red Zone	Clean Date:		Shape:	C

Street:	325 N Linda St	Flow Control:	Not Controlled
City:	Hobart In	Year Renewed:	
Location:	Light Highway	Tape/Media #:	Deliverable 1
Purpose:	Routine Assessment	Dia/Height:	15"
Use:	Sanitary	Material:	VCP
Drain Area:	Northeast	Lining:	
Category:	NA		
Comment:	439-1		
Location Details:	Edge of street	Direction of Survey:	Downstream
US MH:	M-804-061	DS MH:	M-804-060
		Total Length Surveyed (ft):	225.7

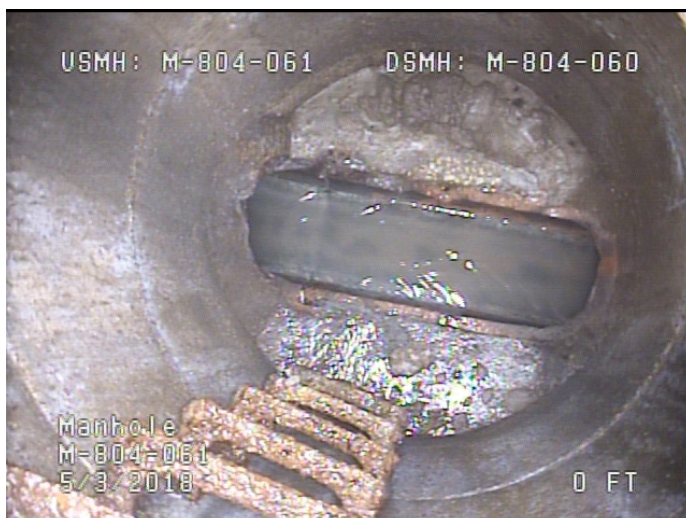
Code: **AMH**
Description: **Manhole**

Distance (ft): **.0**
Structural Grade: **0**
O&M Grade: **0**
Clock Start/From:
Clock To:
1st Value:
2nd Value:
Value Percent:
Continuous Index:
Within 8" of Joint: **NO**
Remarks: **M-804-061**

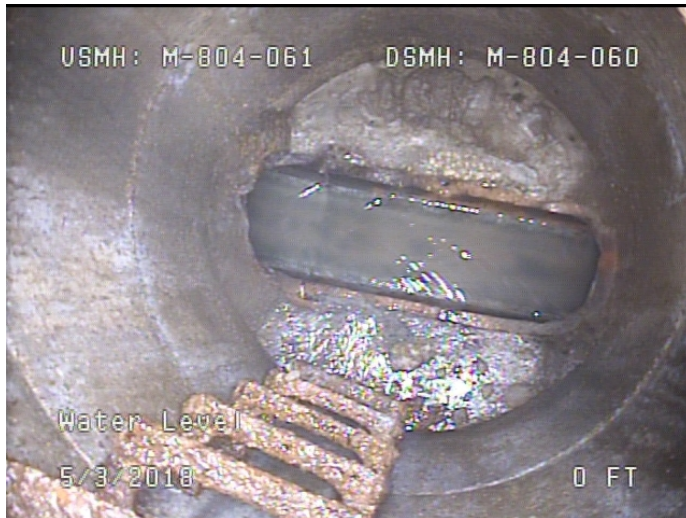
Code: **MWL**
Description: **Water Level**

Distance (ft): **.0**
Structural Grade: **0**
O&M Grade: **0**
Clock Start/From:
Clock To:
1st Value:
2nd Value:
Value Percent: **15.000**
Continuous Index:
Within 8" of Joint: **NO**
Remarks:

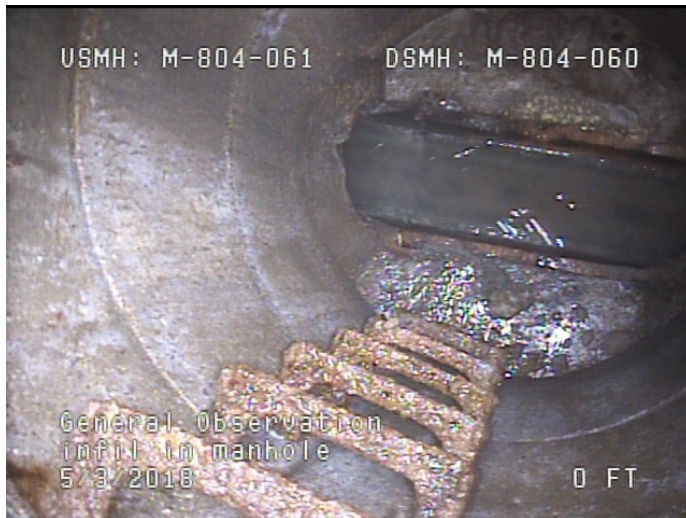
Code: **MGO**
Description: **General Observation**

Distance (ft): **.0**
Structural Grade: **0**
O&M Grade: **0**
Clock Start/From:
Clock To:
1st Value:
2nd Value:
Value Percent:
Continuous Index:
Within 8" of Joint: **NO**
Remarks: **infil in manhole**

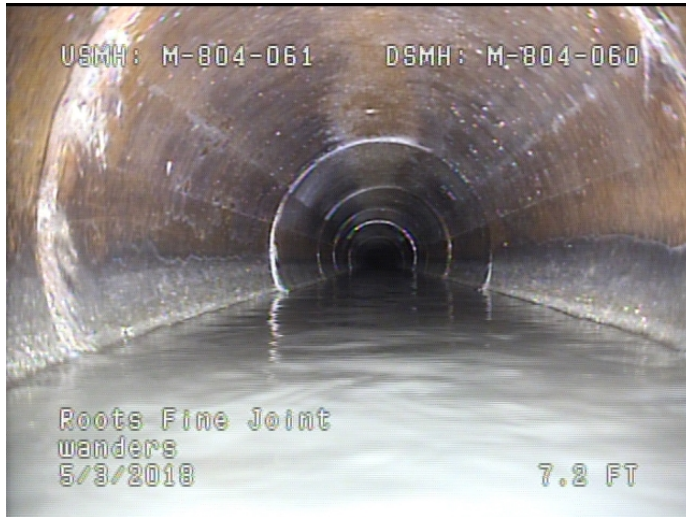
Code:	RFJ
Description:	Roots Fine Joint
Distance (ft):	7.2
Structural Grade:	0
O&M Grade:	1
Clock Start/From:	7
Clock To:	2
1st Value:	
2nd Value:	
Value Percent:	
Continuous Index:	S01
Within 8" of Joint:	YES
Remarks:	wanders

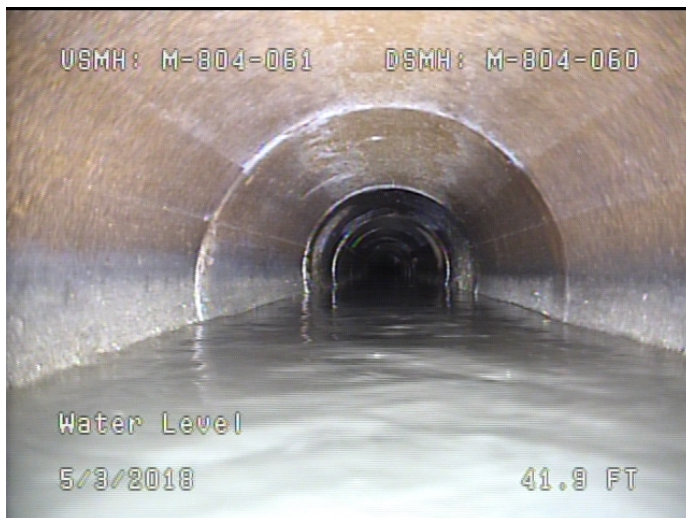
Code:	MWL
Description:	Water Level
Distance (ft):	41.9
Structural Grade:	0
O&M Grade:	0
Clock Start/From:	
Clock To:	
1st Value:	
2nd Value:	
Value Percent:	30.000
Continuous Index:	
Within 8" of Joint:	NO
Remarks:

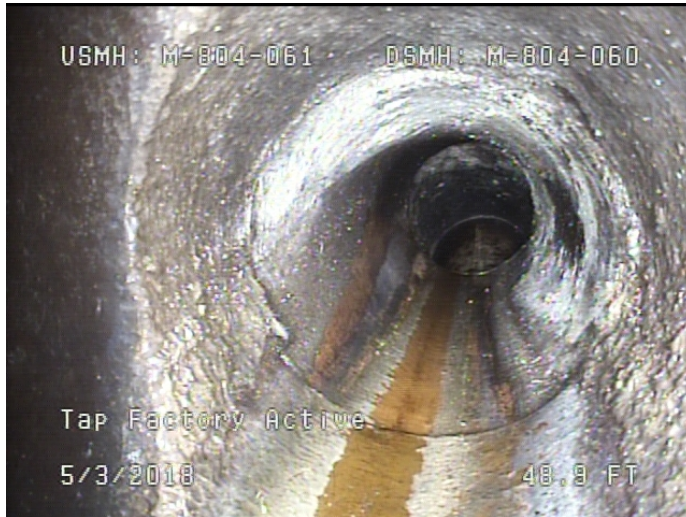
Code:	TFA
Description:	Tap Factory Active
Distance (ft):	48.9
Structural Grade:	0
O&M Grade:	0
Clock Start/From:	10
Clock To:	
1st Value:	6.000
2nd Value:	
Value Percent:	
Continuous Index:	
Within 8" of Joint:	NO
Remarks:

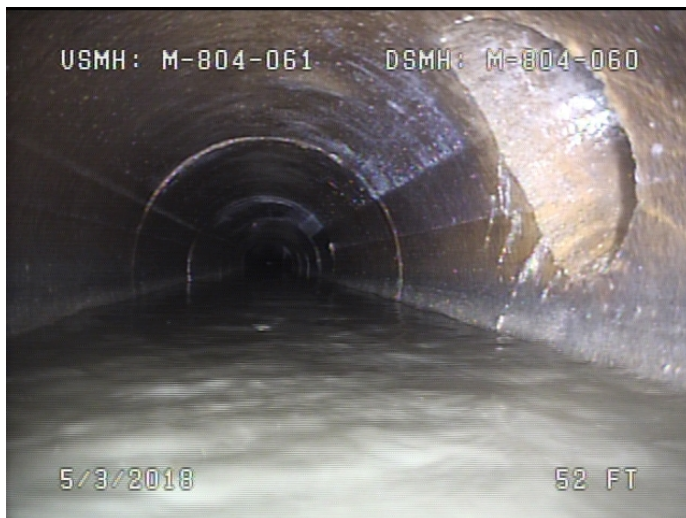
Code:	TF
Description:	Tap Factory
Distance (ft):	52.0
Structural Grade:	0
O&M Grade:	0
Clock Start/From:	2
Clock To:	
1st Value:	6.000
2nd Value:	
Value Percent:	
Continuous Index:	
Within 8" of Joint:	NO
Remarks:	soil in tap

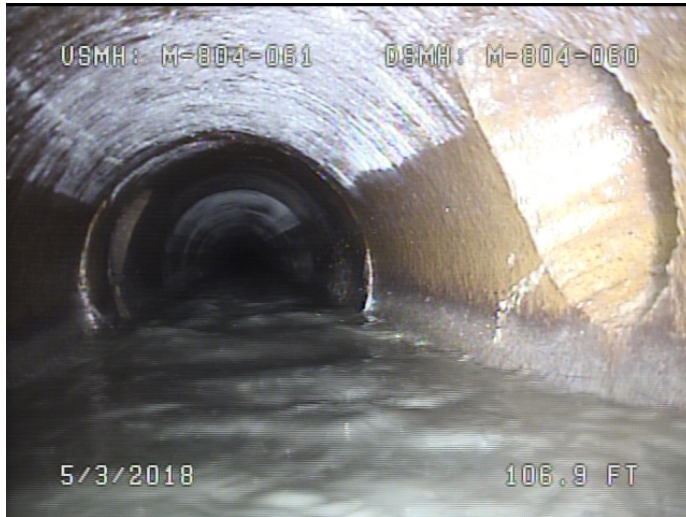
Code:	TF
Description:	Tap Factory
Distance (ft):	106.9
Structural Grade:	0
O&M Grade:	0
Clock Start/From:	3
Clock To:	
1st Value:	6.000
2nd Value:	
Value Percent:	
Continuous Index:	
Within 8" of Joint:	NO
Remarks:	soil in tap

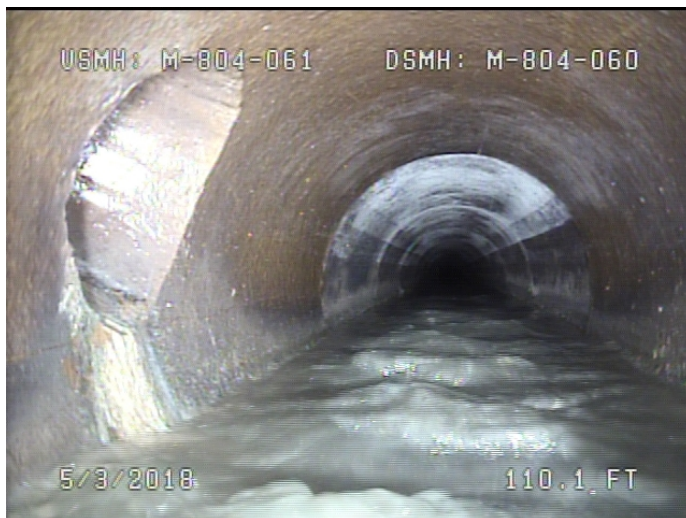
Code:	TF
Description:	Tap Factory
Distance (ft):	110.1
Structural Grade:	0
O&M Grade:	0
Clock Start/From:	9
Clock To:	
1st Value:	6.000
2nd Value:	
Value Percent:	
Continuous Index:	
Within 8" of Joint:	NO
Remarks:

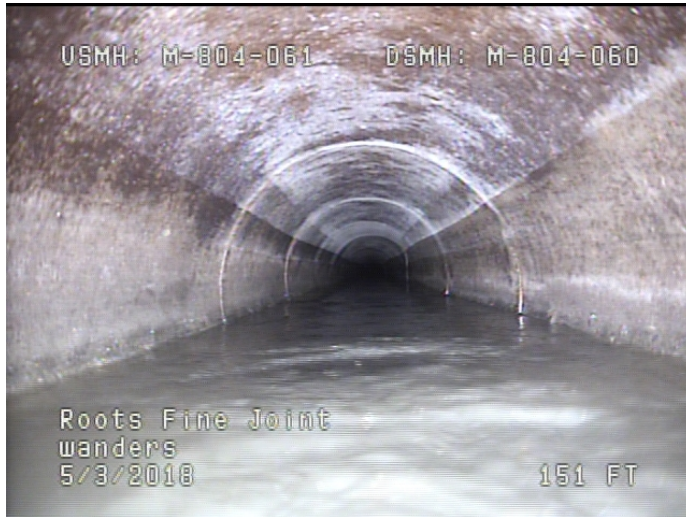
Code:	RFJ
Description:	Roots Fine Joint
Distance (ft):	151.0
Structural Grade:	0
O&M Grade:	1
Clock Start/From:	7
Clock To:	2
1st Value:	
2nd Value:	
Value Percent:	
Continuous Index:	F01
Within 8" of Joint:	YES
Remarks:	wanders

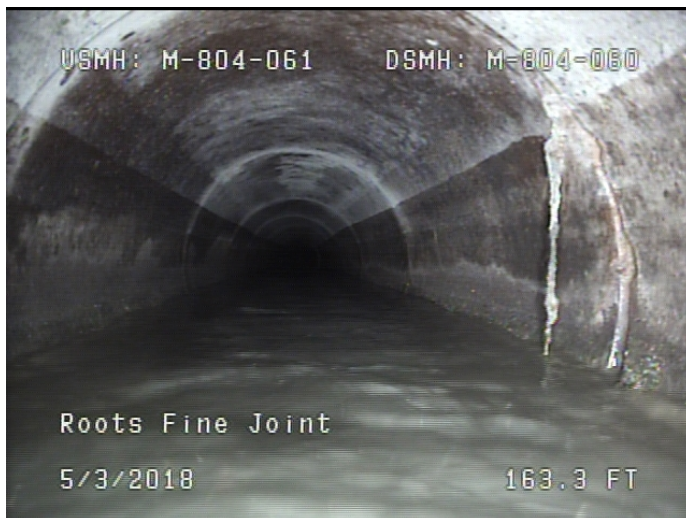
Code:	RFJ
Description:	Roots Fine Joint
Distance (ft):	163.3
Structural Grade:	0
O&M Grade:	1
Clock Start/From:	2
Clock To:	
1st Value:	
2nd Value:	
Value Percent:	
Continuous Index:	
Within 8" of Joint:	YES
Remarks:

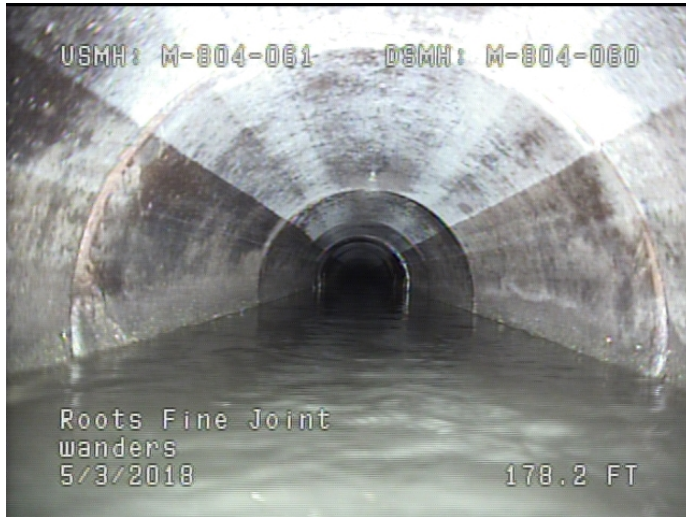
Code:	RFJ
Description:	Roots Fine Joint
Distance (ft):	178.2
Structural Grade:	0
O&M Grade:	1
Clock Start/From:	8
Clock To:	10
1st Value:	
2nd Value:	
Value Percent:	
Continuous Index:	S02
Within 8" of Joint:	YES
Remarks:	wanders

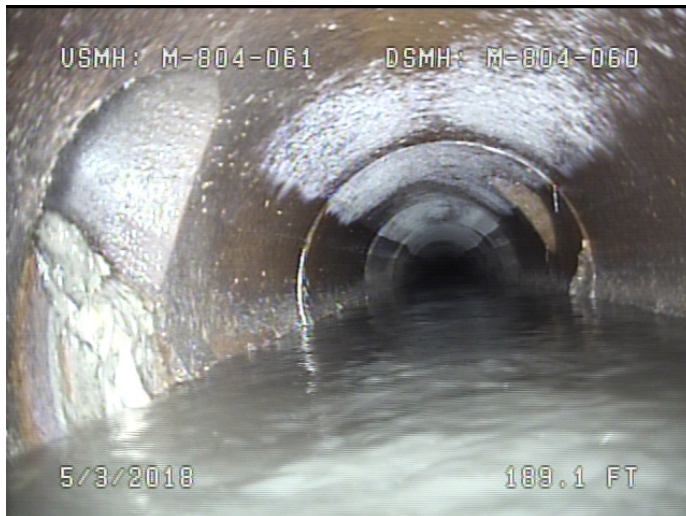
Code:	TFD
Description:	Tap Factory Defective
Distance (ft):	189.1
Structural Grade:	0
O&M Grade:	2
Clock Start/From:	10
Clock To:	
1st Value:	6.000
2nd Value:	
Value Percent:	
Continuous Index:	
Within 8" of Joint:	NO
Remarks:	roots in tap

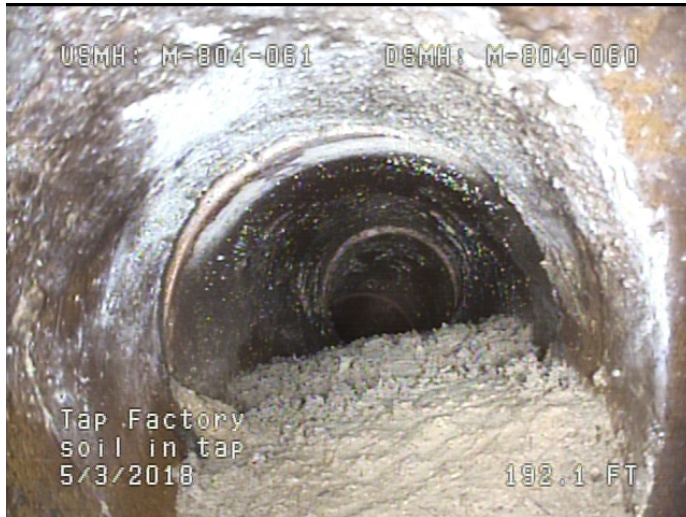
Code:	TF
Description:	Tap Factory
Distance (ft):	192.1
Structural Grade:	0
O&M Grade:	0
Clock Start/From:	2
Clock To:	
1st Value:	6.000
2nd Value:	
Value Percent:	
Continuous Index:	
Within 8" of Joint:	NO
Remarks:	soil in tap

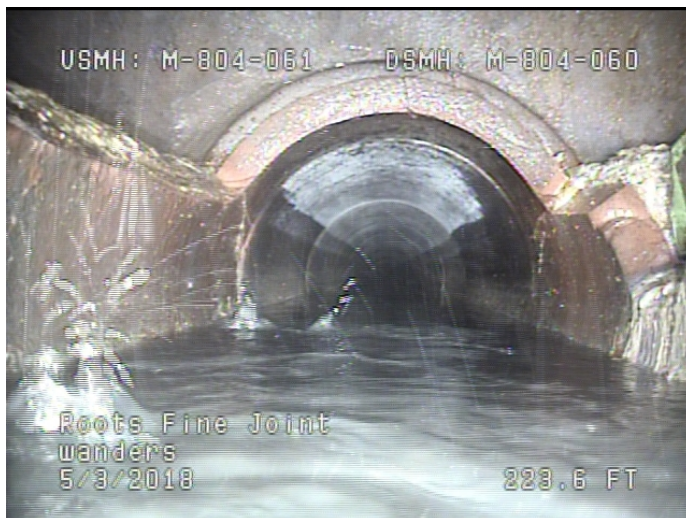
Code:	RFJ
Description:	Roots Fine Joint
Distance (ft):	223.6
Structural Grade:	0
O&M Grade:	1
Clock Start/From:	8
Clock To:	10
1st Value:	
2nd Value:	
Value Percent:	
Continuous Index:	F02
Within 8" of Joint:	YES
Remarks:	wanders

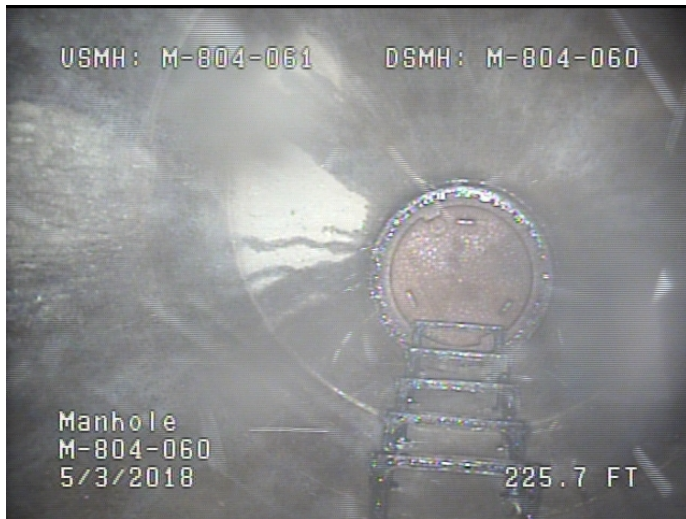
Code:	AMH
Description:	Manhole
Distance (ft):	225.7
Structural Grade:	0
O&M Grade:	0
Clock Start/From:	
Clock To:	
1st Value:	
2nd Value:	
Value Percent:	
Continuous Index:	
Within 8" of Joint:	NO
Remarks:	M-804-060
