## Profile/Photo Observation Report

Street:	<b>Off Hobart Road</b>	Flow Control:	
City:	<b>Hobart, IN</b>	Year Renewed:	
Location:	<b>Sidewalk</b>	Tape/Media #:	<b>889</b>
Purpose:	<b>Routine Assessment</b>	Dia/Height:	<b>12"</b>
Use:	<b>Sanitary</b>	Material:	<b>VCP</b>
Drain Area:		Lining:	
Category:	<b>NA</b>		
Comment:

Location Details:		Direction of Survey:	<b>Upstream</b>
US MH:	<b>M-804-62</b>	DS MH:	<b>M-804-63</b>
		Total Length Surveyed (ft):	<b>10.5</b>

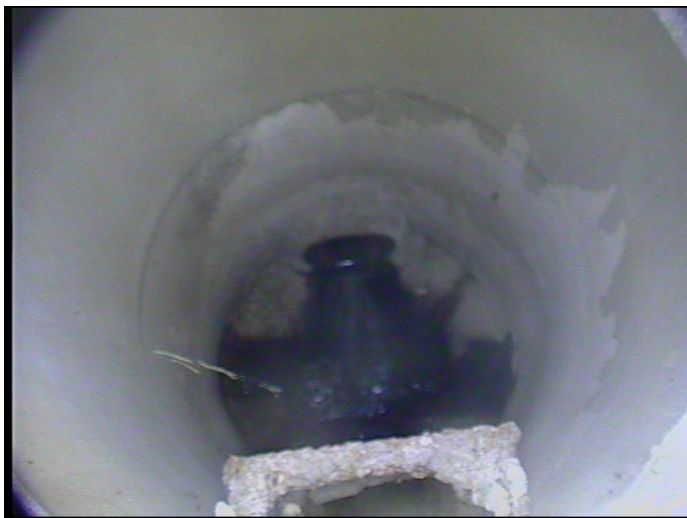
Code: **MWL**  
Description: **Water Level**

Distance (ft): **.0**  
Structural Grade: **0**  
O&M Grade: **0**  
Clock Start/From:  
Clock To:  
1st Value:  
2nd Value:  
Value Percent: **10.000**  
Continuous Index:  
Within 8" of Joint: **NO**  
Remarks:

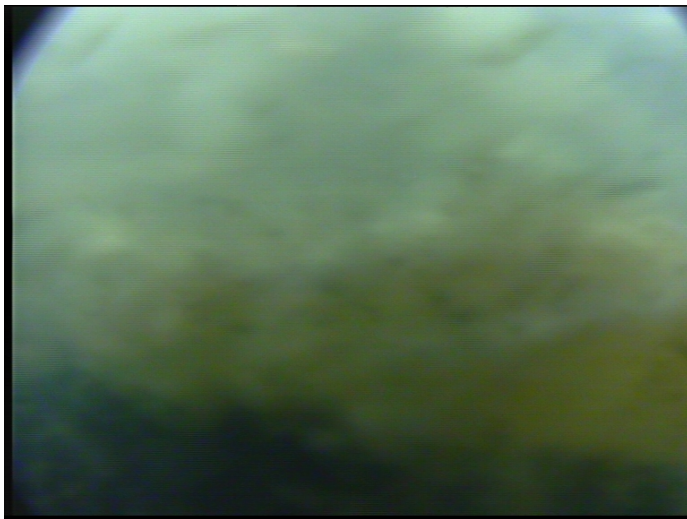
Code: **DSF**  
Description: **Deposits Settled Fine**

Distance (ft): **9.0**  
Structural Grade: **0**  
O&M Grade: **3**  
Clock Start/From: **4**  
Clock To: **8**  
1st Value:  
2nd Value:  
Value Percent: **15.000**  
Continuous Index:  
Within 8" of Joint: **NO**  
Remarks:

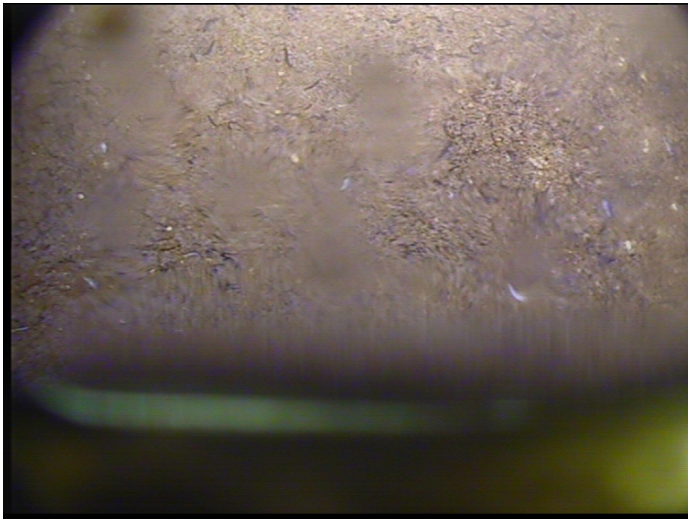
Code:	<b>MSA</b>
Description:	<b>Abandoned Survey</b>
Distance (ft):	<b>10.2</b>
Structural Grade:	<b>0</b>
O&M Grade:	<b>0</b>
Clock Start/From:	
Clock To:	
1st Value:	
2nd Value:	
Value Percent:	
Continuous Index:	
Within 8" of Joint:	<b>NO</b>
Remarks:	<b>Deep sediment</b>
