## Profile/Photo Observation Report

Street:	<b>Off Hobart Road</b>	Flow Control:	
City:	<b>Hobart, IN</b>	Year Renewed:	
Location:	<b>Light Highway</b>	Tape/Media #:	<b>890</b>
Purpose:	<b>Routine Assessment</b>	Dia/Height:	<b>12"</b>
Use:	<b>Sanitary</b>	Material:	<b>VCP</b>
Drain Area:		Lining:	
Category:	<b>NA</b>		
Comment:

Location Details:		Direction of Survey:	<b>Downstream</b>
US MH:	<b>M-804-63</b>	DS MH:	<b>M-804-64</b>
		Total Length Surveyed (ft):	<b>328.2</b>

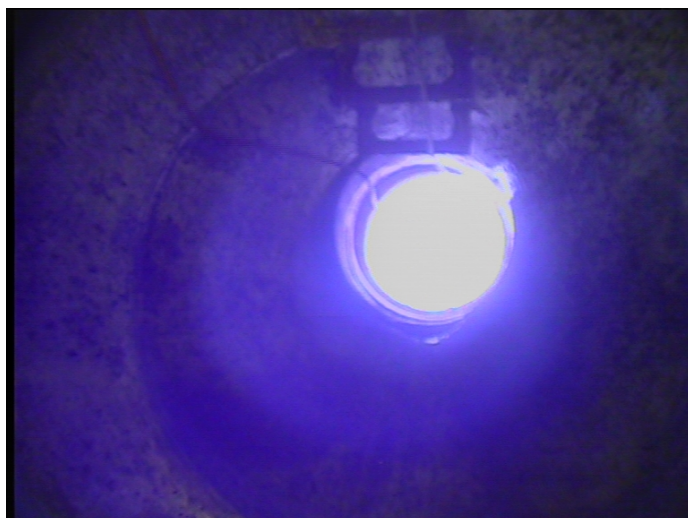
Code: **AMH**  
 Description: **Manhole**

Distance (ft): **.0**  
 Structural Grade: **0**  
 O&M Grade: **0**  
 Clock Start/From:  
 Clock To:  
 1st Value:  
 2nd Value:  
 Value Percent:  
 Continuous Index:  
 Within 8" of Joint: **NO**  
 Remarks: **M-804-63**

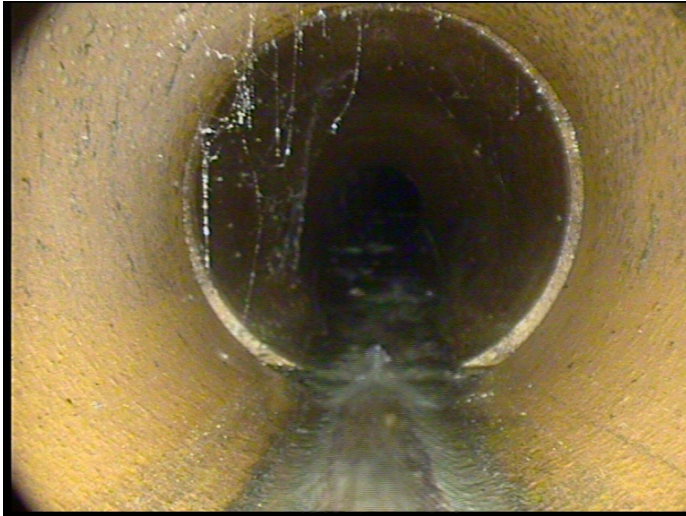
Code: **MWL**  
Description: **Water Level**

Distance (ft): **.0**  
Structural Grade: **0**  
O&M Grade: **0**  
Clock Start/From:  
Clock To:  
1st Value:  
2nd Value:  
Value Percent: **5.000**  
Continuous Index:  
Within 8" of Joint: **NO**  
Remarks:

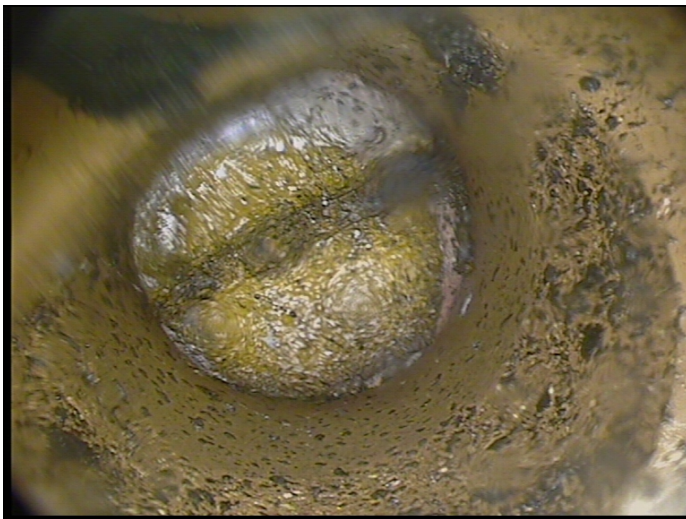
Code: **TFC**  
Description: **Tap Factory Capped**

Distance (ft): **11.6**  
Structural Grade: **0**  
O&M Grade: **0**  
Clock Start/From: **10**  
Clock To:  
1st Value: **4.000**  
2nd Value:  
Value Percent:  
Continuous Index:  
Within 8" of Joint: **NO**  
Remarks:

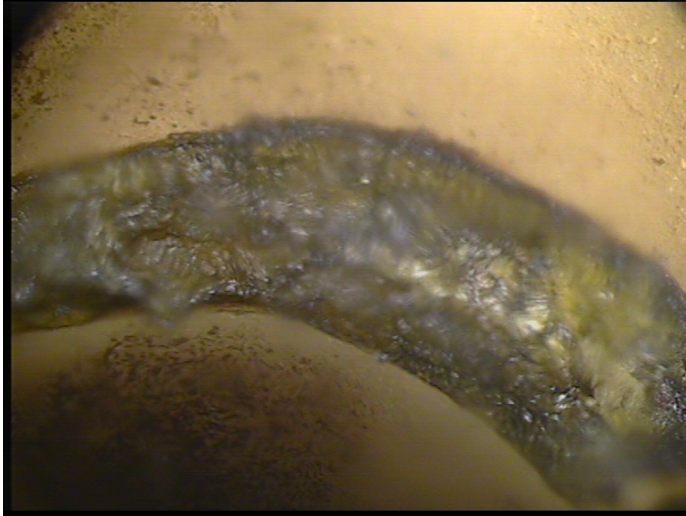
Code:	<b>DAE</b>
Description:	<b>Deposits Attached Encrustation</b>
Distance (ft):	<b>41.0</b>
Structural Grade:	<b>0</b>
O&M Grade:	<b>2</b>
Clock Start/From:	<b>7</b>
Clock To:	<b>5</b>
1st Value:	
2nd Value:	
Value Percent:	<b>5.000</b>
Continuous Index:	
Within 8" of Joint:	<b>YES</b>
Remarks:

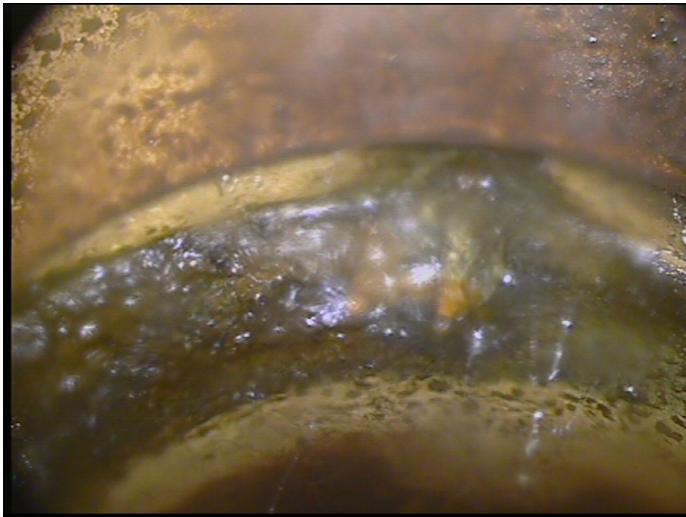
Code:	<b>ID</b>
Description:	<b>Infil Dripper</b>
Distance (ft):	<b>83.2</b>
Structural Grade:	<b>0</b>
O&M Grade:	<b>3</b>
Clock Start/From:	<b>12</b>
Clock To:	
1st Value:	
2nd Value:	
Value Percent:	
Continuous Index:	
Within 8" of Joint:	<b>YES</b>
Remarks:

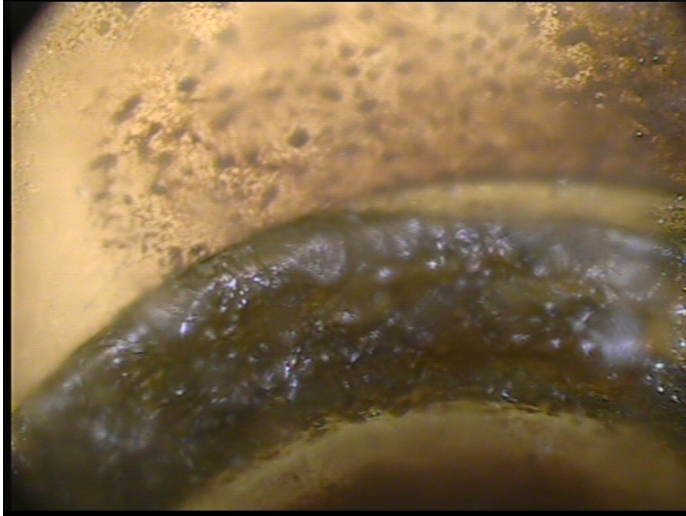
Code:	<b>DAE</b>
Description:	<b>Deposits Attached Encrustation</b>
Distance (ft):	<b>83.2</b>
Structural Grade:	<b>0</b>
O&M Grade:	<b>2</b>
Clock Start/From:	<b>7</b>
Clock To:	<b>5</b>
1st Value:	
2nd Value:	
Value Percent:	<b>5.000</b>
Continuous Index:	
Within 8" of Joint:	<b>YES</b>
Remarks:

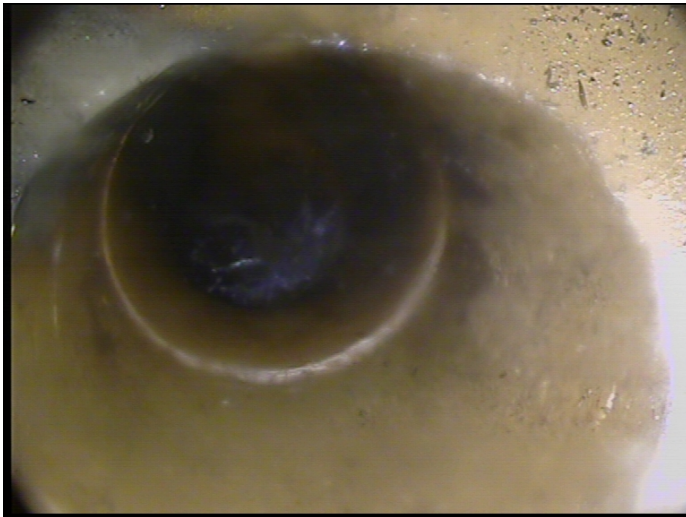
Code:	<b>TF</b>
Description:	<b>Tap Factory</b>
Distance (ft):	<b>121.2</b>
Structural Grade:	<b>0</b>
O&M Grade:	<b>0</b>
Clock Start/From:	<b>10</b>
Clock To:	
1st Value:	<b>4.000</b>
2nd Value:	
Value Percent:	
Continuous Index:	
Within 8" of Joint:	<b>NO</b>
Remarks:

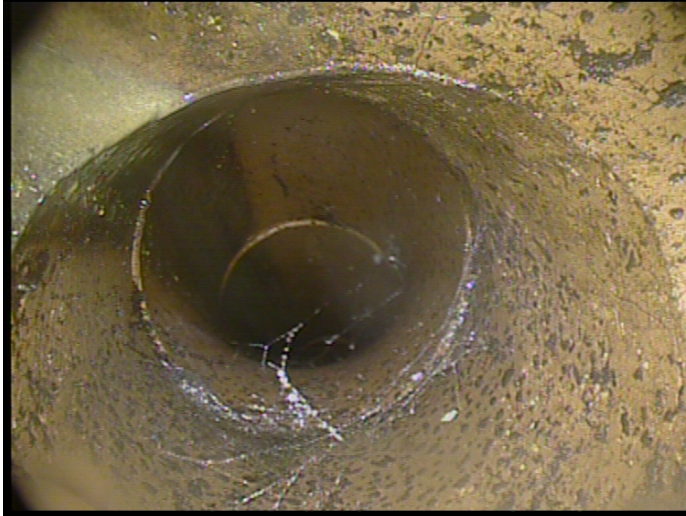
Code: **TF**  
Description: **Tap Factory**

Distance (ft): **236.7**  
Structural Grade: **0**  
O&M Grade: **0**  
Clock Start/From: **10**  
Clock To:  
1st Value: **4.000**  
2nd Value:  
Value Percent:  
Continuous Index:  
Within 8" of Joint: **NO**  
Remarks:

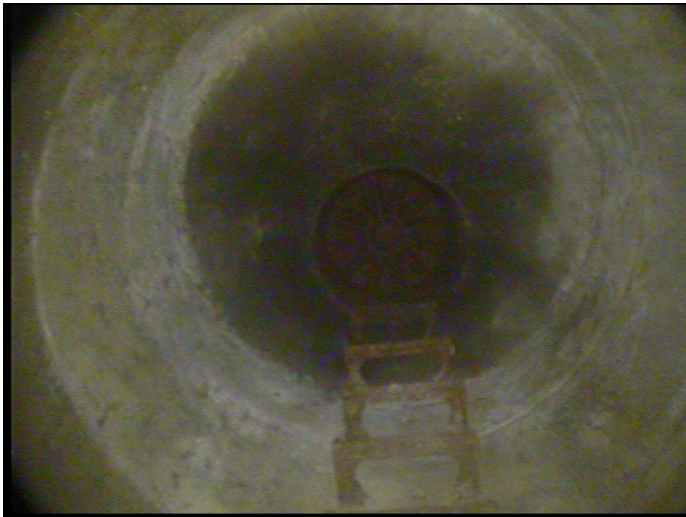
Code: **AMH**  
Description: **Manhole**

Distance (ft): **328.2**  
Structural Grade: **0**  
O&M Grade: **0**  
Clock Start/From:  
Clock To:  
1st Value:  
2nd Value:  
Value Percent:  
Continuous Index:  
Within 8" of Joint: **NO**  
Remarks: **M-804-64**
