Profile/Photo Observation Report

Street:	N Hobart St.	Flow Control:	Not Controlled
City:	Hobart, IN	Year Renewed:	
Location:	Other	Tape/Media #:	
Purpose:	Not Known	Dia/Height:	10"
Use:	Sanitary	Material:	VCP
Drain Area:	NA	Lining:	
Category:	NA		
Comment:

Location Details:		Direction of Survey:	Upstream
US MH:	M-804-064	DS MH:	M-804-065
		Total Length Surveyed (ft):	11.9

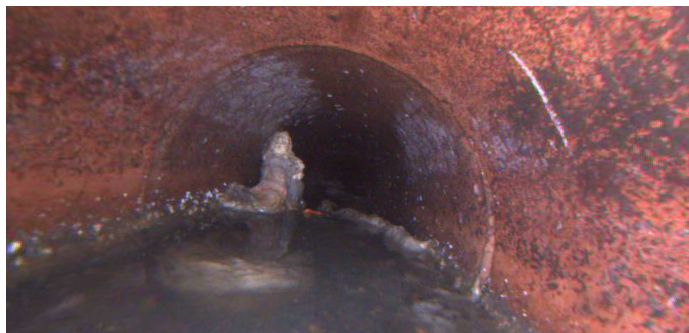
Code: **AMH**
 Description: **Manhole**
 Distance (ft): **.0**
 Structural Grade: **0**
 O&M Grade: **0**
 Clock Start/From:
 Clock To:
 1st Value:
 2nd Value:
 Value Percent:
 Continuous Index:
 Within 8" of Joint: **NO**
 Remarks: **M-804-065**

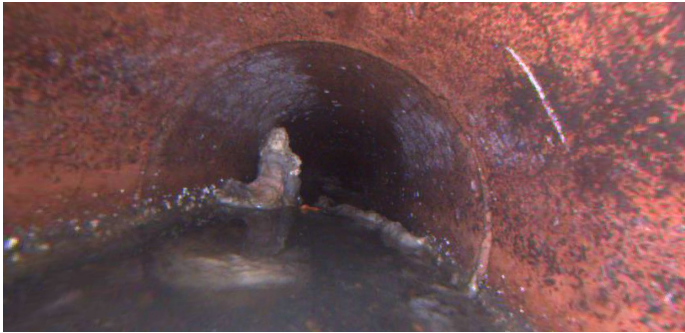
Code:	MWL
Description:	Water Level

Distance (ft):	.0
Structural Grade:	0
O&M Grade:	0
Clock Start/From:	
Clock To:	
1st Value:	
2nd Value:	
Value Percent:	20.000
Continuous Index:	
Within 8" of Joint:	NO
Remarks:

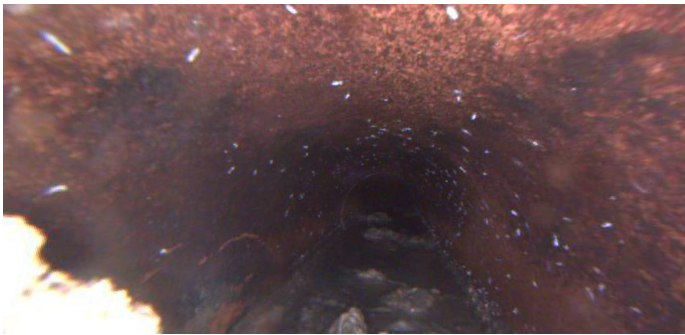
Code:	FS
Description:	Fracture Spiral

Distance (ft):	2.6
Structural Grade:	3
O&M Grade:	0
Clock Start/From:	7
Clock To:	9
1st Value:	
2nd Value:	
Value Percent:	
Continuous Index:	
Within 8" of Joint:	
Remarks:

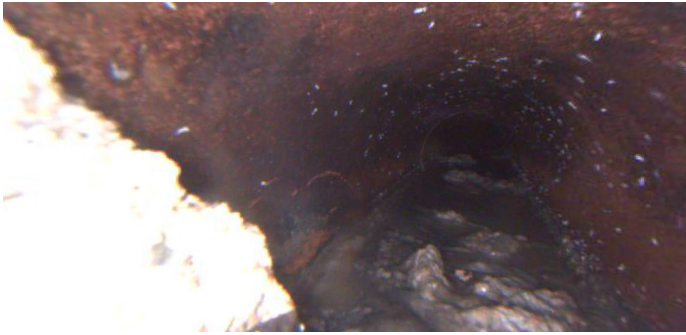
Code: **DAGS**
Description: **Deposits Attached Grease**

Distance (ft): **2.6**
Structural Grade: **0**
O&M Grade: **3**
Clock Start/From: **6**
Clock To: **10**
1st Value:
2nd Value:
Value Percent: **20.000**
Continuous Index:
Within 8" of Joint: **NO**
Remarks:

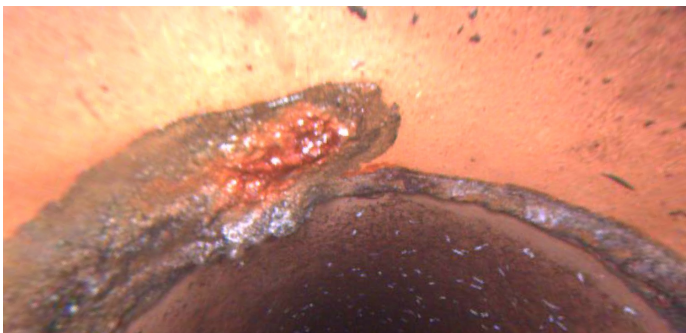
Code: **ID**
Description: **Infil Dripper**

Distance (ft): **9.6**
Structural Grade: **0**
O&M Grade: **3**
Clock Start/From: **12**
Clock To:
1st Value:
2nd Value:
Value Percent:
Continuous Index:
Within 8" of Joint: **YES**
Remarks:

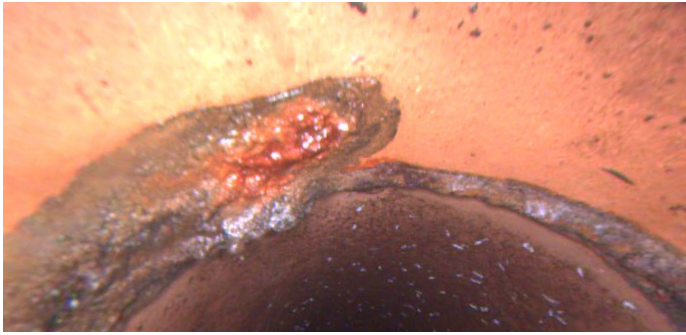
Code: **DAE**
Description: **Deposits Attached Encrustation**

Distance (ft): **9.6**
Structural Grade: **0**
O&M Grade: **2**
Clock Start/From: **8**
Clock To: **4**
1st Value:
2nd Value:
Value Percent: **5.000**
Continuous Index:
Within 8" of Joint: **YES**
Remarks:

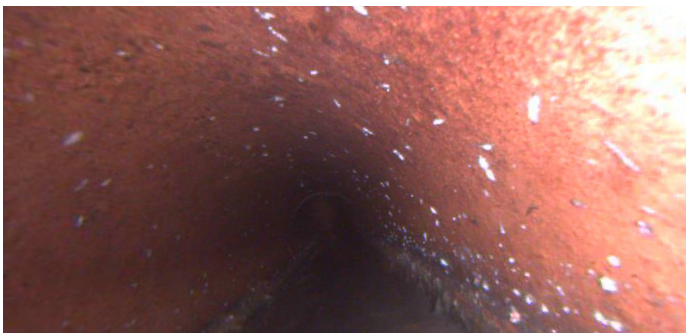
Code: **MSA**
Description: **Abandoned Survey**

Distance (ft): **11.9**
Structural Grade: **0**
O&M Grade: **0**
Clock Start/From:
Clock To:
1st Value:
2nd Value:
Value Percent:
Continuous Index:
Within 8" of Joint: **NO**
Remarks: **unknown**
