Profile/Photo Observation Report

Street:	Hobart Rd.	Flow Control:	Not Controlled
City:	Hobart, IN	Year Renewed:	
Location:	Light Highway	Tape/Media #:	
Purpose:	Routine Assessment	Dia/Height:	10"
Use:	Sanitary	Material:	VCP
Drain Area:	NA	Lining:	
Category:	NA		
Comment:

Location Details:		Direction of Survey:	Upstream
US MH:	M-804-064	DS MH:	M-804-065
		Total Length Surveyed (ft):	19.0

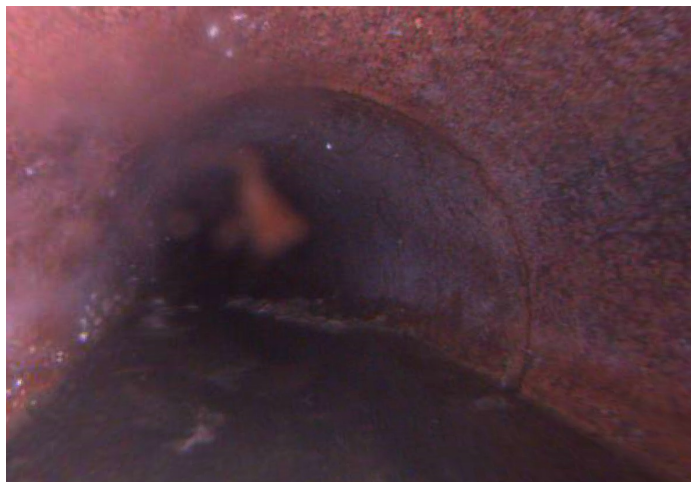
Code: **AMH**
Description: **Manhole**

Distance (ft): **.0**
Structural Grade: **0**
O&M Grade: **0**
Clock Start/From:
Clock To:
1st Value:
2nd Value:
Value Percent:
Continuous Index:
Within 8" of Joint: **NO**
Remarks: **M-804-065**

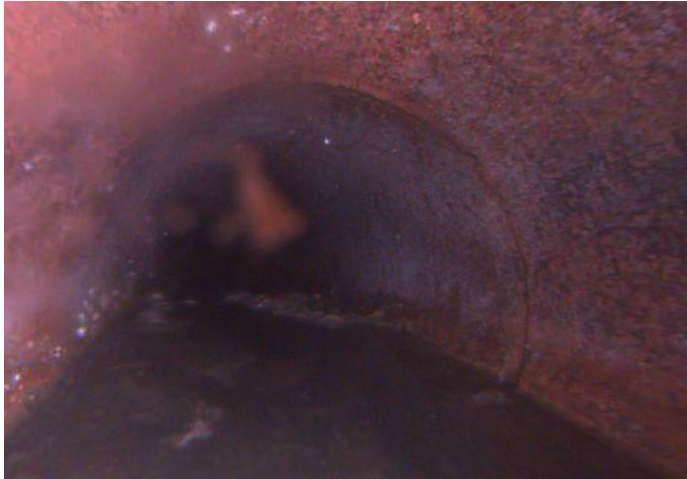
Code: **MWL**
Description: **Water Level**

Distance (ft): **.0**
Structural Grade: **0**
O&M Grade: **0**
Clock Start/From:
Clock To:
1st Value:
2nd Value:
Value Percent: **20.000**
Continuous Index:
Within 8" of Joint: **NO**
Remarks:

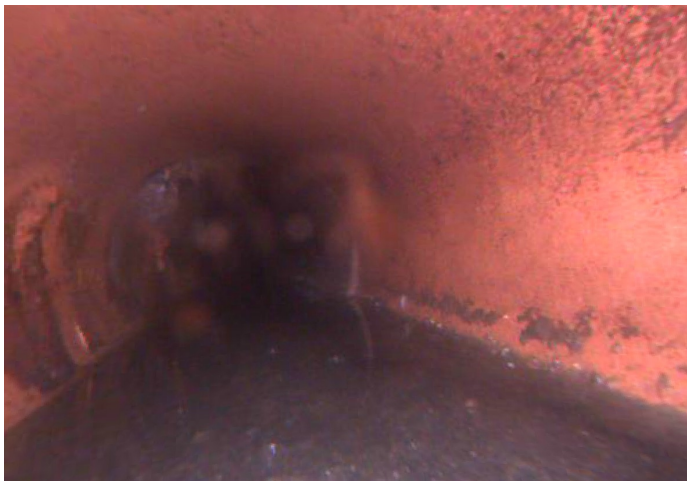
Code: **MSA**
Description: **Abandoned Survey**

Distance (ft): **19.0**
Structural Grade: **0**
O&M Grade: **0**
Clock Start/From:
Clock To:
1st Value:
2nd Value:
Value Percent:
Continuous Index:
Within 8" of Joint: **NO**
Remarks: **Possible Debris**
