Profile/Photo Observation Report

Street:	N HOBART RD	Flow Control:	Not Controlled
City:	Hobart, IN	Year Renewed:	
Location:	Other	Tape/Media #:	
Purpose:	Not Known	Dia/Height:	10"
Use:	Sanitary	Material:	VCP
Drain Area:	NA	Lining:	
Category:	NA		
Comment:

Location Details:		Direction of Survey:	Upstream
US MH:	M-804-065	DS MH:	M-804-066
		Total Length Surveyed (ft):	82.7

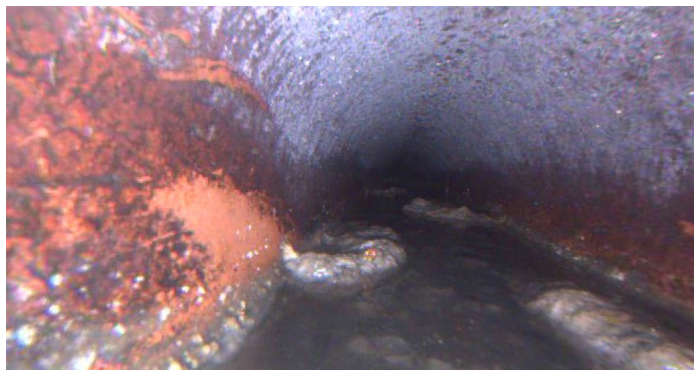
Code: **AMH**
Description: **Manhole**

Distance (ft): **.0**
Structural Grade: **0**
O&M Grade: **0**
Clock Start/From:
Clock To:
1st Value:
2nd Value:
Value Percent:
Continuous Index:
Within 8" of Joint: **NO**
Remarks: **M-804-066**

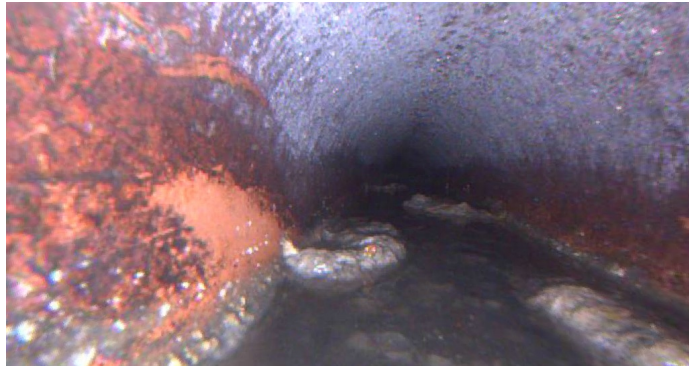
Code: **MWL**
Description: **Water Level**

Distance (ft): **.0**
Structural Grade: **0**
O&M Grade: **0**
Clock Start/From:
Clock To:
1st Value:
2nd Value:
Value Percent: **10.000**
Continuous Index:
Within 8" of Joint: **NO**
Remarks:

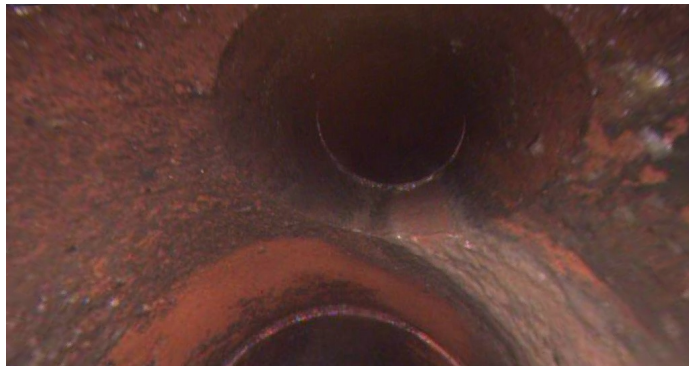
Code: **TF**
Description: **Tap Factory**

Distance (ft): **35.4**
Structural Grade: **0**
O&M Grade: **0**
Clock Start/From: **11**
Clock To:
1st Value: **4.000**
2nd Value:
Value Percent:
Continuous Index:
Within 8" of Joint:
Remarks:

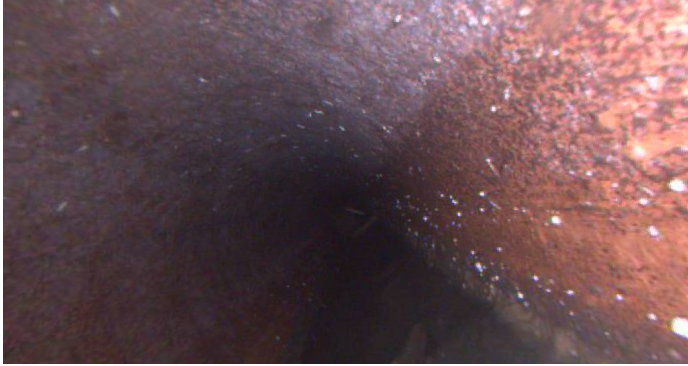
Code:	MSA
Description:	Abandoned Survey
Distance (ft):	82.7
Structural Grade:	0
O&M Grade:	0
Clock Start/From:	
Clock To:	
1st Value:	
2nd Value:	
Value Percent:	
Continuous Index:	
Within 8" of Joint:	NO
Remarks:	Roll max
