Profile/Photo Observation Report

Street:	N Hobart St.	Flow Control:	Not Controlled
City:	Hobart, IN	Year Renewed:	
Location:	Other	Tape/Media #:	
Purpose:	Not Known	Dia/Height:	10"
Use:	Sanitary	Material:	VCP
Drain Area:	NA	Lining:	
Category:	NA		
Comment:

Location Details:		Direction of Survey:	Upstream
US MH:	M-804-065	DS MH:	M-804-066
		Total Length Surveyed (ft):	82.7

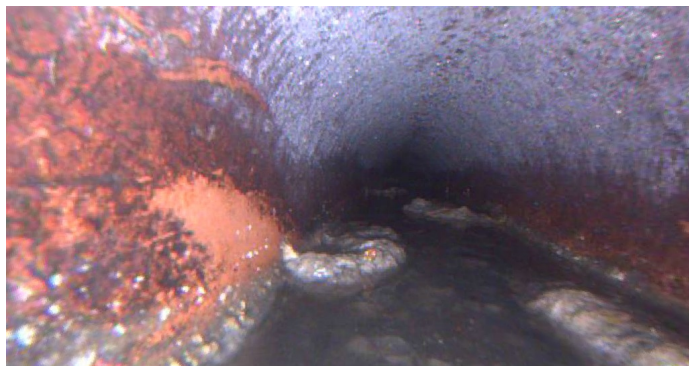
Code: **AMH**
 Description: **Manhole**

Distance (ft): **.0**
 Structural Grade: **0**
 O&M Grade: **0**
 Clock Start/From:
 Clock To:
 1st Value:
 2nd Value:
 Value Percent:
 Continuous Index:
 Within 8" of Joint: **NO**
 Remarks: **M-804-066**

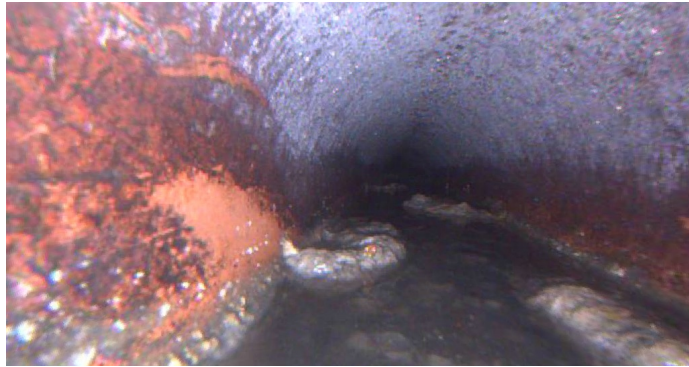
Code: **MWL**
Description: **Water Level**

Distance (ft): **.0**
Structural Grade: **0**
O&M Grade: **0**
Clock Start/From:
Clock To:
1st Value:
2nd Value:
Value Percent: **10.000**
Continuous Index:
Within 8" of Joint: **NO**
Remarks:

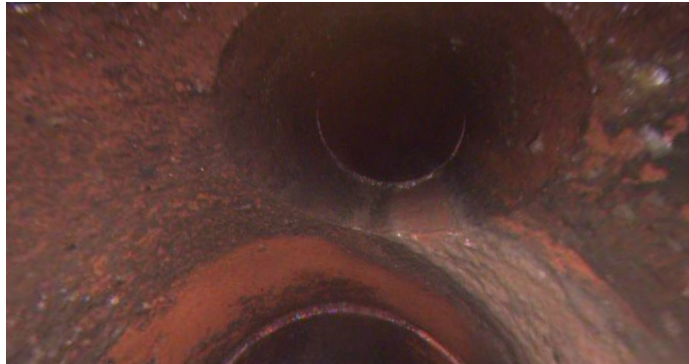
Code: **TF**
Description: **Tap Factory**

Distance (ft): **35.4**
Structural Grade: **0**
O&M Grade: **0**
Clock Start/From: **11**
Clock To:
1st Value: **4.000**
2nd Value:
Value Percent:
Continuous Index:
Within 8" of Joint:
Remarks:

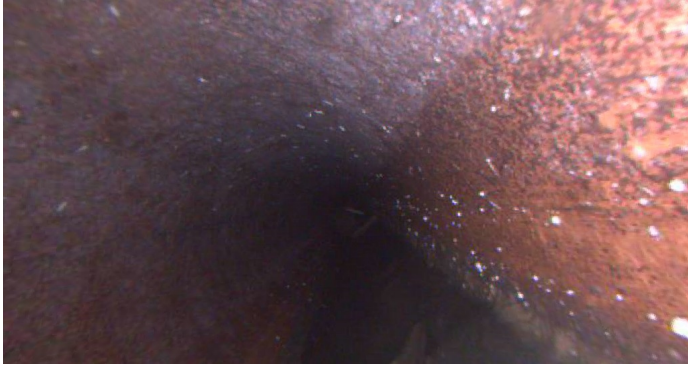
Code:	MSA
Description:	Abandoned Survey
Distance (ft):	82.7
Structural Grade:	0
O&M Grade:	0
Clock Start/From:	
Clock To:	
1st Value:	
2nd Value:	
Value Percent:	
Continuous Index:	
Within 8" of Joint:	NO
Remarks:	Roll max
