Profile/Photo Observation Report

Street:	Hobart Rd.	Flow Control:	Not Controlled
City:	Hobart, IN	Year Renewed:	
Location:	Light Highway	Tape/Media #:	
Purpose:	Routine Assessment	Dia/Height:	10"
Use:	Sanitary	Material:	VCP
Drain Area:	NA	Lining:	
Category:	NA		
Comment:

Location Details:		Direction of Survey:	Upstream
US MH:	M-804-065	DS MH:	M-804-066
		Total Length Surveyed (ft):	92.7

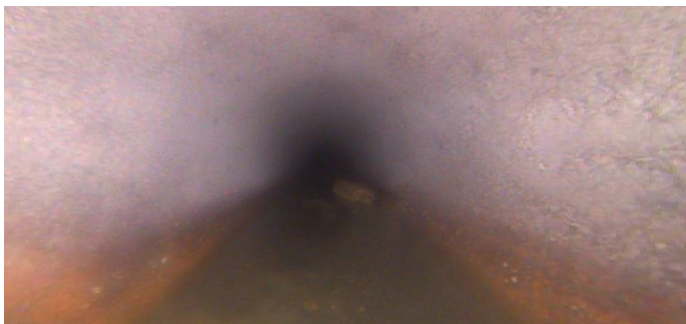
Code: **AMH**
Description: **Manhole**

Distance (ft): **.0**
Structural Grade: **0**
O&M Grade: **0**
Clock Start/From:
Clock To:
1st Value:
2nd Value:
Value Percent:
Continuous Index:
Within 8" of Joint: **NO**
Remarks: **M-804-066**

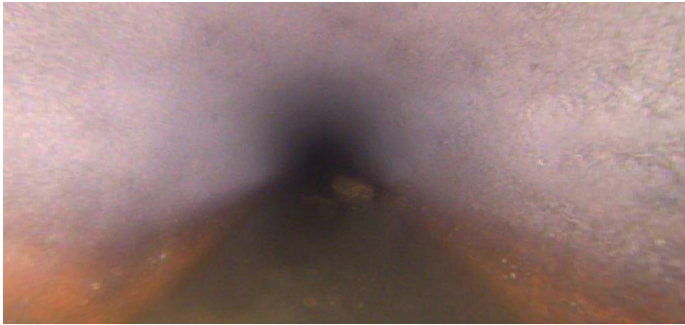
Code:	MWL
Description:	Water Level

Distance (ft):	.0
Structural Grade:	0
O&M Grade:	0
Clock Start/From:	
Clock To:	
1st Value:	
2nd Value:	
Value Percent:	10.000
Continuous Index:	
Within 8" of Joint:	NO
Remarks:

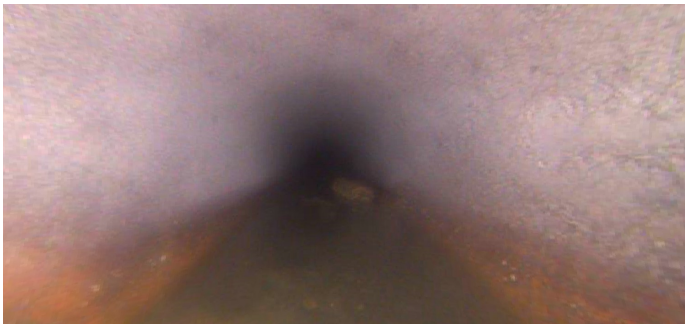
Code:	DAGS
Description:	Deposits Attached Grease

Distance (ft):	.0
Structural Grade:	0
O&M Grade:	2
Clock Start/From:	7
Clock To:	5
1st Value:	
2nd Value:	
Value Percent:	5.000
Continuous Index:	S01
Within 8" of Joint:	YES
Remarks:	WANDER

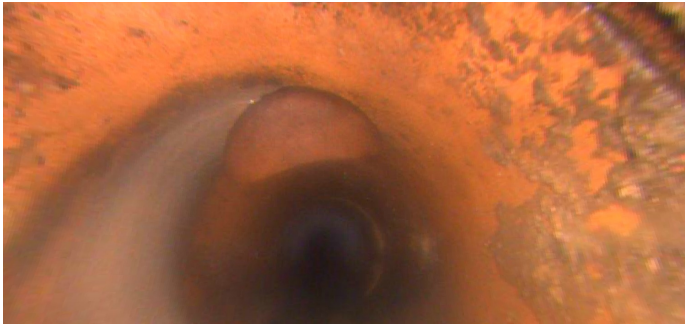
Code: **TF**
Description: **Tap Factory**

Distance (ft): **34.2**
Structural Grade: **0**
O&M Grade: **0**
Clock Start/From: **11**
Clock To:
1st Value: **4.000**
2nd Value:
Value Percent:
Continuous Index:
Within 8" of Joint:
Remarks:

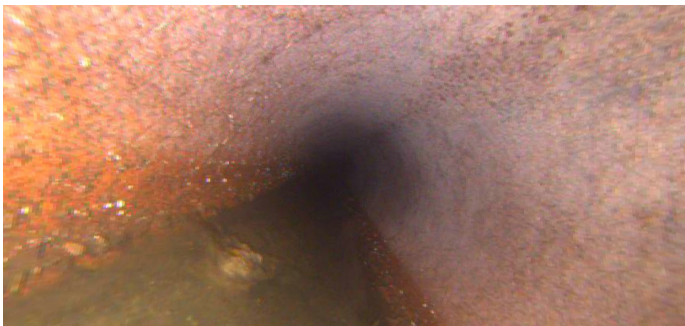
Code: **DAGS**
Description: **Deposits Attached Grease**

Distance (ft): **92.7**
Structural Grade: **0**
O&M Grade: **2**
Clock Start/From: **7**
Clock To: **5**
1st Value:
2nd Value:
Value Percent: **5.000**
Continuous Index: **F01**
Within 8" of Joint: **YES**
Remarks: **WANDER**

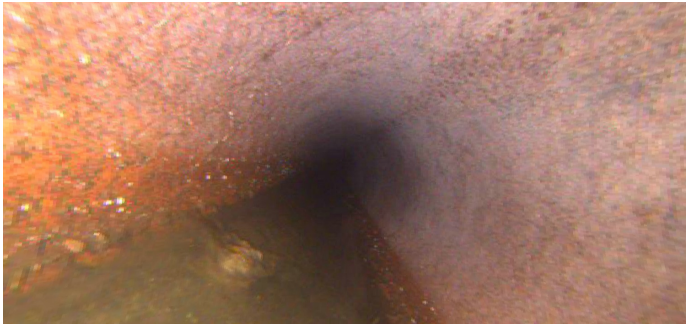
Code:	MSA
Description:	Abandoned Survey
Distance (ft):	92.7
Structural Grade:	0
O&M Grade:	0
Clock Start/From:	
Clock To:	
1st Value:	
2nd Value:	
Value Percent:	
Continuous Index:	
Within 8" of Joint:	NO
Remarks:	ROBOT HAS STOPPED
