Profile/Photo Observation Report

Street:	N Hobart St.	Flow Control:	Not Controlled
City:	Hobart, IN	Year Renewed:	
Location:	Other	Tape/Media #:	
Purpose:	Not Known	Dia/Height:	10"
Use:	Sanitary	Material:	VCP
Drain Area:	NA	Lining:	
Category:	NA		
Comment:

Location Details:		Direction of Survey:	Downstream
US MH:	M-804-066	DS MH:	M-804-067
		Total Length Surveyed (ft):	37.6

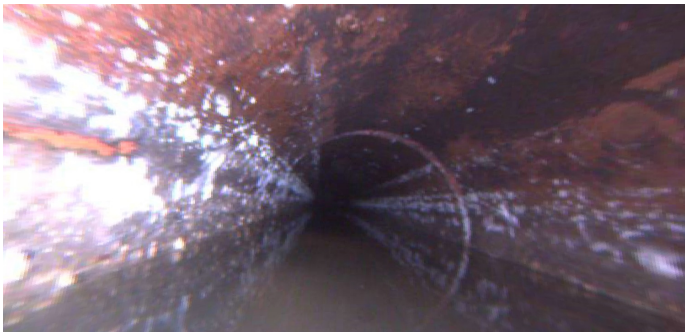
Code:	MWL
Description:	Water Level

Distance (ft):	3.3
Structural Grade:	0
O&M Grade:	0
Clock Start/From:	
Clock To:	
1st Value:	
2nd Value:	
Value Percent:	5.000
Continuous Index:	
Within 8" of Joint:	NO
Remarks:

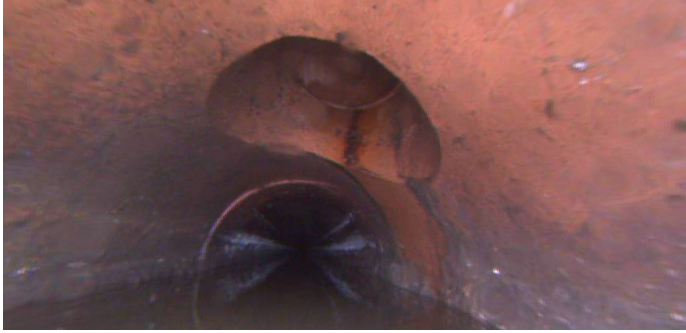
Code: **TF**
Description: **Tap Factory**

Distance (ft): **10.0**
Structural Grade: **0**
O&M Grade: **0**
Clock Start/From: **1**
Clock To:
1st Value: **4.000**
2nd Value:
Value Percent:
Continuous Index:
Within 8" of Joint: **YES**
Remarks:

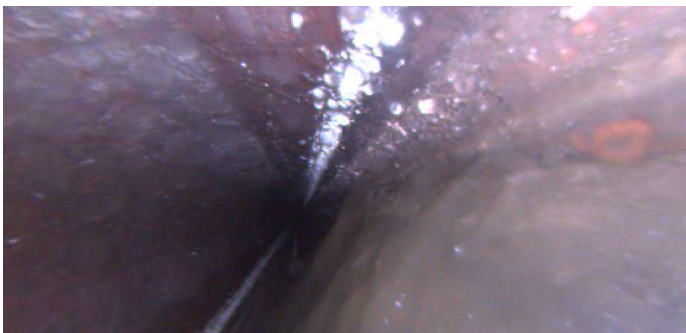
Code: **MSA**
Description: **Abandoned Survey**

Distance (ft): **37.6**
Structural Grade: **0**
O&M Grade: **0**
Clock Start/From:
Clock To:
1st Value:
2nd Value:
Value Percent:
Continuous Index:
Within 8" of Joint: **NO**
Remarks: **camera flipped**
