Profile/Photo Observation Report

Street:	N HOBART RD	Flow Control:	Not Controlled
City:	Hobart, IN	Year Renewed:	
Location:	Other	Tape/Media #:	
Purpose:	Not Known	Dia/Height:	10"
Use:	Sanitary	Material:	VCP
Drain Area:	NA	Lining:	
Category:	NA		
Comment:

Location Details:		Direction of Survey:	Downstream
US MH:	M-804-067	DS MH:	M-903-001
		Total Length Surveyed (ft):	37.8

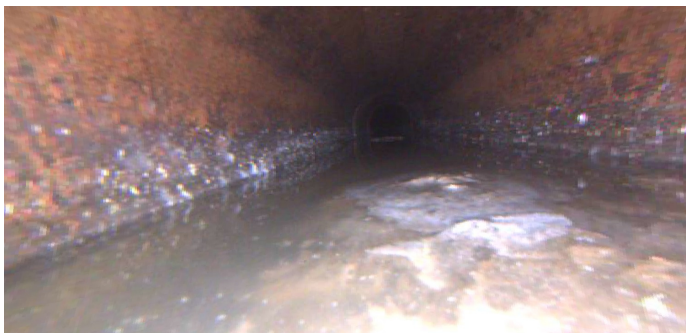
Code: **DSZ**
Description: **Deposits Settled Other**

Distance (ft): **.0**
Structural Grade: **0**
O&M Grade: **2**
Clock Start/From: **6**
Clock To:
1st Value:
2nd Value:
Value Percent: **5.000**
Continuous Index: **S01**
Within 8" of Joint: **NO**
Remarks: **debris/tissue**

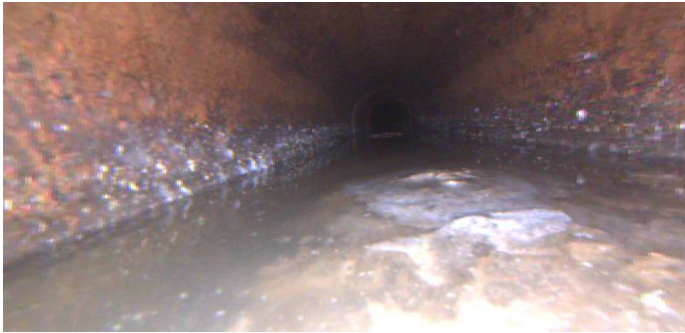
Code:	AMH
Description:	Manhole

Distance (ft):	.0
Structural Grade:	0
O&M Grade:	0
Clock Start/From:	
Clock To:	
1st Value:	
2nd Value:	
Value Percent:	
Continuous Index:	
Within 8" of Joint:	NO
Remarks:	M-804-067

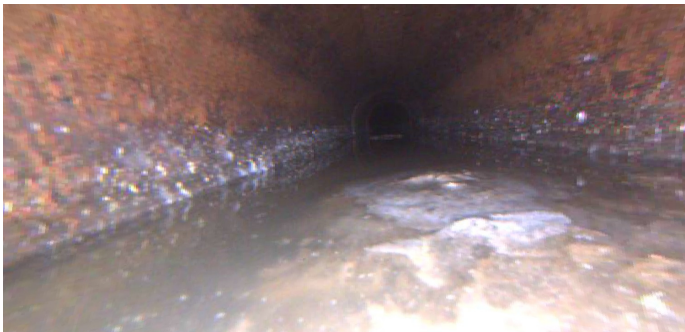
Code:	MWL
Description:	Water Level

Distance (ft):	.0
Structural Grade:	0
O&M Grade:	0
Clock Start/From:	
Clock To:	
1st Value:	
2nd Value:	
Value Percent:	15.000
Continuous Index:	
Within 8" of Joint:	NO
Remarks:

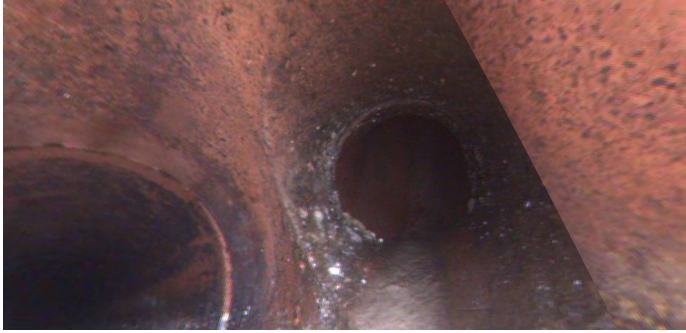
Code: **TF**
Description: **Tap Factory**

Distance (ft): **5.5**
Structural Grade: **0**
O&M Grade: **0**
Clock Start/From: **2**
Clock To:
1st Value: **4.000**
2nd Value:
Value Percent:
Continuous Index:
Within 8" of Joint: **YES**
Remarks:

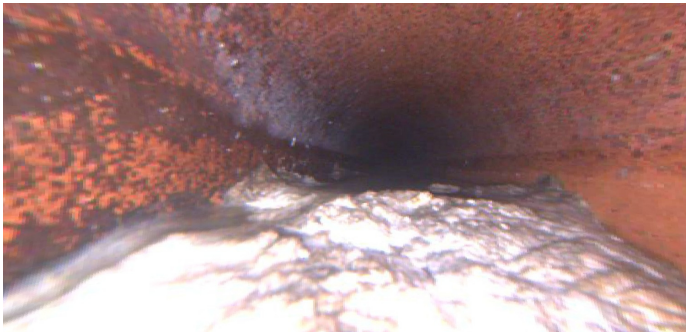
Code: **DSZ**
Description: **Deposits Settled Other**

Distance (ft): **37.1**
Structural Grade: **0**
O&M Grade: **4**
Clock Start/From: **4**
Clock To: **8**
1st Value:
2nd Value:
Value Percent: **25.000**
Continuous Index:
Within 8" of Joint: **NO**
Remarks: **unknown blockage**

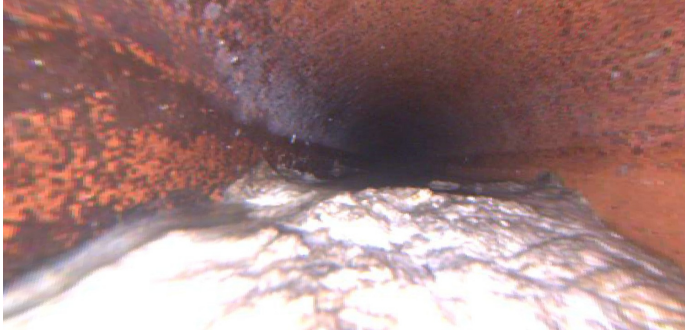
Code: **DSZ**
Description: **Deposits Settled Other**

Distance (ft): **37.1**
Structural Grade: **0**
O&M Grade: **2**
Clock Start/From: **6**
Clock To:
1st Value:
2nd Value:
Value Percent: **5.000**
Continuous Index: **F01**
Within 8" of Joint: **NO**
Remarks: **debris/tissue**

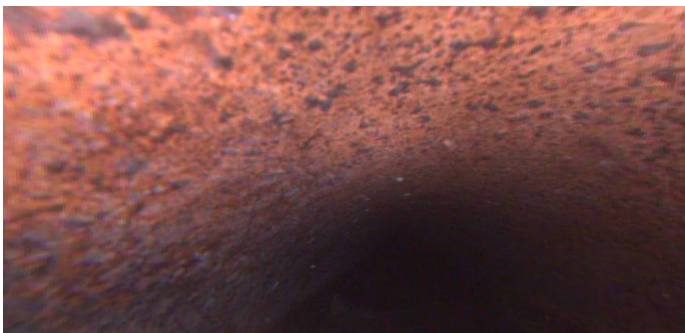
Code: **MSA**
Description: **Abandoned Survey**

Distance (ft): **37.8**
Structural Grade: **0**
O&M Grade: **0**
Clock Start/From:
Clock To:
1st Value:
2nd Value:
Value Percent:
Continuous Index:
Within 8" of Joint: **NO**
Remarks: **dsz**
