## Profile/Photo Observation Report

Street:	<b>East Home Avenue</b>	Flow Control:	
City:	<b>Hobart, IN</b>	Year Renewed:	
Location:	<b>Light Highway</b>	Tape/Media #:	<b>848</b>
Purpose:	<b>Routine Assessment</b>	Dia/Height:	<b>12"</b>
Use:	<b>Sanitary</b>	Material:	<b>VCP</b>
Drain Area:		Lining:	
Category:	<b>NA</b>		
Comment:

Location Details:		Direction of Survey:	<b>Downstream</b>
US MH:	<b>M-804-77</b>	DS MH:	<b>M-804-78</b>
		Total Length Surveyed (ft):	<b>30.4</b>

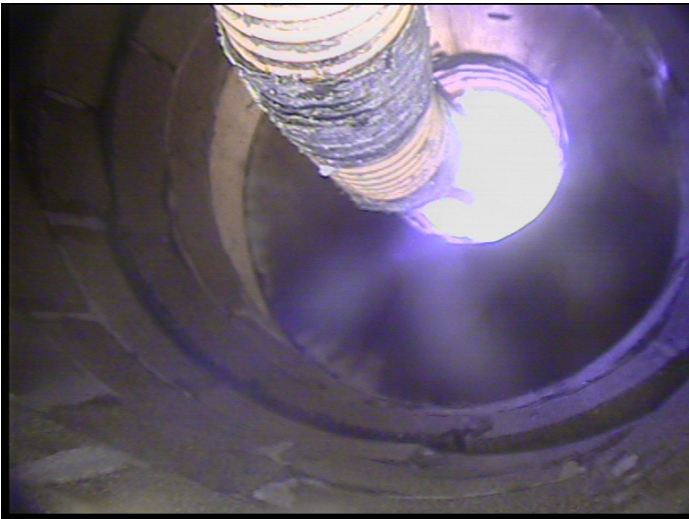
AMH

Manhole

.0

M-804-77

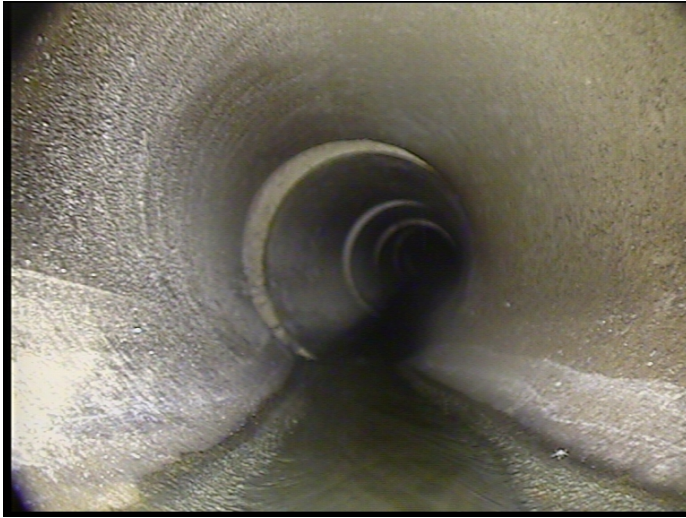
Code: **MWL**  
Description: **Water Level**

Distance (ft): **.0**  
Structural Grade: **0**  
O&M Grade: **0**  
Clock Start/From:  
Clock To:  
1st Value:  
2nd Value:  
Value Percent: **5.000**  
Continuous Index:  
Within 8" of Joint: **NO**  
Remarks:

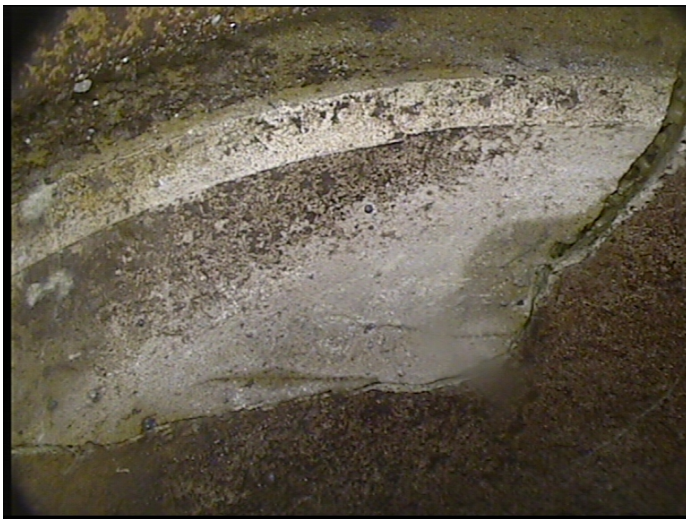
Code: **FC**  
Description: **Fracture Circumferential**

Distance (ft): **13.2**  
Structural Grade: **2**  
O&M Grade: **0**  
Clock Start/From: **7**  
Clock To: **9**  
1st Value:  
2nd Value:  
Value Percent:  
Continuous Index:  
Within 8" of Joint: **YES**  
Remarks:

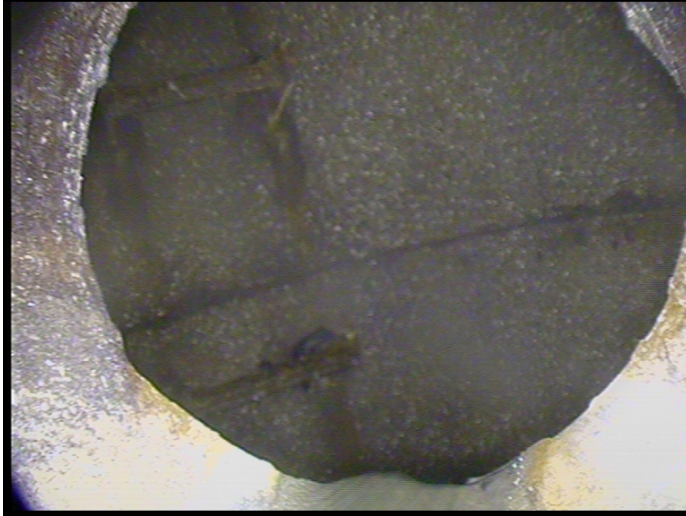
Code:	<b>AMH</b>
Description:	<b>Manhole</b>
Distance (ft):	<b>30.4</b>
Structural Grade:	<b>0</b>
O&M Grade:	<b>0</b>
Clock Start/From:	
Clock To:	
1st Value:	
2nd Value:	
Value Percent:	
Continuous Index:	
Within 8" of Joint:	<b>NO</b>
Remarks:	<b>M-804-78</b>
