Profile/Photo Observation Report

Street:	Hobart Road	Flow Control:	Not Controlled
City:	Hobart, IN	Year Renewed:	
Location:	Light Highway	Tape/Media #:	DEP 195
Purpose:	Routine Assessment	Dia/Height:	18"
Use:	Sanitary	Material:	PVC
Drain Area:		Lining:	
Category:	NA		
Comment:	5-21-2018		
Location Details:		Direction of Survey:	Upstream
US MH:	M-805-001	DS MH:	M-905-017
		Total Length Surveyed (ft):	83.8

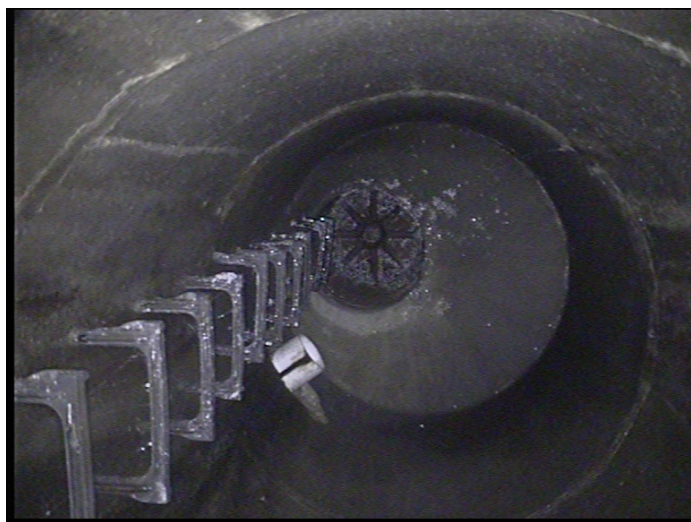
Code: **AMH**
Description: **Manhole**

Distance (ft): **.0**
Structural Grade: **0**
O&M Grade: **0**
Clock Start/From:
Clock To:
1st Value:
2nd Value:
Value Percent:
Continuous Index:
Within 8" of Joint: **NO**
Remarks: **M-805-001**

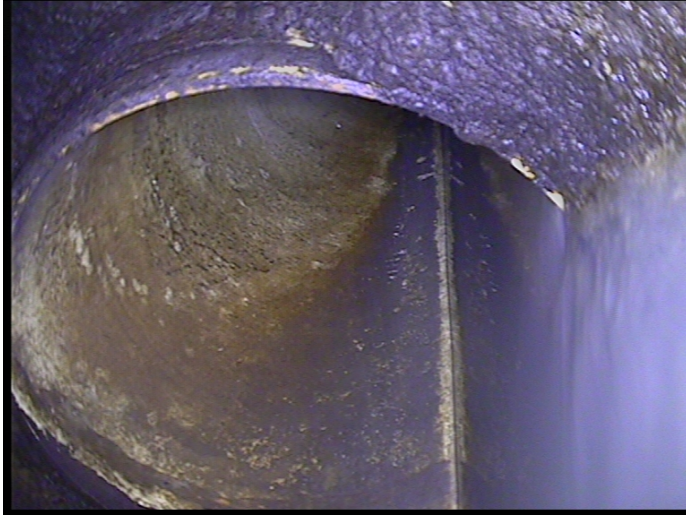
Code:	MWL
Description:	Water Level
Distance (ft):	.0
Structural Grade:	0
O&M Grade:	0
Clock Start/From:	
Clock To:	
1st Value:	
2nd Value:	
Value Percent:	15.000
Continuous Index:	
Within 8" of Joint:	NO
Remarks:

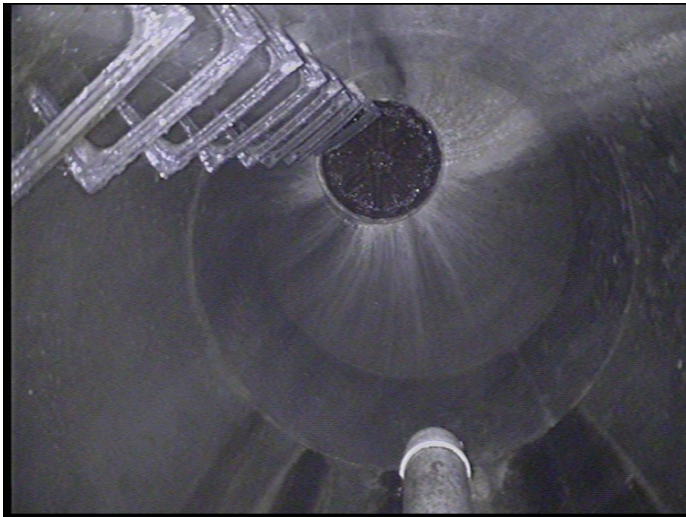
Code:	AMH
Description:	Manhole
Distance (ft):	83.8
Structural Grade:	0
O&M Grade:	0
Clock Start/From:	
Clock To:	
1st Value:	
2nd Value:	
Value Percent:	
Continuous Index:	
Within 8" of Joint:	NO
Remarks:	M-905-017
