Profile/Photo Observation Report

Date:	05/05/2018	Weather:		Coding:	PACP 6.0
Pipe Length (ft):		Owner:	City of Hobart	Pre Clean:	No Pre-Cleaning
P.O.#:	195	Surveyor:	M. Pielacha	PSR:	P-805-001-002
Customer:	City of Hobart	Clean Date:		Shape:	C

Street:	Hobart Road	Flow Control:	Not Controlled
City:	Hobart, IN	Year Renewed:	
Location:	Light Highway	Tape/Media #:	DEP 195
Purpose:	Routine Assessment	Dia/Height:	18"
Use:	Sanitary	Material:	VCP
Drain Area:		Lining:	
Category:	NA		
Comment:	5-21-2018		
Location Details:		Direction of Survey:	Upstream
US MH:	M-805-002	DS MH:	M-805-001
		Total Length Surveyed (ft):	160.1

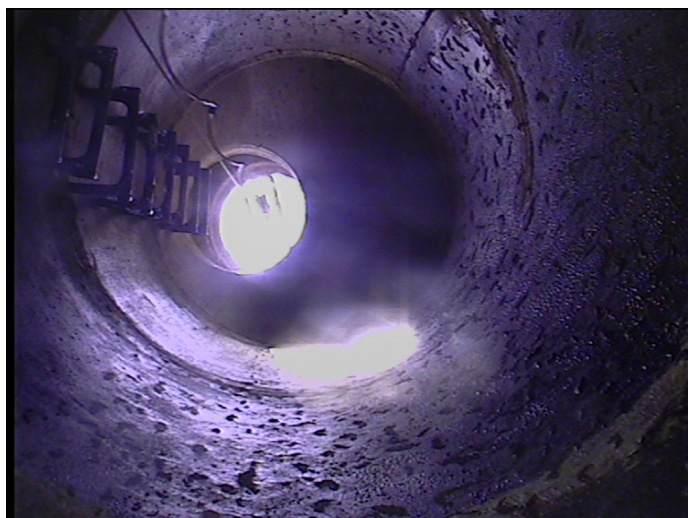
Code: **AMH**
Description: **Manhole**

Distance (ft): **.0**
Structural Grade: **0**
O&M Grade: **0**
Clock Start/From:
Clock To:
1st Value:
2nd Value:
Value Percent:
Continuous Index:
Within 8" of Joint: **NO**
Remarks: **M-805-002**

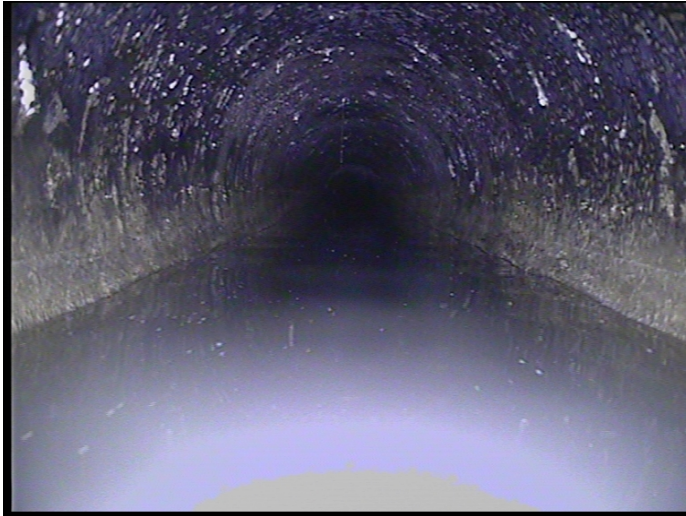
Code:	MWL
Description:	Water Level
Distance (ft):	.0
Structural Grade:	0
O&M Grade:	0
Clock Start/From:	
Clock To:	
1st Value:	
2nd Value:	
Value Percent:	20.000
Continuous Index:	
Within 8" of Joint:	NO
Remarks:

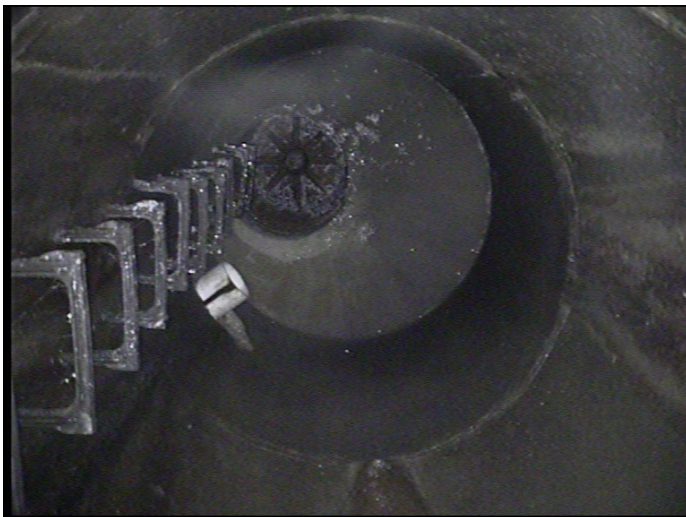
Code:	AMH
Description:	Manhole
Distance (ft):	160.1
Structural Grade:	0
O&M Grade:	0
Clock Start/From:	
Clock To:	
1st Value:	
2nd Value:	
Value Percent:	
Continuous Index:	
Within 8" of Joint:	NO
Remarks:	M-805-001
