## Profile/Photo Observation Report

Street:	<b>ALLEY BETWEEN S LAWRENCE ST &amp; S</b>	Flow Control:	<b>Not Controlled</b>
City:	<b>Hobart, IN</b>	Year Renewed:	
Location:	<b>Alley</b>	Tape/Media #:	
Purpose:	<b>Maintenance Related</b>	Dia/Height:	<b>8"</b>
Use:	<b>Sanitary</b>	Material:	<b>PVC</b>
Drain Area:	<b>NA</b>	Lining:	<b>Cured in Place</b>
Category:	<b>NA</b>		
Comment:	<b>Flow direction wrong.</b>

Location Details:		Direction of Survey:	<b>Upstream</b>
US MH:	<b>M-805-004</b>	DS MH:	<b>M-805-068</b>
		Total Length Surveyed (ft):	<b>34.5</b>

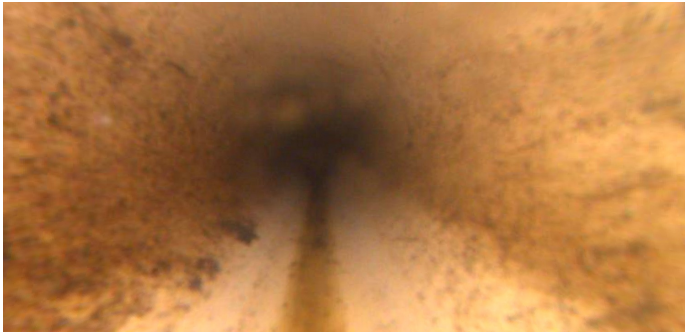
Code:	<b>MWL</b>
Description:	<b>Water Level</b>

Distance (ft):	<b>.0</b>
Structural Grade:	<b>0</b>
O&M Grade:	<b>0</b>
Clock Start/From:	
Clock To:	
1st Value:	
2nd Value:	
Value Percent:	<b>5.000</b>
Continuous Index:	
Within 8" of Joint:	<b>NO</b>
Remarks:

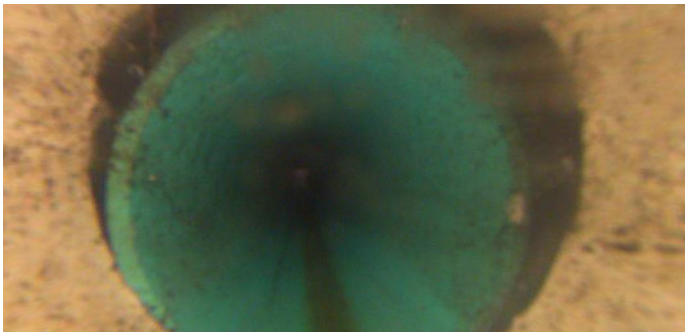
Code:	<b>JSM</b>
Description:	<b>Joint Separated Medium</b>

Distance (ft):	<b>26.3</b>
Structural Grade:	<b>1</b>
O&M Grade:	<b>0</b>
Clock Start/From:	
Clock To:	
1st Value:	
2nd Value:	
Value Percent:	
Continuous Index:	
Within 8" of Joint:	<b>NO</b>
Remarks:

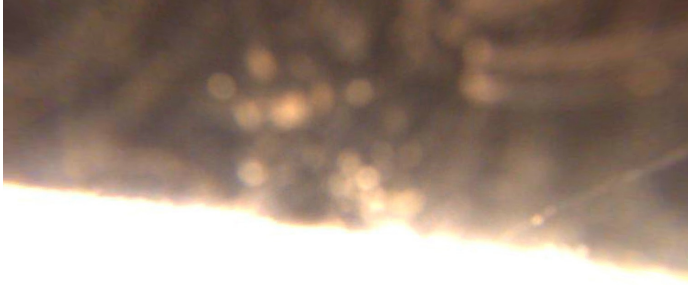
Code:	AMH
Description:	Manhole
Distance (ft):	34.5
Structural Grade:	0
O&M Grade:	0
Clock Start/From:	
Clock To:	
1st Value:	
2nd Value:	
Value Percent:	
Continuous Index:	
Within 8" of Joint:	NO
Remarks:	M-805-004
