## Profile/Photo Observation Report

Street:	<b>E 5TH ST</b>	Flow Control:	<b>Not Controlled</b>
City:	<b>Hobart, IN</b>	Year Renewed:	
Location:	<b>Alley</b>	Tape/Media #:	
Purpose:	<b>Maintenance Related</b>	Dia/Height:	<b>12"</b>
Use:	<b>Sanitary</b>	Material:	<b>PVC</b>
Drain Area:	<b>NA</b>	Lining:	<b>Cured in Place</b>
Category:	<b>NA</b>		
Comment:	<b>Flow direction wrong. Manhole found.</b>		
Location Details:		Direction of Survey:	<b>Upstream</b>
US MH:	<b>M-805-005</b>	DS MH:	<b>M-805-004</b>
		Total Length Surveyed (ft):	<b>229.1</b>

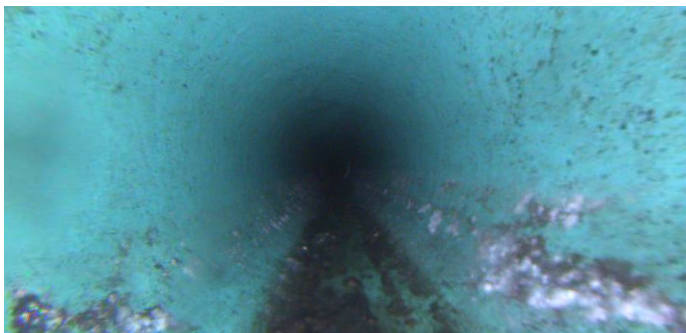
Code: **AMH**  
Description: **Manhole**

Distance (ft): **.0**  
Structural Grade: **0**  
O&M Grade: **0**  
Clock Start/From:  
Clock To:  
1st Value:  
2nd Value:  
Value Percent:  
Continuous Index:  
Within 8" of Joint: **NO**  
Remarks: **M-805-004**

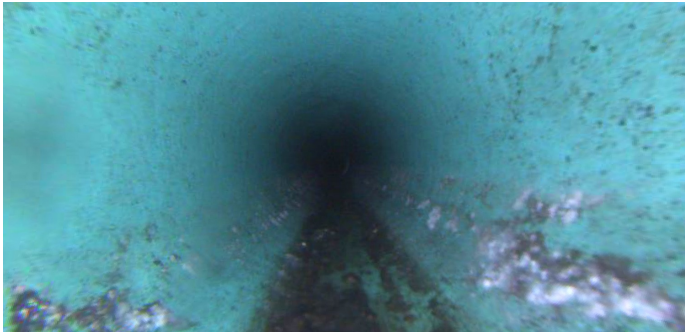
Code:	<b>MWL</b>
Description:	<b>Water Level</b>

Distance (ft):	<b>.0</b>
Structural Grade:	<b>0</b>
O&M Grade:	<b>0</b>
Clock Start/From:	
Clock To:	
1st Value:	
2nd Value:	
Value Percent:	<b>5.000</b>
Continuous Index:	
Within 8" of Joint:	<b>NO</b>
Remarks:

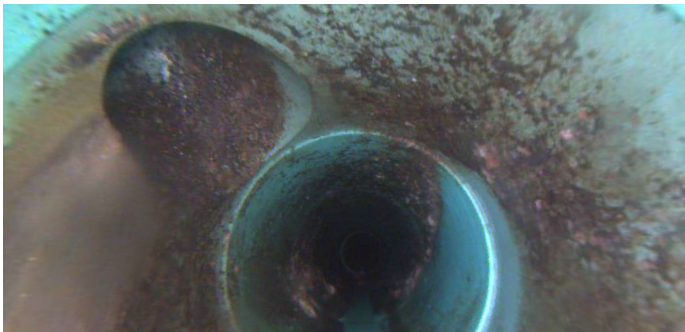
Code:	<b>TF</b>
Description:	<b>Tap Factory</b>

Distance (ft):	<b>9.9</b>
Structural Grade:	<b>0</b>
O&M Grade:	<b>0</b>
Clock Start/From:	<b>10</b>
Clock To:	
1st Value:	<b>4.000</b>
2nd Value:	
Value Percent:	
Continuous Index:	
Within 8" of Joint:	
Remarks:

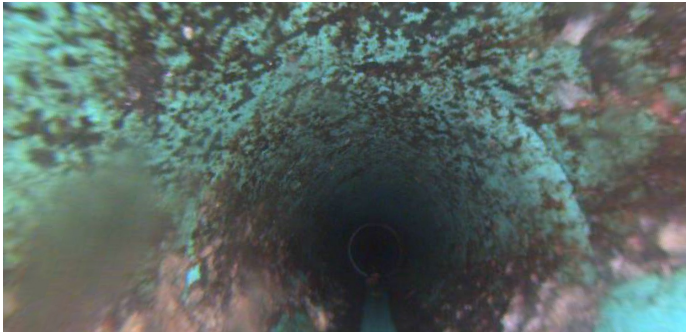
Code: **DAGS**  
Description: **Deposits Attached Grease**

Distance (ft): **11.4**  
Structural Grade: **0**  
O&M Grade: **2**  
Clock Start/From: **7**  
Clock To: **5**  
1st Value:  
2nd Value:  
Value Percent: **5.000**  
Continuous Index:  
Within 8" of Joint: **NO**  
Remarks:

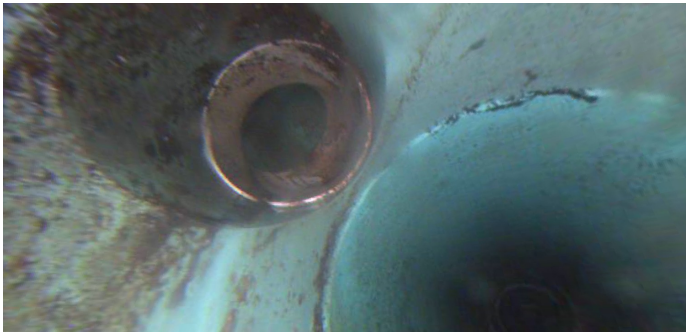
Code: **TF**  
Description: **Tap Factory**

Distance (ft): **17.2**  
Structural Grade: **0**  
O&M Grade: **0**  
Clock Start/From: **2**  
Clock To:  
1st Value: **4.000**  
2nd Value:  
Value Percent:  
Continuous Index:  
Within 8" of Joint:  
Remarks:

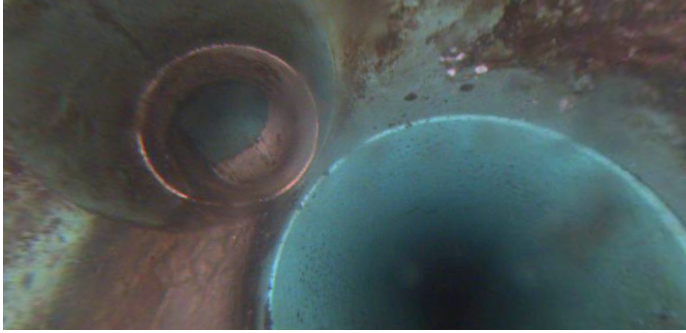
Code: **TF**  
Description: **Tap Factory**

Distance (ft): **65.4**  
Structural Grade: **0**  
O&M Grade: **0**  
Clock Start/From: **2**  
Clock To:  
1st Value: **4.000**  
2nd Value:  
Value Percent:  
Continuous Index:  
Within 8" of Joint:  
Remarks:

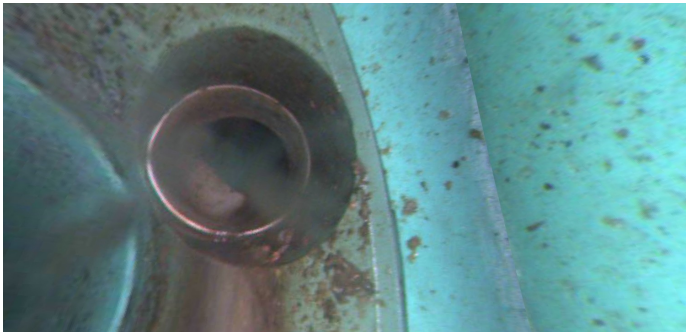
Code: **TF**  
Description: **Tap Factory**

Distance (ft): **78.0**  
Structural Grade: **0**  
O&M Grade: **0**  
Clock Start/From: **10**  
Clock To:  
1st Value: **4.000**  
2nd Value:  
Value Percent:  
Continuous Index:  
Within 8" of Joint:  
Remarks:

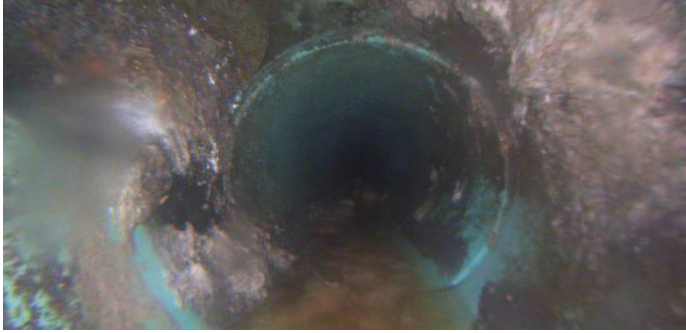
Code: **DAGS**  
Description: **Deposits Attached Grease**

Distance (ft): **107.5**  
Structural Grade: **0**  
O&M Grade: **2**  
Clock Start/From: **8**  
Clock To: **4**  
1st Value:  
2nd Value:  
Value Percent: **5.000**  
Continuous Index:  
Within 8" of Joint: **NO**  
Remarks:

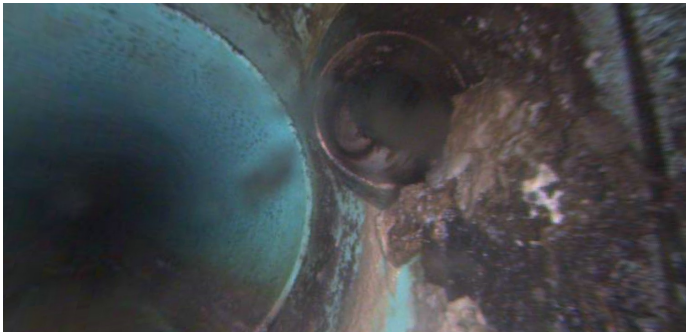
Code: **TFD**  
Description: **Tap Factory Defective**

Distance (ft): **108.5**  
Structural Grade: **0**  
O&M Grade: **2**  
Clock Start/From: **10**  
Clock To:  
1st Value: **4.000**  
2nd Value:  
Value Percent:  
Continuous Index:  
Within 8" of Joint:  
Remarks: **DAGS**

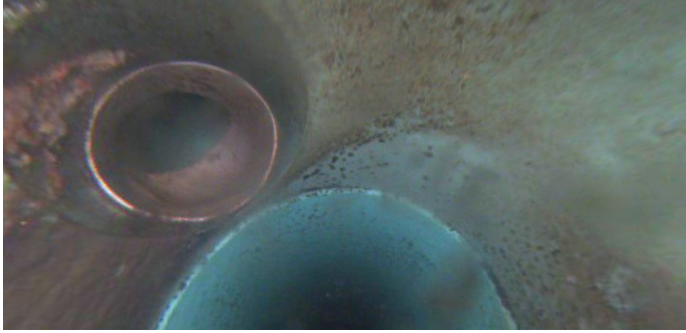
Code: **TF**  
Description: **Tap Factory**

Distance (ft): **135.3**  
Structural Grade: **0**  
O&M Grade: **0**  
Clock Start/From: **2**  
Clock To:  
1st Value: **4.000**  
2nd Value:  
Value Percent:  
Continuous Index:  
Within 8" of Joint:  
Remarks:

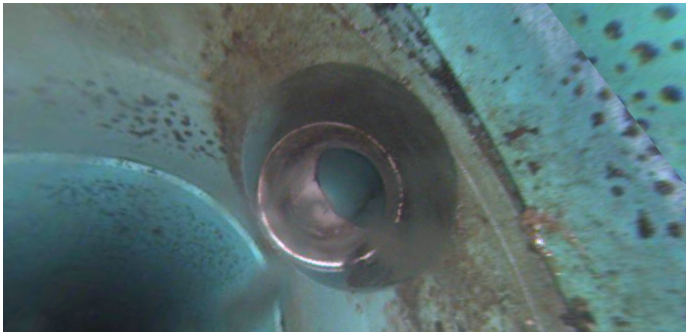
Code: **TF**  
Description: **Tap Factory**

Distance (ft): **156.9**  
Structural Grade: **0**  
O&M Grade: **0**  
Clock Start/From: **10**  
Clock To:  
1st Value: **4.000**  
2nd Value:  
Value Percent:  
Continuous Index:  
Within 8" of Joint:  
Remarks:

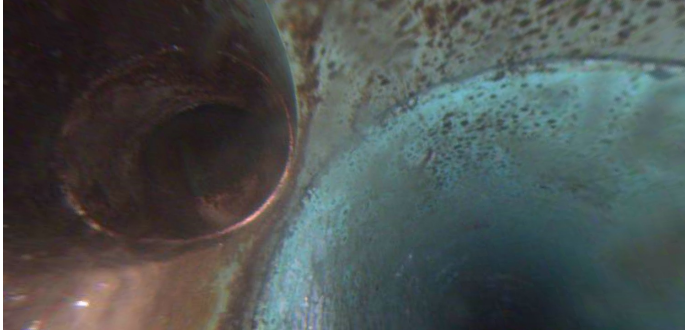
Code: **TF**  
Description: **Tap Factory**

Distance (ft): **186.3**  
Structural Grade: **0**  
O&M Grade: **0**  
Clock Start/From: **2**  
Clock To:  
1st Value: **4.000**  
2nd Value:  
Value Percent:  
Continuous Index:  
Within 8" of Joint:  
Remarks:

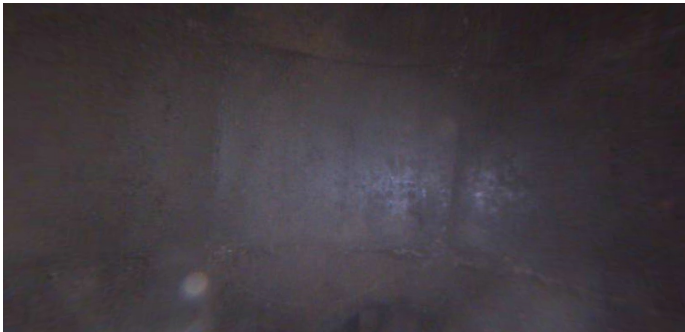
Code: **AMH**  
Description: **Manhole**

Distance (ft): **229.1**  
Structural Grade: **0**  
O&M Grade: **0**  
Clock Start/From:  
Clock To:  
1st Value:  
2nd Value:  
Value Percent:  
Continuous Index:  
Within 8" of Joint: **NO**  
Remarks: **M-805-005**
