## Profile/Photo Observation Report

Street:	<b>Hobart</b>	Flow Control:	<b>Not Controlled</b>
City:	<b>Hobart, IN</b>	Year Renewed:	
Location:	<b>Alley</b>	Tape/Media #:	
Purpose:	<b>Maintenance Related</b>	Dia/Height:	<b>12"</b>
Use:	<b>Sanitary</b>	Material:	<b>PVC</b>
Drain Area:	<b>NA</b>	Lining:	<b>Cured in Place</b>
Category:	<b>NA</b>		
Comment:	<b>Flow direction wrong. Manhole found.</b>		
Location Details:		Direction of Survey:	<b>Upstream</b>
US MH:	<b>M-805-005</b>	DS MH:	<b>M-805-004</b>
		Total Length Surveyed (ft):	<b>229.1</b>

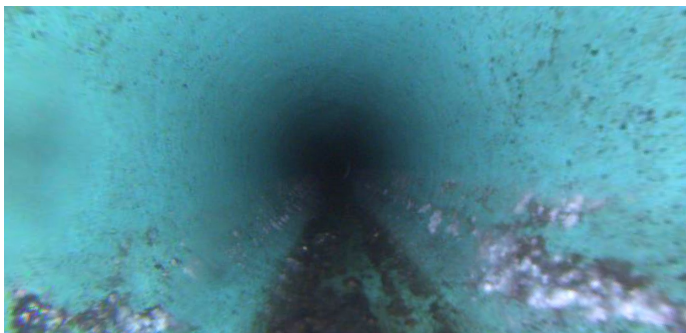
Code: **AMH**  
Description: **Manhole**

Distance (ft): **.0**  
Structural Grade: **0**  
O&M Grade: **0**  
Clock Start/From:  
Clock To:  
1st Value:  
2nd Value:  
Value Percent:  
Continuous Index:  
Within 8" of Joint: **NO**  
Remarks: **M-805-004**

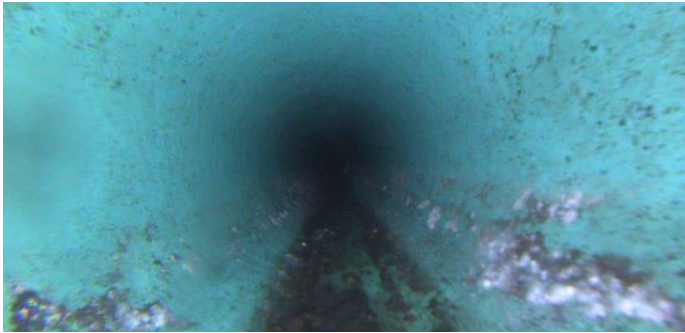
Code:	<b>MWL</b>
Description:	<b>Water Level</b>

Distance (ft):	<b>.0</b>
Structural Grade:	<b>0</b>
O&M Grade:	<b>0</b>
Clock Start/From:	
Clock To:	
1st Value:	
2nd Value:	
Value Percent:	<b>5.000</b>
Continuous Index:	
Within 8" of Joint:	<b>NO</b>
Remarks:

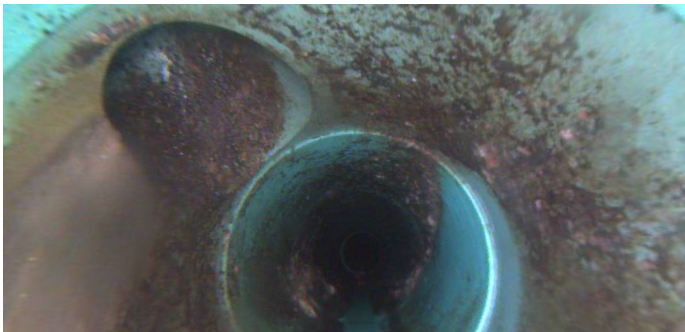
Code:	<b>TF</b>
Description:	<b>Tap Factory</b>

Distance (ft):	<b>9.9</b>
Structural Grade:	<b>0</b>
O&M Grade:	<b>0</b>
Clock Start/From:	<b>10</b>
Clock To:	
1st Value:	<b>4.000</b>
2nd Value:	
Value Percent:	
Continuous Index:	
Within 8" of Joint:	
Remarks:

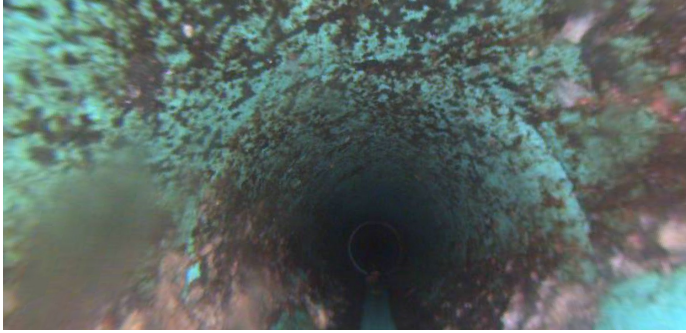
Code: **DAGS**  
Description: **Deposits Attached Grease**

Distance (ft): **11.4**  
Structural Grade: **0**  
O&M Grade: **2**  
Clock Start/From: **7**  
Clock To: **5**  
1st Value:  
2nd Value:  
Value Percent: **5.000**  
Continuous Index:  
Within 8" of Joint: **NO**  
Remarks:

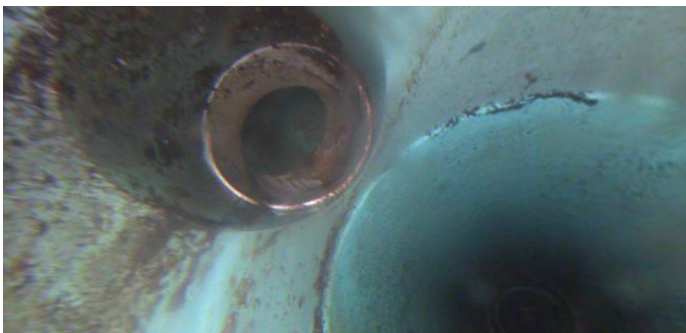
Code: **TF**  
Description: **Tap Factory**

Distance (ft): **17.2**  
Structural Grade: **0**  
O&M Grade: **0**  
Clock Start/From: **2**  
Clock To:  
1st Value: **4.000**  
2nd Value:  
Value Percent:  
Continuous Index:  
Within 8" of Joint:  
Remarks:

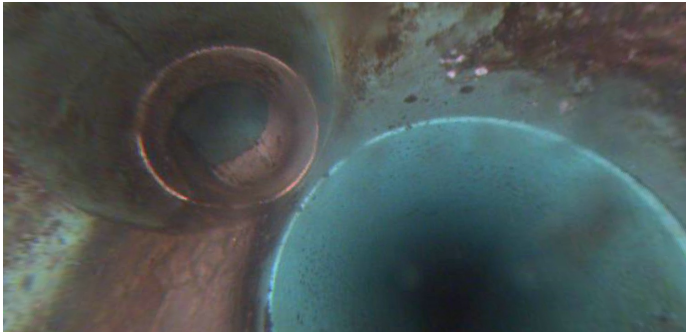
Code: **TF**  
Description: **Tap Factory**

Distance (ft): **65.4**  
Structural Grade: **0**  
O&M Grade: **0**  
Clock Start/From: **2**  
Clock To:  
1st Value: **4.000**  
2nd Value:  
Value Percent:  
Continuous Index:  
Within 8" of Joint:  
Remarks:

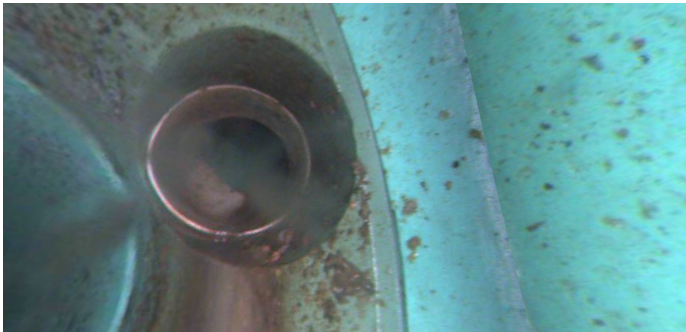
Code: **TF**  
Description: **Tap Factory**

Distance (ft): **78.0**  
Structural Grade: **0**  
O&M Grade: **0**  
Clock Start/From: **10**  
Clock To:  
1st Value: **4.000**  
2nd Value:  
Value Percent:  
Continuous Index:  
Within 8" of Joint:  
Remarks:

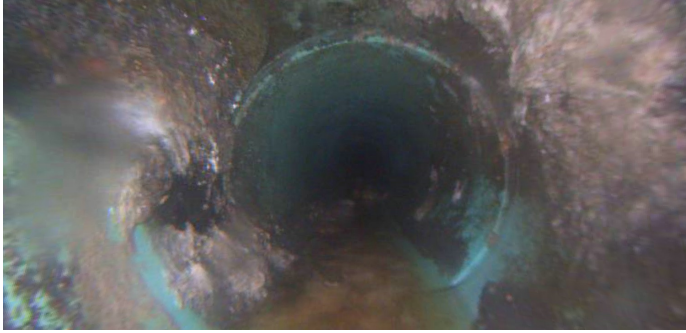
Code: **DAGS**  
Description: **Deposits Attached Grease**

Distance (ft): **107.5**  
Structural Grade: **0**  
O&M Grade: **2**  
Clock Start/From: **8**  
Clock To: **4**  
1st Value:  
2nd Value:  
Value Percent: **5.000**  
Continuous Index:  
Within 8" of Joint: **NO**  
Remarks:

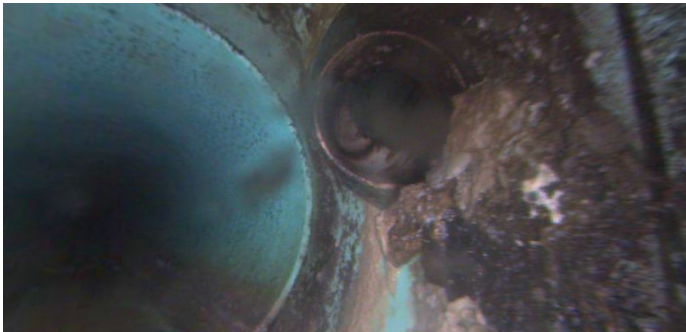
Code: **TFD**  
Description: **Tap Factory Defective**

Distance (ft): **108.5**  
Structural Grade: **0**  
O&M Grade: **2**  
Clock Start/From: **10**  
Clock To:  
1st Value: **4.000**  
2nd Value:  
Value Percent:  
Continuous Index:  
Within 8" of Joint:  
Remarks: **DAGS**

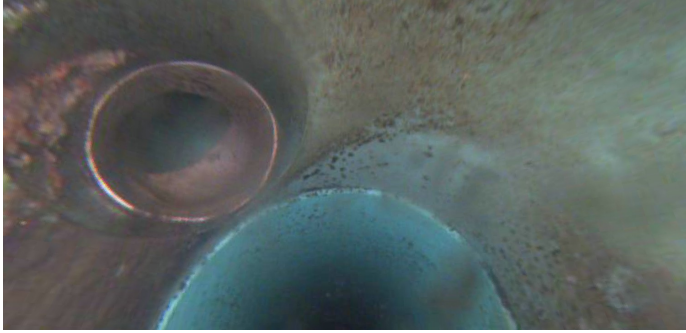
Code: **TF**  
Description: **Tap Factory**

Distance (ft): **135.3**  
Structural Grade: **0**  
O&M Grade: **0**  
Clock Start/From: **2**  
Clock To:  
1st Value: **4.000**  
2nd Value:  
Value Percent:  
Continuous Index:  
Within 8" of Joint:  
Remarks:

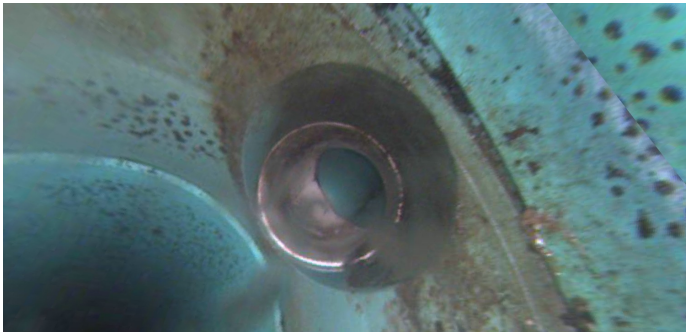
Code: **TF**  
Description: **Tap Factory**

Distance (ft): **156.9**  
Structural Grade: **0**  
O&M Grade: **0**  
Clock Start/From: **10**  
Clock To:  
1st Value: **4.000**  
2nd Value:  
Value Percent:  
Continuous Index:  
Within 8" of Joint:  
Remarks:

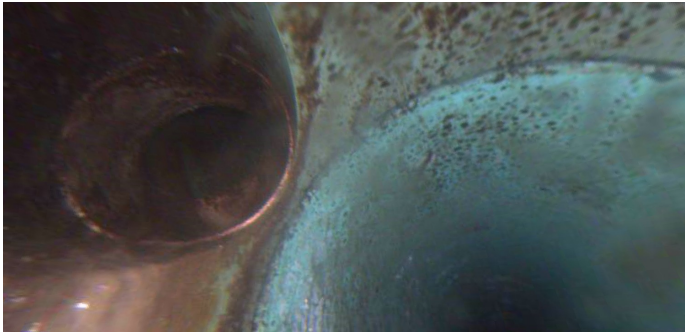
Code: **TF**  
Description: **Tap Factory**

Distance (ft): **186.3**  
Structural Grade: **0**  
O&M Grade: **0**  
Clock Start/From: **2**  
Clock To:  
1st Value: **4.000**  
2nd Value:  
Value Percent:  
Continuous Index:  
Within 8" of Joint:  
Remarks:

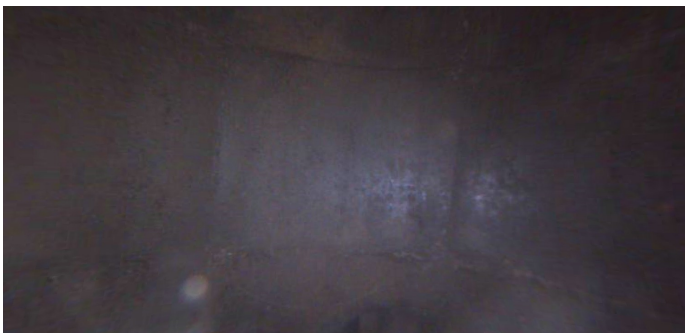
Code: **AMH**  
Description: **Manhole**

Distance (ft): **229.1**  
Structural Grade: **0**  
O&M Grade: **0**  
Clock Start/From:  
Clock To:  
1st Value:  
2nd Value:  
Value Percent:  
Continuous Index:  
Within 8" of Joint: **NO**  
Remarks: **M-805-005**
