## Profile/Photo Observation Report

Street:	<b>E 5TH ST</b>	Flow Control:	<b>Not Controlled</b>
City:	<b>Hobart, IN</b>	Year Renewed:	
Location:	<b>Alley</b>	Tape/Media #:	
Purpose:	<b>Maintenance Related</b>	Dia/Height:	<b>8"</b>
Use:	<b>Sanitary</b>	Material:	<b>PVC</b>
Drain Area:	<b>NA</b>	Lining:	<b>Cured in Place</b>
Category:	<b>NA</b>		
Comment:	<b>Flow direction wrong. 12\" line.</b>		
Location Details:		Direction of Survey:	<b>Upstream</b>
US MH:	<b>M-805-005</b>	DS MH:	<b>M-805-006</b>
		Total Length Surveyed (ft):	<b>6.2</b>

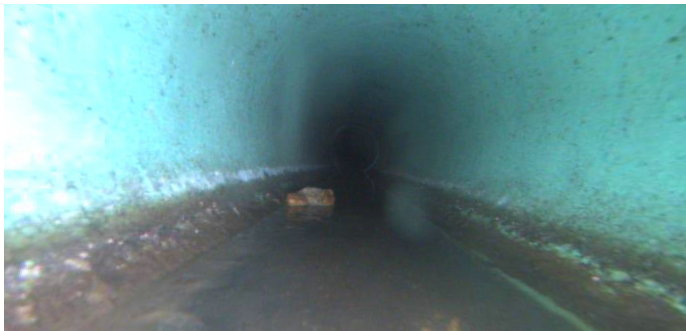
Code: **AMH**  
Description: **Manhole**

Distance (ft): **.0**  
Structural Grade: **0**  
O&M Grade: **0**  
Clock Start/From:  
Clock To:  
1st Value:  
2nd Value:  
Value Percent:  
Continuous Index:  
Within 8" of Joint: **NO**  
Remarks: **M-805-006**

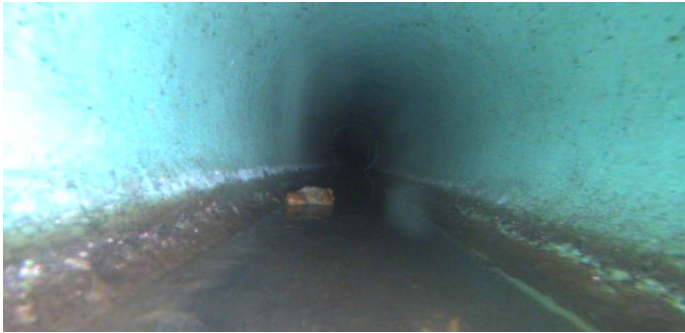
Code:	<b>MWL</b>
Description:	<b>Water Level</b>

Distance (ft):	<b>.0</b>
Structural Grade:	<b>0</b>
O&M Grade:	<b>0</b>
Clock Start/From:	
Clock To:	
1st Value:	
2nd Value:	
Value Percent:	<b>10.000</b>
Continuous Index:	
Within 8" of Joint:	<b>NO</b>
Remarks:

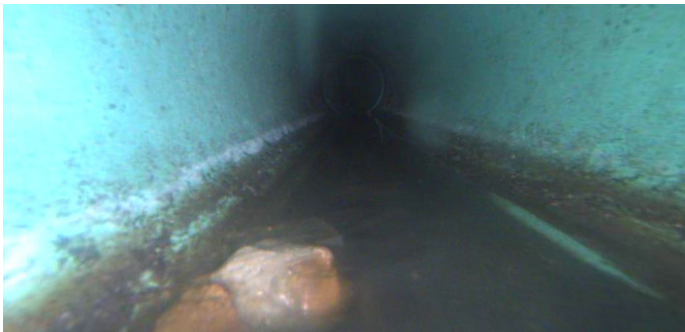
Code:	<b>OBR</b>
Description:	<b>Obstacle Rocks</b>

Distance (ft):	<b>1.1</b>
Structural Grade:	<b>0</b>
O&M Grade:	<b>2</b>
Clock Start/From:	<b>6</b>
Clock To:	
1st Value:	
2nd Value:	
Value Percent:	<b>5.000</b>
Continuous Index:	
Within 8" of Joint:	<b>NO</b>
Remarks:

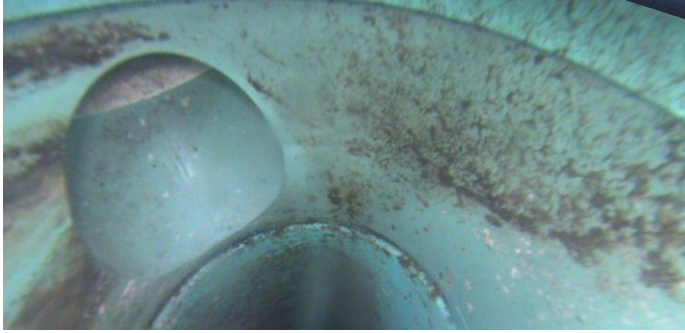
Code: **TF**  
Description: **Tap Factory**

Distance (ft): **5.3**  
Structural Grade: **0**  
O&M Grade: **0**  
Clock Start/From: **11**  
Clock To:  
1st Value: **4.000**  
2nd Value:  
Value Percent:  
Continuous Index:  
Within 8" of Joint:  
Remarks:

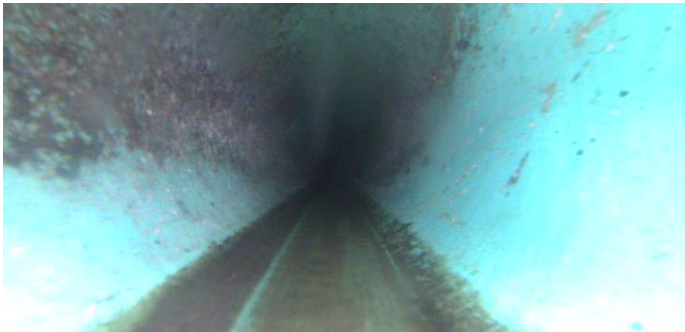
Code: **MSA**  
Description: **Abandoned Survey**

Distance (ft): **6.2**  
Structural Grade: **0**  
O&M Grade: **0**  
Clock Start/From:  
Clock To:  
1st Value:  
2nd Value:  
Value Percent:  
Continuous Index:  
Within 8" of Joint: **NO**  
Remarks: **rock**
