Profile/Photo Observation Report

Street:	Lawrence	Flow Control:	Not Controlled
City:	Hobart, IN	Year Renewed:	
Location:	Alley	Tape/Media #:	
Purpose:	Maintenance Related	Dia/Height:	8"
Use:	Sanitary	Material:	PVC
Drain Area:	NA	Lining:	Cured in Place
Category:	NA		
Comment:	Flow direction wrong. 12\" line.		
Location Details:		Direction of Survey:	Upstream
US MH:	M-805-005	DS MH:	M-805-006
		Total Length Surveyed (ft):	6.2

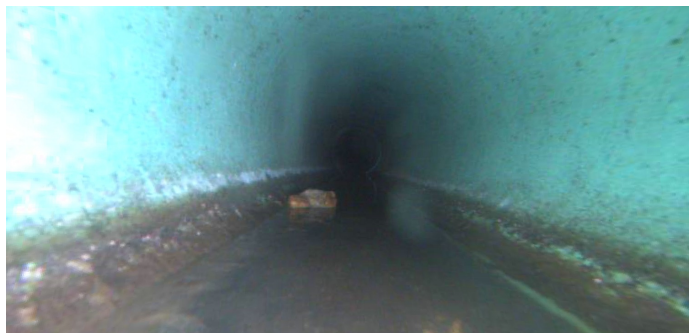
Code: **AMH**
 Description: **Manhole**
 Distance (ft): **.0**
 Structural Grade: **0**
 O&M Grade: **0**
 Clock Start/From:
 Clock To:
 1st Value:
 2nd Value:
 Value Percent:
 Continuous Index:
 Within 8" of Joint: **NO**
 Remarks: **M-805-006**

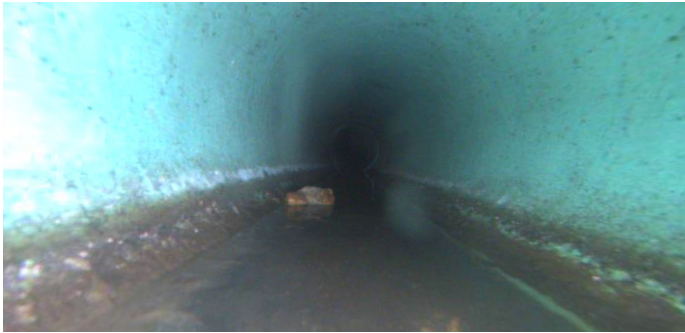
Code:	MWL
Description:	Water Level

Distance (ft):	.0
Structural Grade:	0
O&M Grade:	0
Clock Start/From:	
Clock To:	
1st Value:	
2nd Value:	
Value Percent:	10.000
Continuous Index:	
Within 8" of Joint:	NO
Remarks:

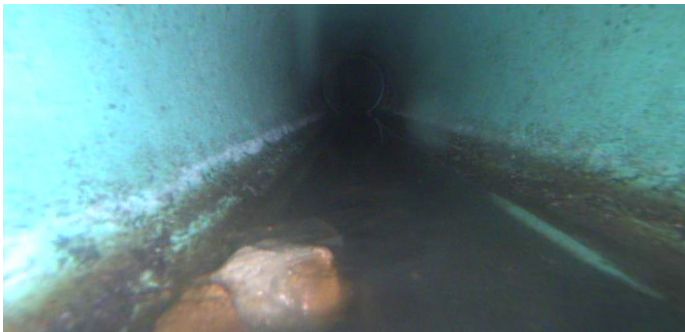
Code:	OBR
Description:	Obstacle Rocks

Distance (ft):	1.1
Structural Grade:	0
O&M Grade:	2
Clock Start/From:	6
Clock To:	
1st Value:	
2nd Value:	
Value Percent:	5.000
Continuous Index:	
Within 8" of Joint:	NO
Remarks:

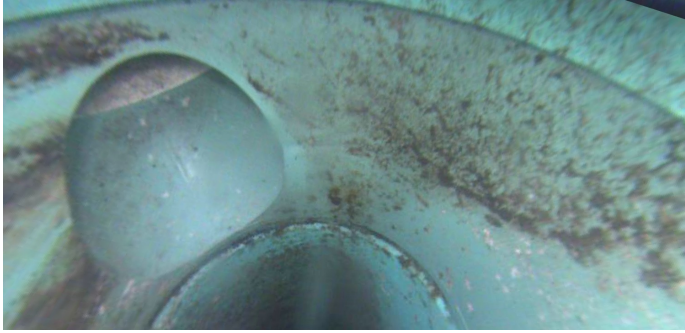
Code: **TF**
Description: **Tap Factory**

Distance (ft): **5.3**
Structural Grade: **0**
O&M Grade: **0**
Clock Start/From: **11**
Clock To:
1st Value: **4.000**
2nd Value:
Value Percent:
Continuous Index:
Within 8" of Joint:
Remarks:

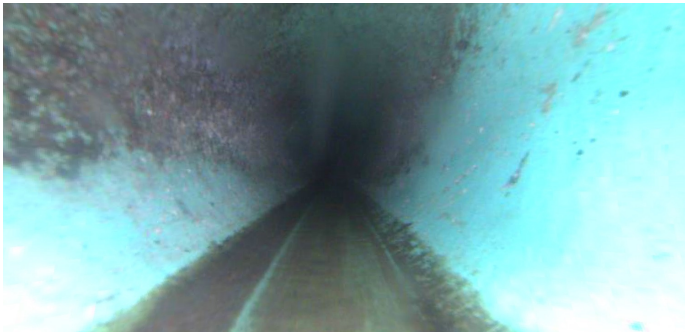
Code: **MSA**
Description: **Abandoned Survey**

Distance (ft): **6.2**
Structural Grade: **0**
O&M Grade: **0**
Clock Start/From:
Clock To:
1st Value:
2nd Value:
Value Percent:
Continuous Index:
Within 8" of Joint: **NO**
Remarks: **rock**
