Profile/Photo Observation Report

Date:	04/23/2018	Weather:		Coding:	PACP 6.0
Pipe Length (ft):	199.6	Owner:	NA	Pre Clean:	Not Known
P.O.#:		Surveyor:	Jen Costello	PSR:	P-805-006-005
Customer:		Clean Date:	01/01/1900	Shape:	C

Street:	E 5TH ST	Flow Control:	Not Controlled
City:	Hobart, IN	Year Renewed:	
Location:	Alley	Tape/Media #:	
Purpose:	Maintenance Related	Dia/Height:	12"
Use:	Sanitary	Material:	PVC
Drain Area:	NA	Lining:	Cured in Place
Category:	NA		
Comment:	Flow direction wrong. Redeployment.		
Location Details:		Direction of Survey:	Upstream
US MH:	M-805-005	DS MH:	M-805-006
		Total Length Surveyed (ft):	267.4

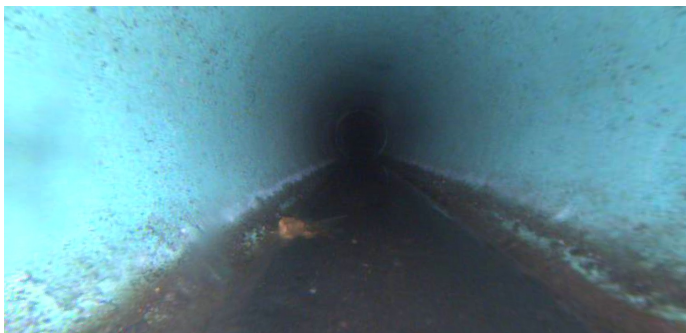
Code: **AMH**
Description: **Manhole**

Distance (ft): **.0**
Structural Grade: **0**
O&M Grade: **0**
Clock Start/From:
Clock To:
1st Value:
2nd Value:
Value Percent:
Continuous Index:
Within 8" of Joint: **NO**
Remarks: **M-805-006**

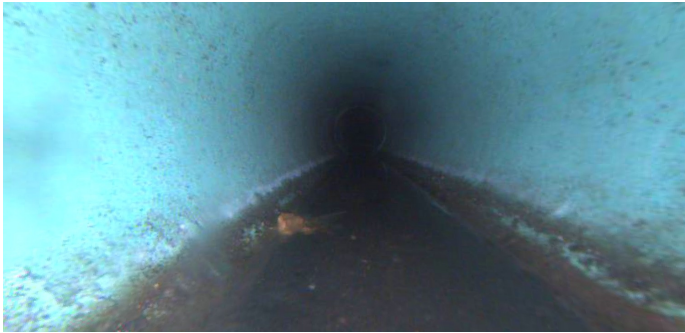
Code:	MWL
Description:	Water Level

Distance (ft):	.0
Structural Grade:	0
O&M Grade:	0
Clock Start/From:	
Clock To:	
1st Value:	
2nd Value:	
Value Percent:	10.000
Continuous Index:	
Within 8" of Joint:	NO
Remarks:

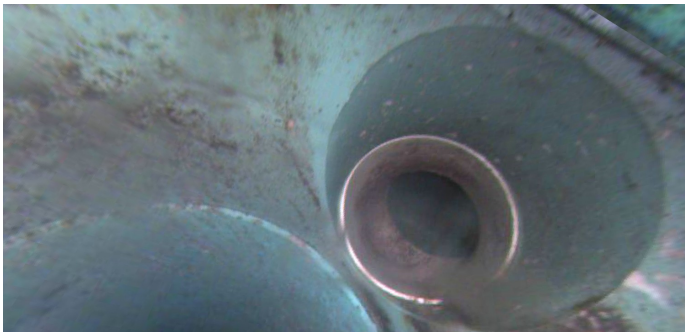
Code:	TF
Description:	Tap Factory

Distance (ft):	6.6
Structural Grade:	0
O&M Grade:	0
Clock Start/From:	10
Clock To:	
1st Value:	4.000
2nd Value:	
Value Percent:	
Continuous Index:	
Within 8" of Joint:	
Remarks:

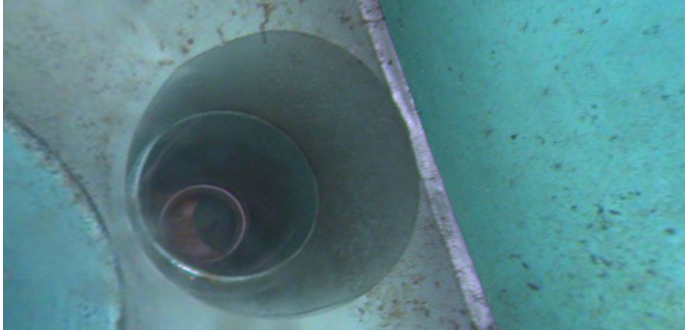
Code: **TF**
Description: **Tap Factory**

Distance (ft): **54.6**
Structural Grade: **0**
O&M Grade: **0**
Clock Start/From: **10**
Clock To:
1st Value: **4.000**
2nd Value:
Value Percent:
Continuous Index:
Within 8" of Joint:
Remarks:

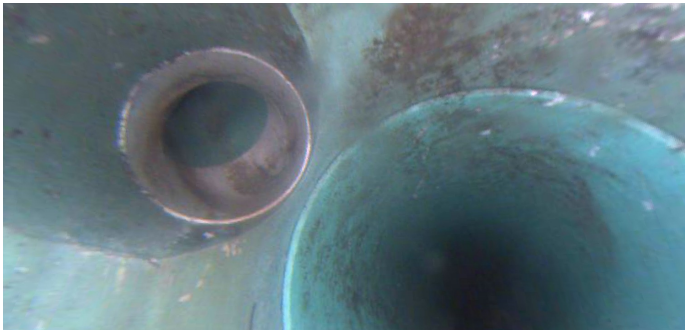
Code: **TF**
Description: **Tap Factory**

Distance (ft): **66.0**
Structural Grade: **0**
O&M Grade: **0**
Clock Start/From: **2**
Clock To:
1st Value: **4.000**
2nd Value:
Value Percent:
Continuous Index:
Within 8" of Joint:
Remarks:

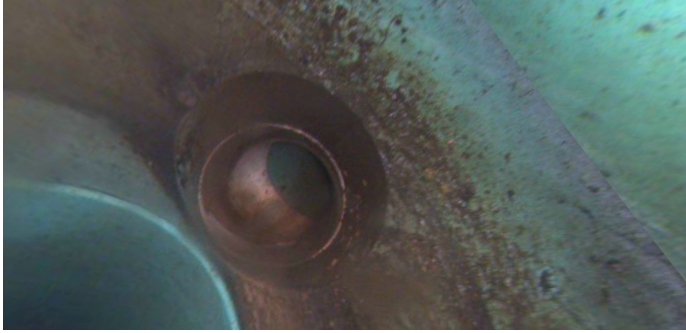
Code: **TF**
Description: **Tap Factory**

Distance (ft): **97.3**
Structural Grade: **0**
O&M Grade: **0**
Clock Start/From: **10**
Clock To:
1st Value: **4.000**
2nd Value:
Value Percent:
Continuous Index:
Within 8" of Joint:
Remarks:

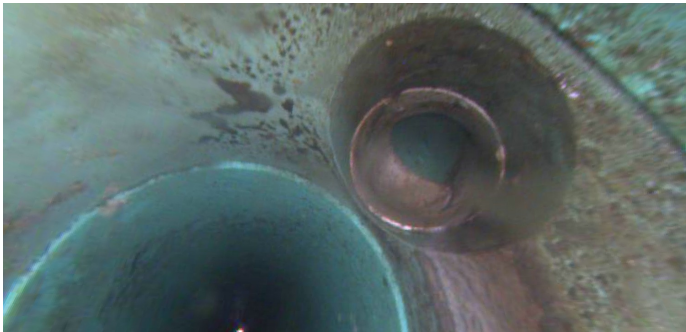
Code: **TF**
Description: **Tap Factory**

Distance (ft): **177.5**
Structural Grade: **0**
O&M Grade: **0**
Clock Start/From: **11**
Clock To:
1st Value: **4.000**
2nd Value:
Value Percent:
Continuous Index:
Within 8" of Joint:
Remarks:

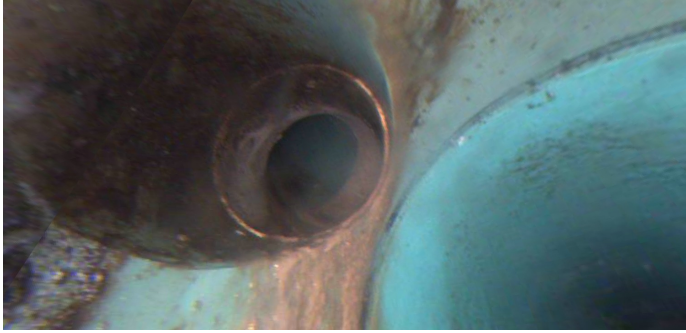
Code: **TF**
Description: **Tap Factory**

Distance (ft): **210.4**
Structural Grade: **0**
O&M Grade: **0**
Clock Start/From: **2**
Clock To:
1st Value: **4.000**
2nd Value:
Value Percent:
Continuous Index:
Within 8" of Joint:
Remarks:

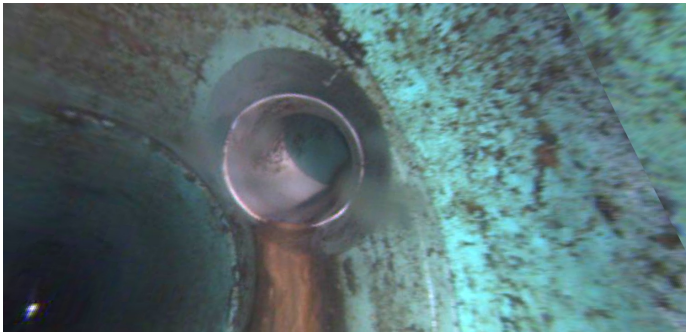
Code: **TF**
Description: **Tap Factory**

Distance (ft): **229.0**
Structural Grade: **0**
O&M Grade: **0**
Clock Start/From: **10**
Clock To:
1st Value: **4.000**
2nd Value:
Value Percent:
Continuous Index:
Within 8" of Joint:
Remarks:

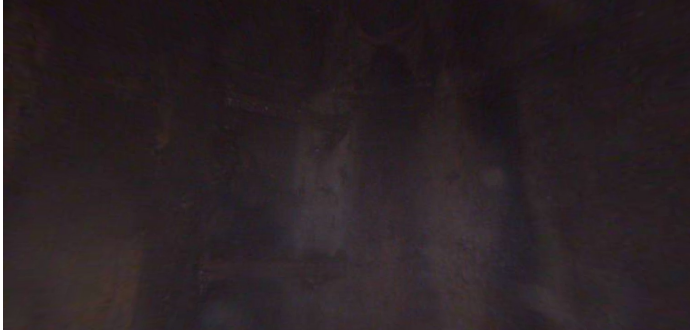
Code:	AMH
Description:	Manhole
Distance (ft):	267.4
Structural Grade:	0
O&M Grade:	0
Clock Start/From:	
Clock To:	
1st Value:	
2nd Value:	
Value Percent:	
Continuous Index:	
Within 8" of Joint:	NO
Remarks:	M-805-005
