Profile/Photo Observation Report

Street:	Lawrence	Flow Control:	Not Controlled
City:	Hobart, IN	Year Renewed:	
Location:	Alley	Tape/Media #:	
Purpose:	Maintenance Related	Dia/Height:	12"
Use:	Sanitary	Material:	PVC
Drain Area:	NA	Lining:	Cured in Place
Category:	NA		
Comment:	Flow direction wrong. Redeployment.		
Location Details:		Direction of Survey:	Upstream
US MH:	M-805-005	DS MH:	M-805-006
		Total Length Surveyed (ft):	267.4

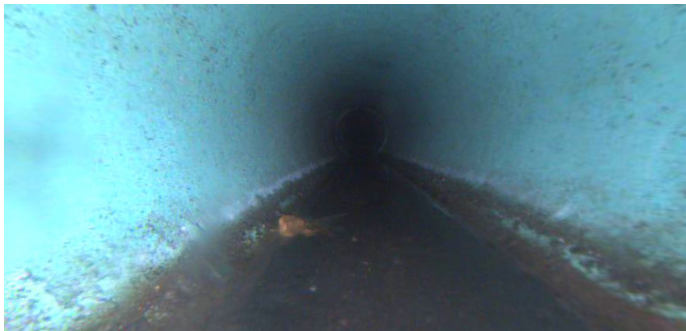
Code: **AMH**
Description: **Manhole**

Distance (ft): **.0**
Structural Grade: **0**
O&M Grade: **0**
Clock Start/From:
Clock To:
1st Value:
2nd Value:
Value Percent:
Continuous Index:
Within 8" of Joint: **NO**
Remarks: **M-805-006**

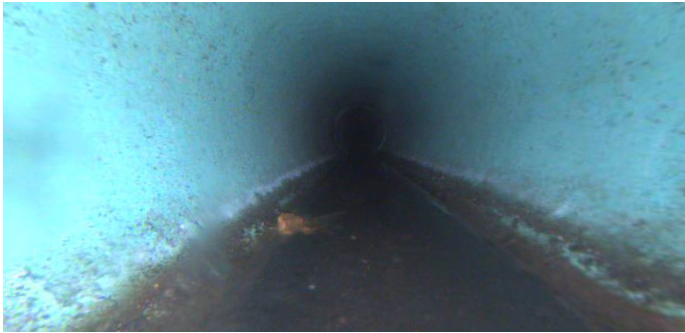
Code:	MWL
Description:	Water Level

Distance (ft):	.0
Structural Grade:	0
O&M Grade:	0
Clock Start/From:	
Clock To:	
1st Value:	
2nd Value:	
Value Percent:	10.000
Continuous Index:	
Within 8" of Joint:	NO
Remarks:

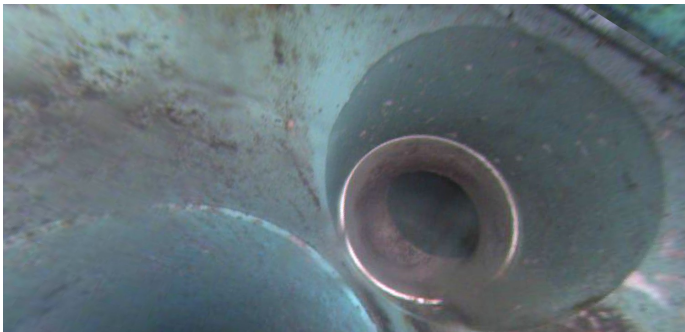
Code:	TF
Description:	Tap Factory

Distance (ft):	6.6
Structural Grade:	0
O&M Grade:	0
Clock Start/From:	10
Clock To:	
1st Value:	4.000
2nd Value:	
Value Percent:	
Continuous Index:	
Within 8" of Joint:	
Remarks:

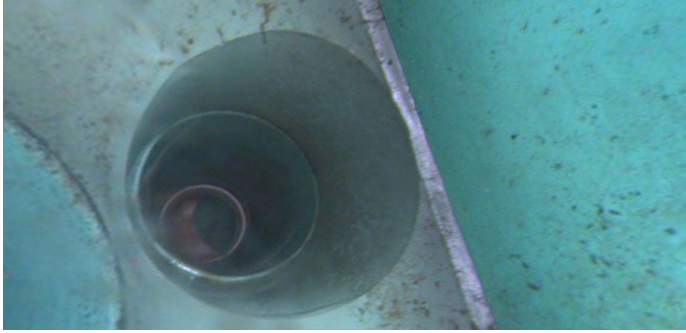
Code: **TF**
Description: **Tap Factory**

Distance (ft): **54.6**
Structural Grade: **0**
O&M Grade: **0**
Clock Start/From: **10**
Clock To:
1st Value: **4.000**
2nd Value:
Value Percent:
Continuous Index:
Within 8" of Joint:
Remarks:

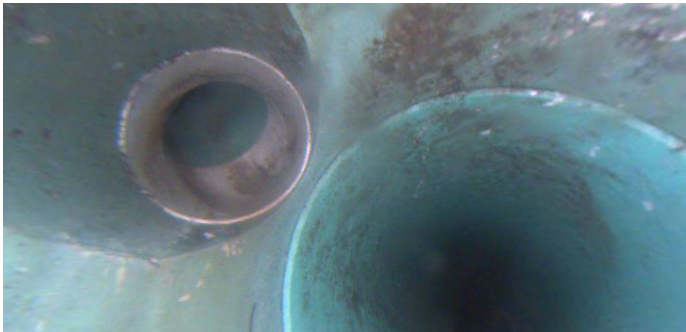
Code: **TF**
Description: **Tap Factory**

Distance (ft): **66.0**
Structural Grade: **0**
O&M Grade: **0**
Clock Start/From: **2**
Clock To:
1st Value: **4.000**
2nd Value:
Value Percent:
Continuous Index:
Within 8" of Joint:
Remarks:

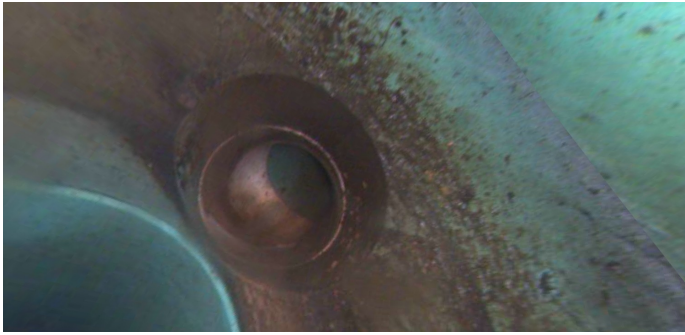
Code: **TF**
Description: **Tap Factory**

Distance (ft): **97.3**
Structural Grade: **0**
O&M Grade: **0**
Clock Start/From: **10**
Clock To:
1st Value: **4.000**
2nd Value:
Value Percent:
Continuous Index:
Within 8" of Joint:
Remarks:

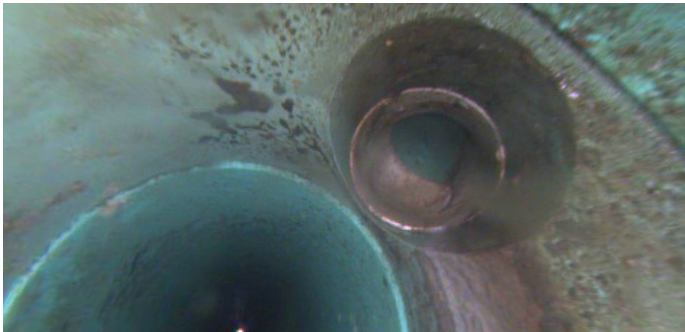
Code: **TF**
Description: **Tap Factory**

Distance (ft): **177.5**
Structural Grade: **0**
O&M Grade: **0**
Clock Start/From: **11**
Clock To:
1st Value: **4.000**
2nd Value:
Value Percent:
Continuous Index:
Within 8" of Joint:
Remarks:

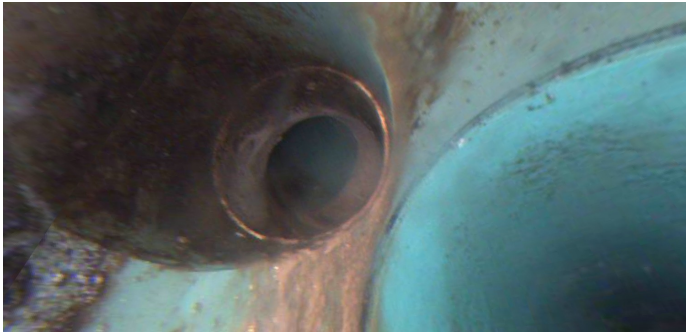
Code: **TF**
Description: **Tap Factory**

Distance (ft): **210.4**
Structural Grade: **0**
O&M Grade: **0**
Clock Start/From: **2**
Clock To:
1st Value: **4.000**
2nd Value:
Value Percent:
Continuous Index:
Within 8" of Joint:
Remarks:

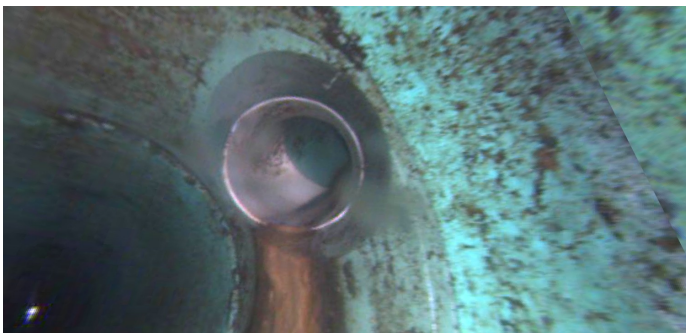
Code: **TF**
Description: **Tap Factory**

Distance (ft): **229.0**
Structural Grade: **0**
O&M Grade: **0**
Clock Start/From: **10**
Clock To:
1st Value: **4.000**
2nd Value:
Value Percent:
Continuous Index:
Within 8" of Joint:
Remarks:
