Profile/Photo Observation Report

Date:	04/23/2018	Weather:		Coding:	PACP 6.0
Pipe Length (ft):	169.2	Owner:	NA	Pre Clean:	Not Known
P.O.#:		Surveyor:	Jen Costello	PSR:	P-805-007-006
Customer:		Clean Date:	01/01/1900	Shape:	C

Street:	ALLEY BETWEEN S HOBART RD & S L	Flow Control:	Not Controlled
City:	Hobart, IN	Year Renewed:	
Location:	Alley	Tape/Media #:	
Purpose:	Maintenance Related	Dia/Height:	12"
Use:	Sanitary	Material:	PVC
Drain Area:	NA	Lining:	Cured in Place
Category:	NA		
Comment:	Flow direction wrong.

Location Details:		Direction of Survey:	Downstream
US MH:	M-805-006	DS MH:	M-805-007
		Total Length Surveyed (ft):	264.3

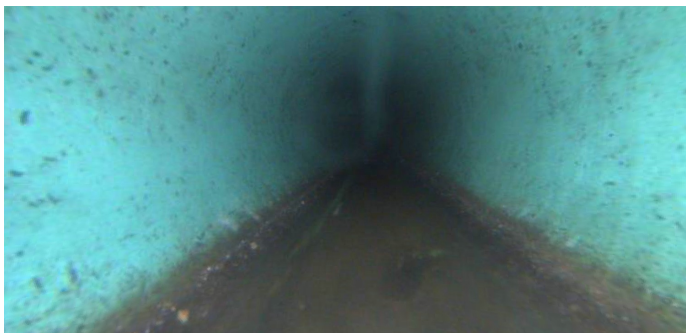
Code: **AMH**
Description: **Manhole**

Distance (ft): **.0**
Structural Grade: **0**
O&M Grade: **0**
Clock Start/From:
Clock To:
1st Value:
2nd Value:
Value Percent:
Continuous Index:
Within 8" of Joint: **NO**
Remarks: **M-805-006**

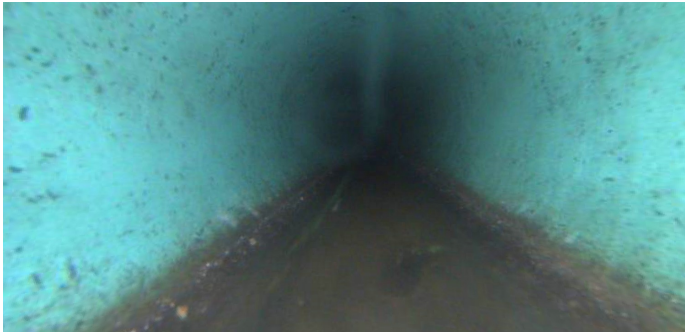
Code:	MWL
Description:	Water Level

Distance (ft):	.0
Structural Grade:	0
O&M Grade:	0
Clock Start/From:	
Clock To:	
1st Value:	
2nd Value:	
Value Percent:	10.000
Continuous Index:	
Within 8" of Joint:	NO
Remarks:

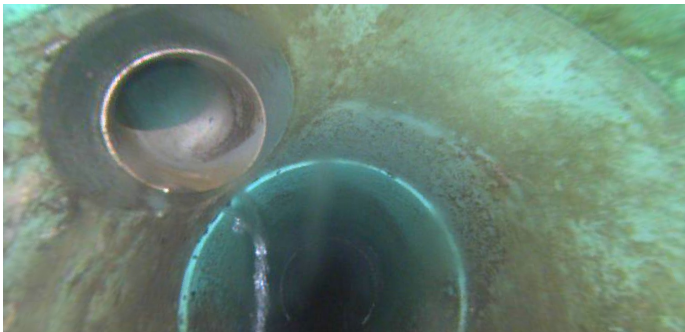
Code:	TFA
Description:	Tap Factory Active

Distance (ft):	23.4
Structural Grade:	0
O&M Grade:	0
Clock Start/From:	10
Clock To:	
1st Value:	4.000
2nd Value:	
Value Percent:	
Continuous Index:	
Within 8" of Joint:	
Remarks:

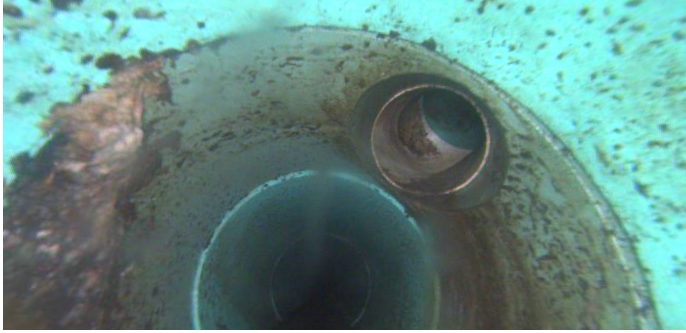
Code: **DAGS**
Description: **Deposits Attached Grease**

Distance (ft): **53.8**
Structural Grade: **0**
O&M Grade: **2**
Clock Start/From: **10**
Clock To:
1st Value:
2nd Value:
Value Percent: **5.000**
Continuous Index:
Within 8" of Joint: **NO**
Remarks:

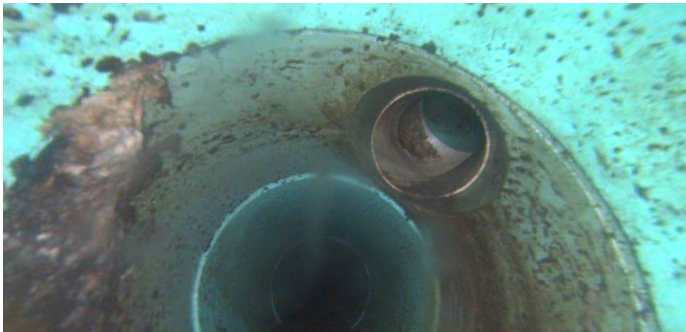
Code: **TF**
Description: **Tap Factory**

Distance (ft): **53.8**
Structural Grade: **0**
O&M Grade: **0**
Clock Start/From: **1**
Clock To:
1st Value: **4.000**
2nd Value:
Value Percent:
Continuous Index:
Within 8" of Joint:
Remarks:

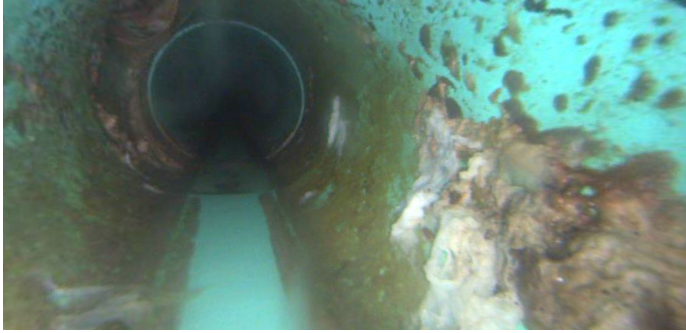
Code: **DAGS**
Description: **Deposits Attached Grease**

Distance (ft): **102.1**
Structural Grade: **0**
O&M Grade: **2**
Clock Start/From: **3**
Clock To: **5**
1st Value:
2nd Value:
Value Percent: **5.000**
Continuous Index:
Within 8" of Joint: **NO**
Remarks:

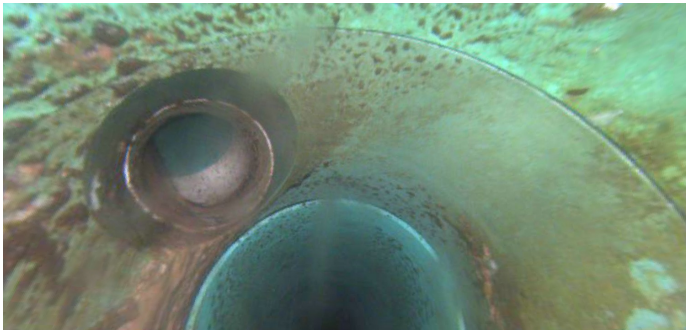
Code: **TF**
Description: **Tap Factory**

Distance (ft): **103.0**
Structural Grade: **0**
O&M Grade: **0**
Clock Start/From: **11**
Clock To:
1st Value: **4.000**
2nd Value:
Value Percent:
Continuous Index:
Within 8" of Joint:
Remarks:

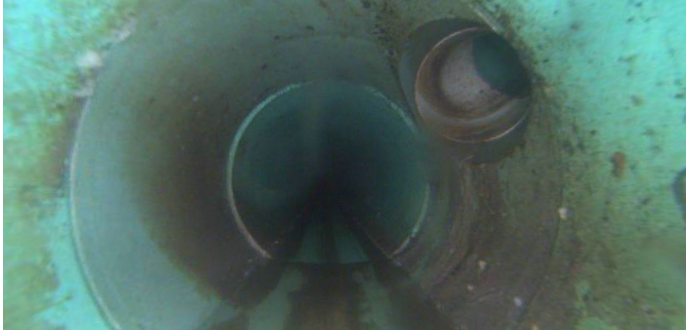
Code: **TF**
Description: **Tap Factory**

Distance (ft): **110.6**
Structural Grade: **0**
O&M Grade: **0**
Clock Start/From: **2**
Clock To:
1st Value: **4.000**
2nd Value:
Value Percent:
Continuous Index:
Within 8" of Joint:
Remarks:

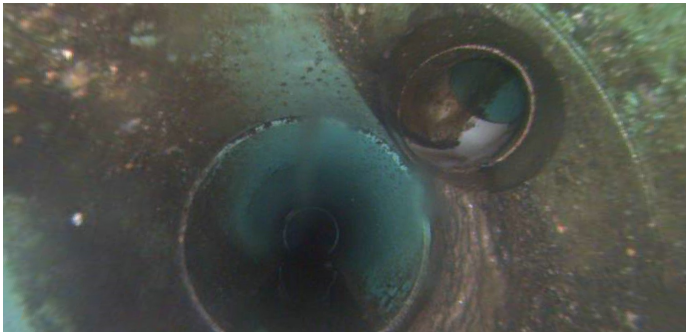
Code: **TF**
Description: **Tap Factory**

Distance (ft): **151.5**
Structural Grade: **0**
O&M Grade: **0**
Clock Start/From: **2**
Clock To:
1st Value: **4.000**
2nd Value:
Value Percent:
Continuous Index:
Within 8" of Joint:
Remarks:

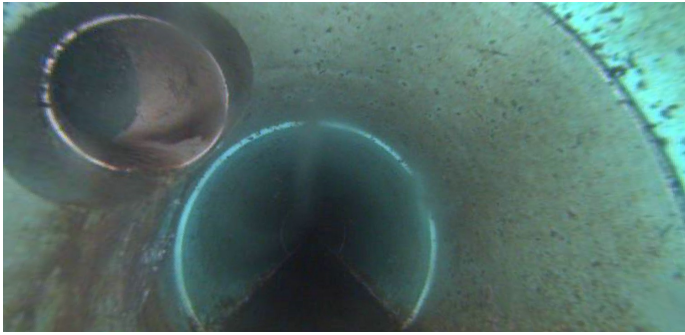
Code: **TFA**
Description: **Tap Factory Active**

Distance (ft): **155.8**
Structural Grade: **0**
O&M Grade: **0**
Clock Start/From: **10**
Clock To:
1st Value: **4.000**
2nd Value:
Value Percent:
Continuous Index:
Within 8" of Joint:
Remarks:

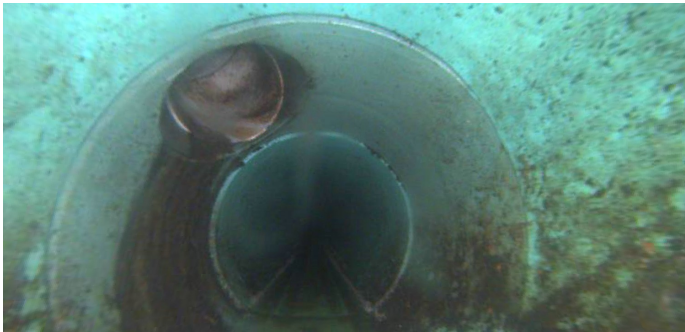
Code: **TF**
Description: **Tap Factory**

Distance (ft): **224.0**
Structural Grade: **0**
O&M Grade: **0**
Clock Start/From: **11**
Clock To:
1st Value: **4.000**
2nd Value:
Value Percent:
Continuous Index:
Within 8" of Joint:
Remarks:

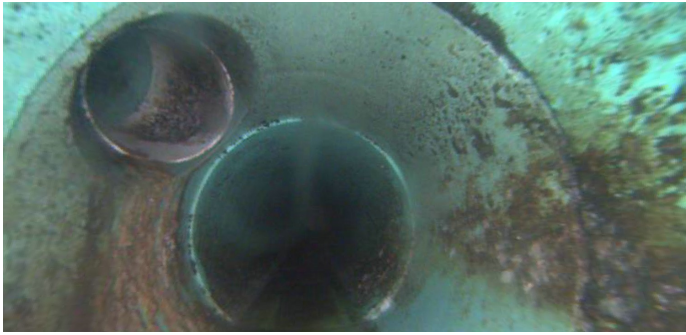
Code: **TF**
Description: **Tap Factory**

Distance (ft): **256.7**
Structural Grade: **0**
O&M Grade: **0**
Clock Start/From: **10**
Clock To:
1st Value: **4.000**
2nd Value:
Value Percent:
Continuous Index:
Within 8" of Joint:
Remarks:

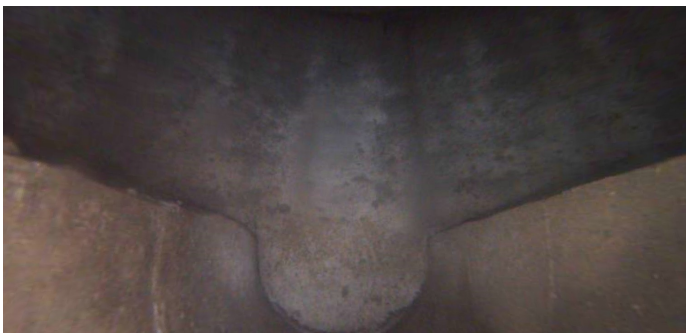
Code: **AMH**
Description: **Manhole**

Distance (ft): **264.3**
Structural Grade: **0**
O&M Grade: **0**
Clock Start/From:
Clock To:
1st Value:
2nd Value:
Value Percent:
Continuous Index:
Within 8" of Joint: **NO**
Remarks: **M-805-007**
