## Profile/Photo Observation Report

Street:	<b>Lawrence</b>	Flow Control:	<b>Not Controlled</b>
City:	<b>Hobart, IN</b>	Year Renewed:	
Location:	<b>Alley</b>	Tape/Media #:	
Purpose:	<b>Maintenance Related</b>	Dia/Height:	<b>12"</b>
Use:	<b>Sanitary</b>	Material:	<b>PVC</b>
Drain Area:	<b>NA</b>	Lining:	<b>Cured in Place</b>
Category:	<b>NA</b>		
Comment:	<b>Flow direction wrong.</b>

Location Details:		Direction of Survey:	<b>Downstream</b>
US MH:	<b>M-805-006</b>	DS MH:	<b>M-805-007</b>
		Total Length Surveyed (ft):	<b>264.3</b>

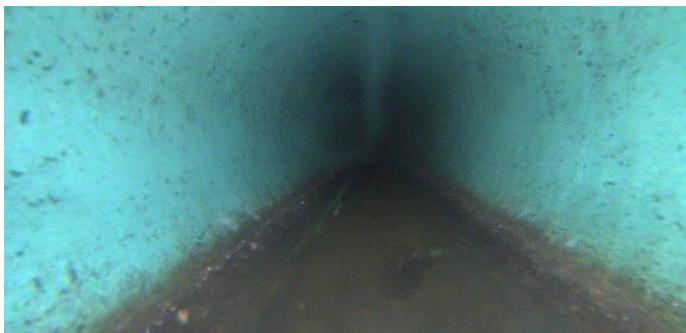
Code: **AMH**  
Description: **Manhole**

Distance (ft): **.0**  
Structural Grade: **0**  
O&M Grade: **0**  
Clock Start/From:  
Clock To:  
1st Value:  
2nd Value:  
Value Percent:  
Continuous Index:  
Within 8" of Joint: **NO**  
Remarks: **M-805-006**

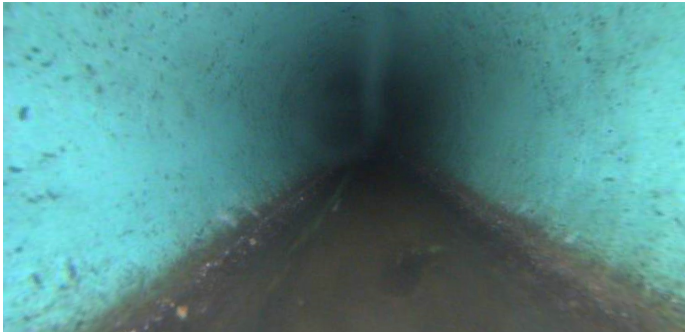
Code: **MWL**  
Description: **Water Level**

Distance (ft): **.0**  
Structural Grade: **0**  
O&M Grade: **0**  
Clock Start/From:  
Clock To:  
1st Value:  
2nd Value:  
Value Percent: **10.000**  
Continuous Index:  
Within 8" of Joint: **NO**  
Remarks:

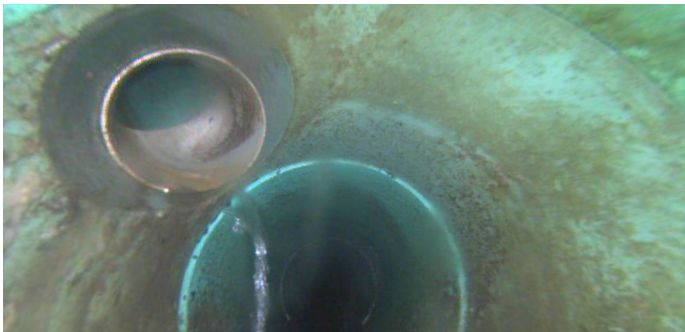
Code: **TFA**  
Description: **Tap Factory Active**

Distance (ft): **23.4**  
Structural Grade: **0**  
O&M Grade: **0**  
Clock Start/From: **10**  
Clock To:  
1st Value: **4.000**  
2nd Value:  
Value Percent:  
Continuous Index:  
Within 8" of Joint:  
Remarks:

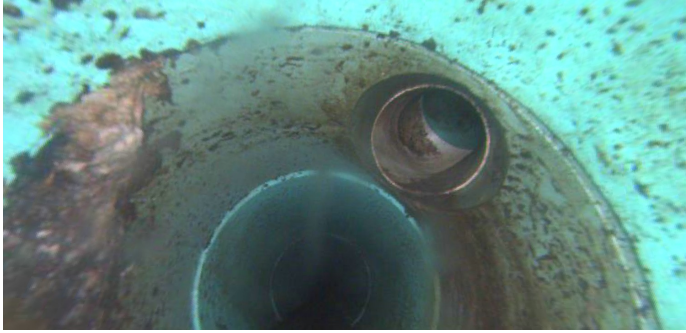
Code: **DAGS**  
Description: **Deposits Attached Grease**

Distance (ft): **53.8**  
Structural Grade: **0**  
O&M Grade: **2**  
Clock Start/From: **10**  
Clock To:  
1st Value:  
2nd Value:  
Value Percent: **5.000**  
Continuous Index:  
Within 8" of Joint: **NO**  
Remarks:

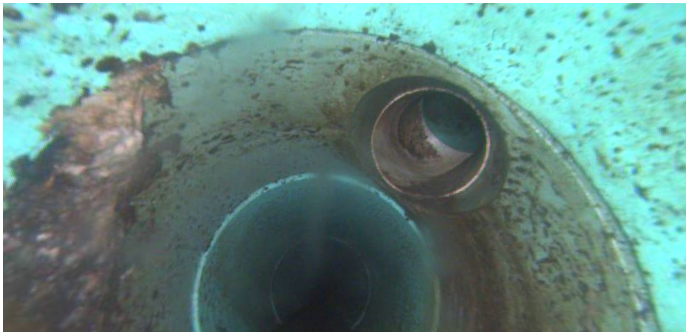
Code: **TF**  
Description: **Tap Factory**

Distance (ft): **53.8**  
Structural Grade: **0**  
O&M Grade: **0**  
Clock Start/From: **1**  
Clock To:  
1st Value: **4.000**  
2nd Value:  
Value Percent:  
Continuous Index:  
Within 8" of Joint:  
Remarks:

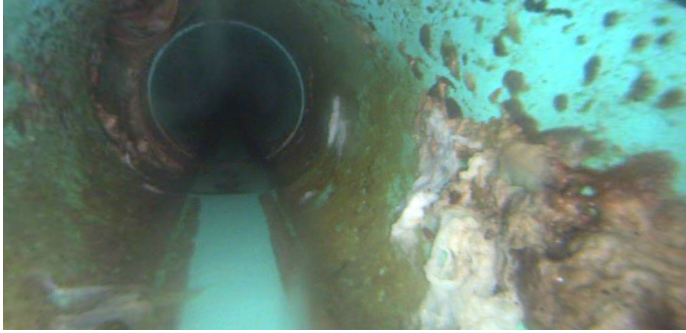
Code: **DAGS**  
Description: **Deposits Attached Grease**

Distance (ft): **102.1**  
Structural Grade: **0**  
O&M Grade: **2**  
Clock Start/From: **3**  
Clock To: **5**  
1st Value:  
2nd Value:  
Value Percent: **5.000**  
Continuous Index:  
Within 8" of Joint: **NO**  
Remarks:

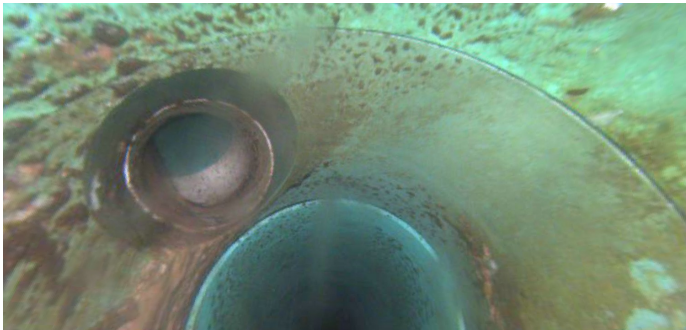
Code: **TF**  
Description: **Tap Factory**

Distance (ft): **103.0**  
Structural Grade: **0**  
O&M Grade: **0**  
Clock Start/From: **11**  
Clock To:  
1st Value: **4.000**  
2nd Value:  
Value Percent:  
Continuous Index:  
Within 8" of Joint:  
Remarks:

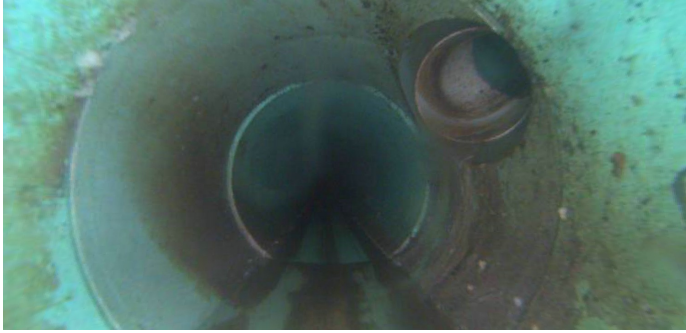
Code: **TF**  
Description: **Tap Factory**

Distance (ft): **110.6**  
Structural Grade: **0**  
O&M Grade: **0**  
Clock Start/From: **2**  
Clock To:  
1st Value: **4.000**  
2nd Value:  
Value Percent:  
Continuous Index:  
Within 8" of Joint:  
Remarks:

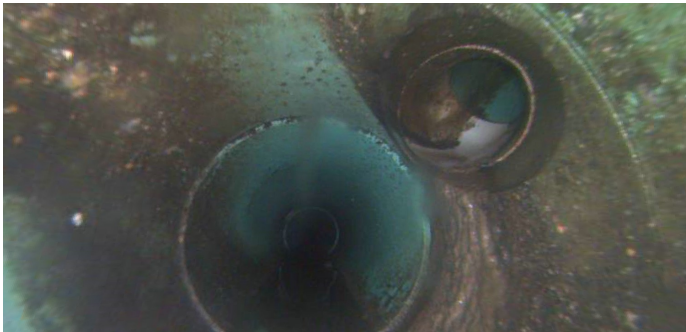
Code: **TF**  
Description: **Tap Factory**

Distance (ft): **151.5**  
Structural Grade: **0**  
O&M Grade: **0**  
Clock Start/From: **2**  
Clock To:  
1st Value: **4.000**  
2nd Value:  
Value Percent:  
Continuous Index:  
Within 8" of Joint:  
Remarks:

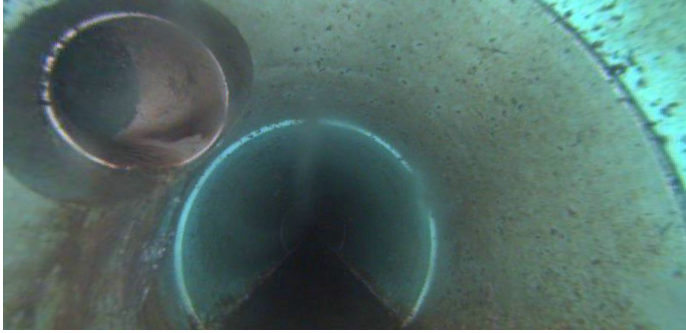
Code: **TFA**  
Description: **Tap Factory Active**

Distance (ft): **155.8**  
Structural Grade: **0**  
O&M Grade: **0**  
Clock Start/From: **10**  
Clock To:  
1st Value: **4.000**  
2nd Value:  
Value Percent:  
Continuous Index:  
Within 8" of Joint:  
Remarks:

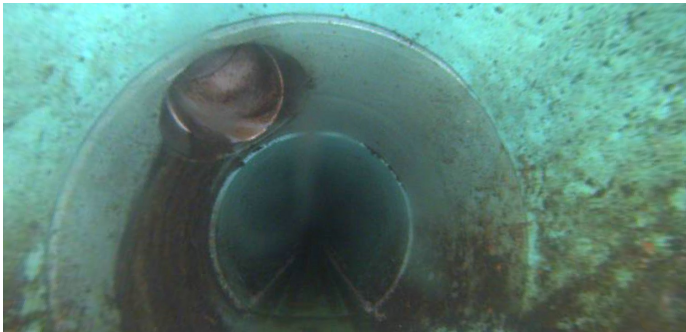
Code: **TF**  
Description: **Tap Factory**

Distance (ft): **224.0**  
Structural Grade: **0**  
O&M Grade: **0**  
Clock Start/From: **11**  
Clock To:  
1st Value: **4.000**  
2nd Value:  
Value Percent:  
Continuous Index:  
Within 8" of Joint:  
Remarks:

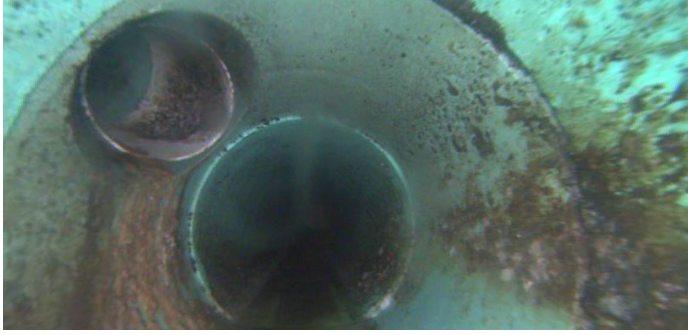
Code: **TF**  
Description: **Tap Factory**

Distance (ft): **256.7**  
Structural Grade: **0**  
O&M Grade: **0**  
Clock Start/From: **10**  
Clock To:  
1st Value: **4.000**  
2nd Value:  
Value Percent:  
Continuous Index:  
Within 8" of Joint:  
Remarks:

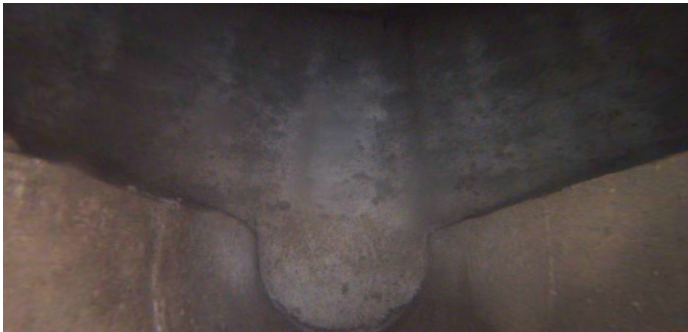
Code: **AMH**  
Description: **Manhole**

Distance (ft): **264.3**  
Structural Grade: **0**  
O&M Grade: **0**  
Clock Start/From:  
Clock To:  
1st Value:  
2nd Value:  
Value Percent:  
Continuous Index:  
Within 8" of Joint: **NO**  
Remarks: **M-805-007**
