Profile/Photo Observation Report

Date:	05/05/2018	Weather:		Coding:	PACP 6.0
Pipe Length (ft):		Owner:	City of Hobart	Pre Clean:	No Pre-Cleaning
P.O.#:	193	Surveyor:	M. Pielacha	PSR:	P-805-005-009
Customer:	City of Hobart	Clean Date:		Shape:	C

Street:	5th Street	Flow Control:	Not Controlled
City:	Hobart, IN	Year Renewed:	
Location:	Light Highway	Tape/Media #:	DEP 193
Purpose:	Routine Assessment	Dia/Height:	20"
Use:	Sanitary	Material:	VCP
Drain Area:		Lining:	
Category:	NA		
Comment:	5-21-2018		
Location Details:		Direction of Survey:	Upstream
US MH:	M-805-009	DS MH:	M-805-005
		Total Length Surveyed (ft):	328.1

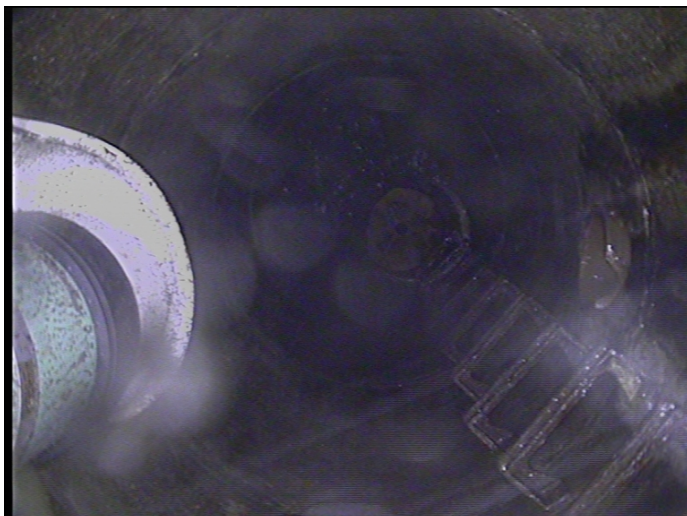
Code: **AMH**
 Description: **Manhole**

Distance (ft): **.0**
 Structural Grade: **0**
 O&M Grade: **0**
 Clock Start/From:
 Clock To:
 1st Value:
 2nd Value:
 Value Percent:
 Continuous Index:
 Within 8" of Joint: **NO**
 Remarks: **M-805-009**

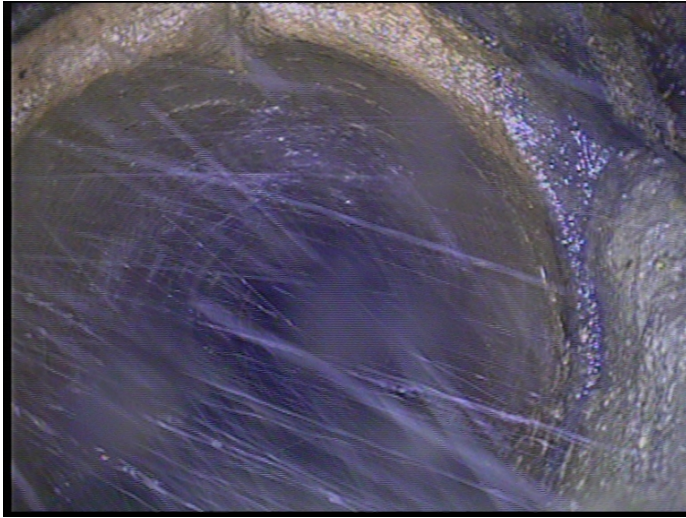
Code:	MWL
Description:	Water Level
Distance (ft):	.0
Structural Grade:	0
O&M Grade:	0
Clock Start/From:	
Clock To:	
1st Value:	
2nd Value:	
Value Percent:	10.000
Continuous Index:	
Within 8" of Joint:	NO
Remarks:

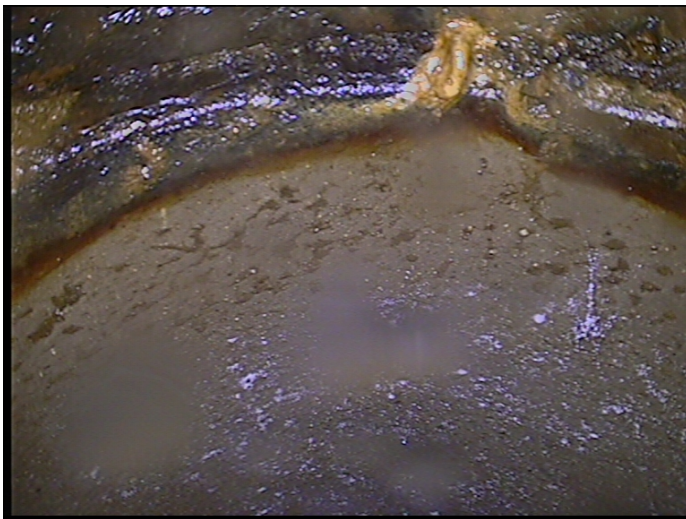
Code:	ID
Description:	Infil Dripper
Distance (ft):	11.0
Structural Grade:	0
O&M Grade:	3
Clock Start/From:	12
Clock To:	
1st Value:	
2nd Value:	
Value Percent:	
Continuous Index:	
Within 8" of Joint:	YES
Remarks:

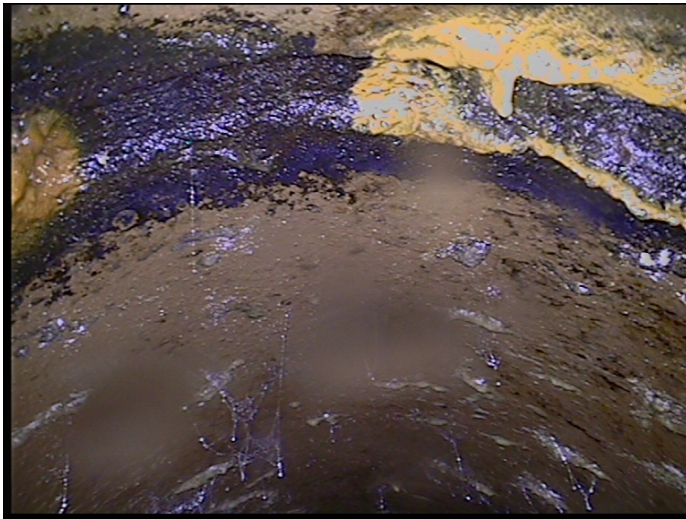
Code:	ID
Description:	Infil Dripper
Distance (ft):	49.7
Structural Grade:	0
O&M Grade:	3
Clock Start/From:	11
Clock To:	1
1st Value:	
2nd Value:	
Value Percent:	
Continuous Index:	
Within 8" of Joint:	YES
Remarks:

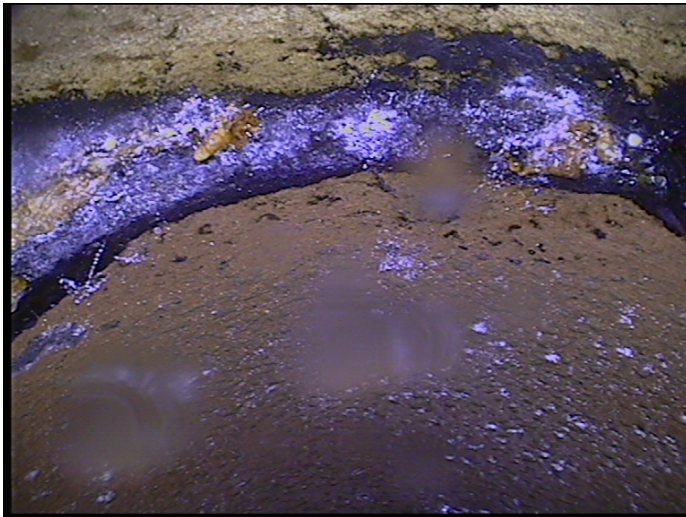
Code:	ID
Description:	Infil Dripper
Distance (ft):	59.5
Structural Grade:	0
O&M Grade:	3
Clock Start/From:	11
Clock To:	
1st Value:	
2nd Value:	
Value Percent:	
Continuous Index:	S01
Within 8" of Joint:	YES
Remarks:

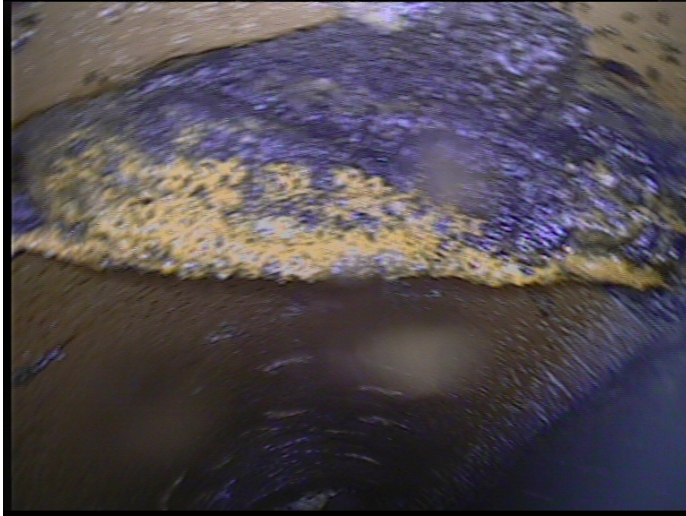
Code:	DAE
Description:	Deposits Attached Encrustation
Distance (ft):	102.8
Structural Grade:	0
O&M Grade:	2
Clock Start/From:	1
Clock To:	5
1st Value:	
2nd Value:	
Value Percent:	10.000
Continuous Index:	
Within 8" of Joint:	YES
Remarks:

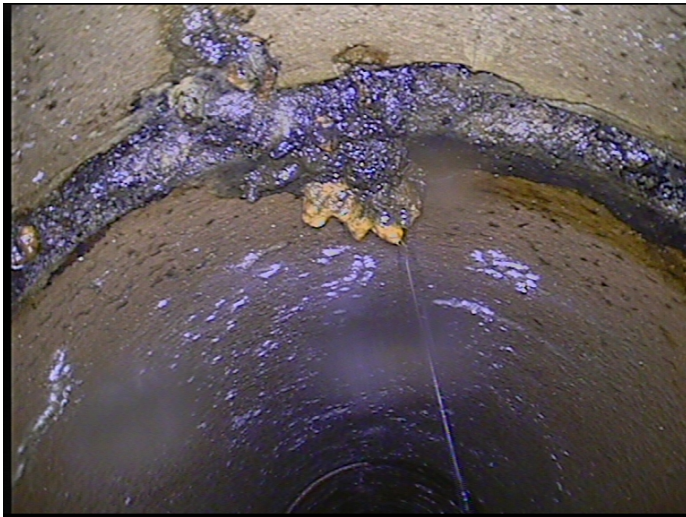
Code:	IR
Description:	Infil Runner
Distance (ft):	121.0
Structural Grade:	0
O&M Grade:	4
Clock Start/From:	12
Clock To:	
1st Value:	
2nd Value:	
Value Percent:	
Continuous Index:	
Within 8" of Joint:	YES
Remarks:

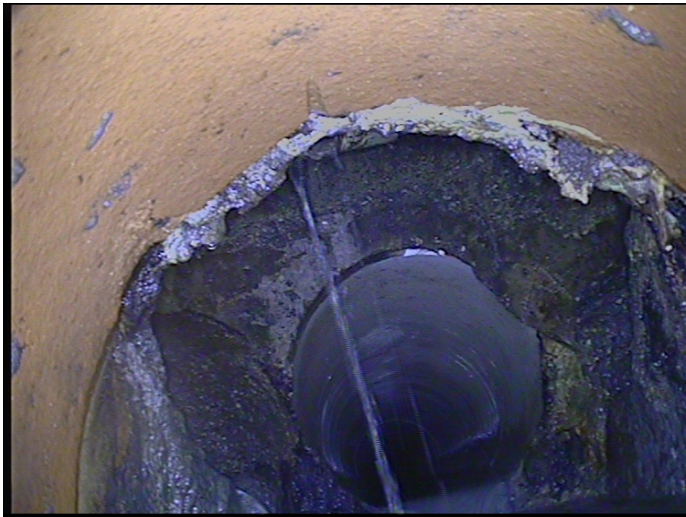
Code: **ID**
 Description: **Infil Dripper**

Distance (ft): **328.1**
 Structural Grade: **0**
 O&M Grade: **3**
 Clock Start/From: **11**
 Clock To:
 1st Value:
 2nd Value:
 Value Percent:
 Continuous Index: **F01**
 Within 8" of Joint: **NO**
 Remarks:

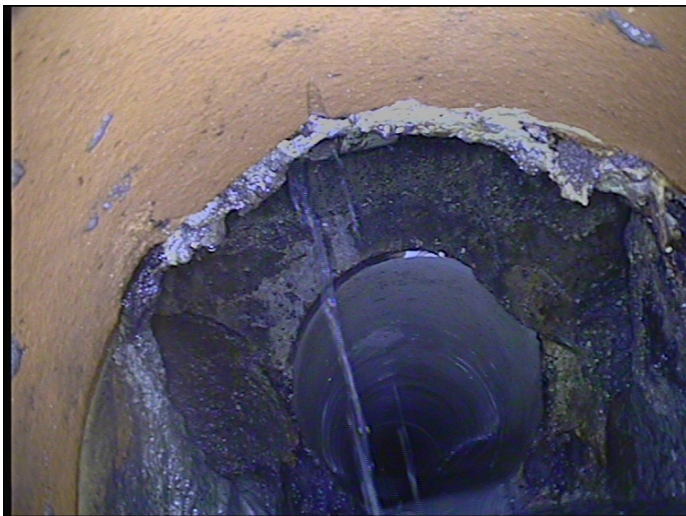
Code: **AMH**
 Description: **Manhole**

Distance (ft): **328.1**
 Structural Grade: **0**
 O&M Grade: **0**
 Clock Start/From:
 Clock To:
 1st Value:
 2nd Value:
 Value Percent:
 Continuous Index:
 Within 8" of Joint: **NO**
 Remarks: **M-805-005**
