Profile/Photo Observation Report

Street:	S LAWRENCE ST & S LIBERTY ST	Flow Control:	Not Controlled
City:	Hobart, IN	Year Renewed:	
Location:	Alley	Tape/Media #:	
Purpose:	Maintenance Related	Dia/Height:	12"
Use:	Sanitary	Material:	PVC
Drain Area:	NA	Lining:	Cured in Place
Category:	NA		
Comment:	flow incorrect.

Location Details:		Direction of Survey:	Downstream
US MH:	M-805-010	DS MH:	M-805-011
		Total Length Surveyed (ft):	266.9

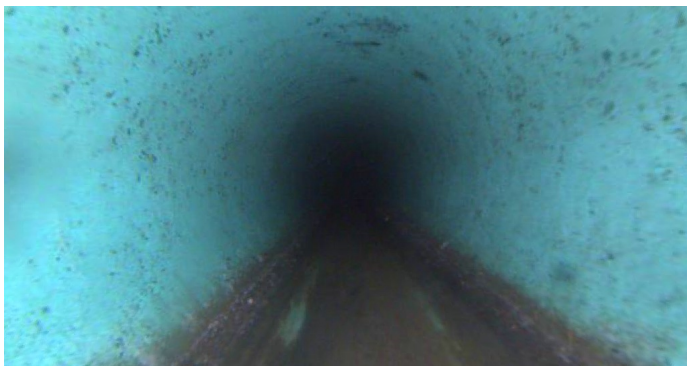
Code: **AMH**
Description: **Manhole**

Distance (ft): **.0**
Structural Grade: **0**
O&M Grade: **0**
Clock Start/From:
Clock To:
1st Value:
2nd Value:
Value Percent:
Continuous Index:
Within 8" of Joint: **NO**
Remarks: **M-805-010**

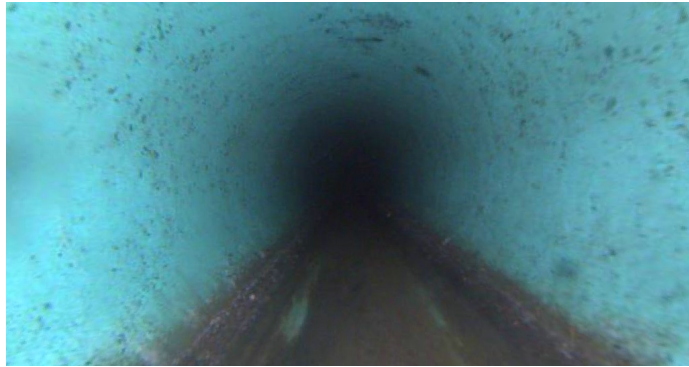
Code: **MWL**
Description: **Water Level**

Distance (ft): **.0**
Structural Grade: **0**
O&M Grade: **0**
Clock Start/From:
Clock To:
1st Value:
2nd Value:
Value Percent: **10.000**
Continuous Index:
Within 8" of Joint: **NO**
Remarks:

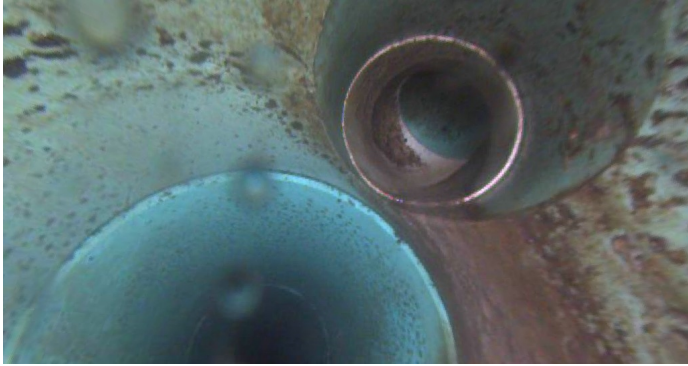
Code: **TF**
Description: **Tap Factory**

Distance (ft): **54.9**
Structural Grade: **0**
O&M Grade: **0**
Clock Start/From: **2**
Clock To:
1st Value: **4.000**
2nd Value:
Value Percent:
Continuous Index:
Within 8" of Joint:
Remarks:

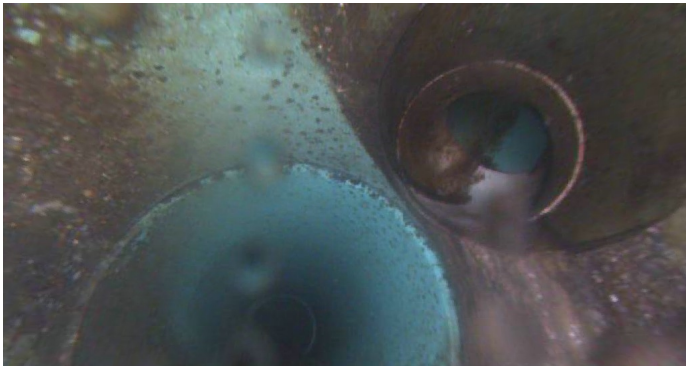
Code: **TF**
Description: **Tap Factory**

Distance (ft): **153.5**
Structural Grade: **0**
O&M Grade: **0**
Clock Start/From: **2**
Clock To:
1st Value: **4.000**
2nd Value:
Value Percent:
Continuous Index:
Within 8" of Joint:
Remarks:

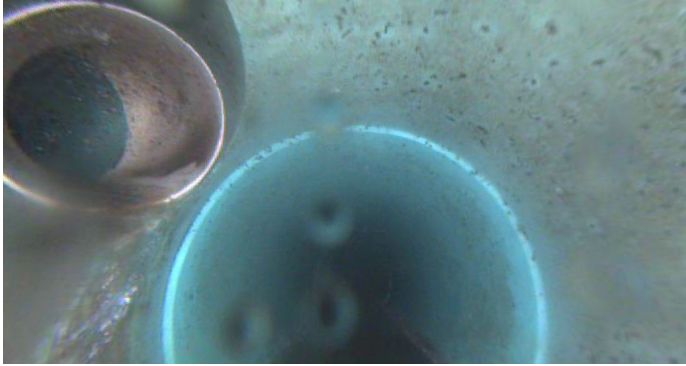
Code: **TFA**
Description: **Tap Factory Active**

Distance (ft): **157.8**
Structural Grade: **0**
O&M Grade: **0**
Clock Start/From: **10**
Clock To:
1st Value: **4.000**
2nd Value:
Value Percent:
Continuous Index:
Within 8" of Joint:
Remarks:

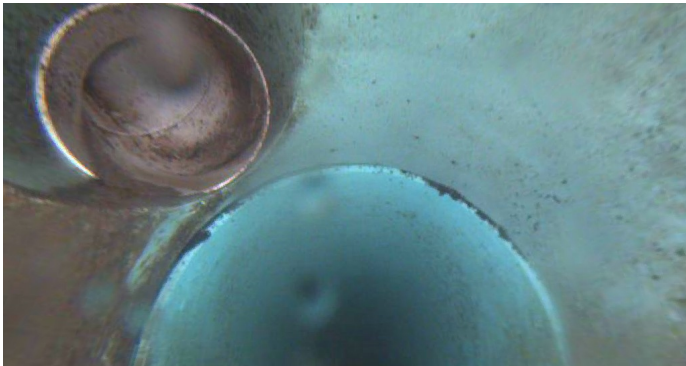
Code: **TF**
Description: **Tap Factory**

Distance (ft): **227.1**
Structural Grade: **0**
O&M Grade: **0**
Clock Start/From: **10**
Clock To:
1st Value: **4.000**
2nd Value:
Value Percent:
Continuous Index:
Within 8" of Joint:
Remarks:

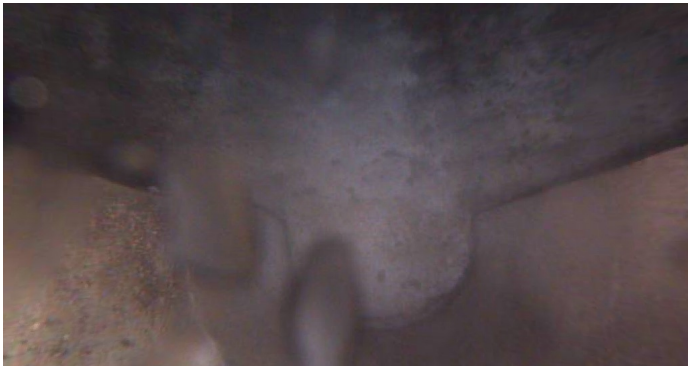
Code: **AMH**
Description: **Manhole**

Distance (ft): **266.9**
Structural Grade: **0**
O&M Grade: **0**
Clock Start/From:
Clock To:
1st Value:
2nd Value:
Value Percent:
Continuous Index:
Within 8" of Joint: **NO**
Remarks: **M-805-011**
